**Section Three - Systems Description**

**Building Name:** *Fire Station 1*

**Building Name:** *Fire Station 4*

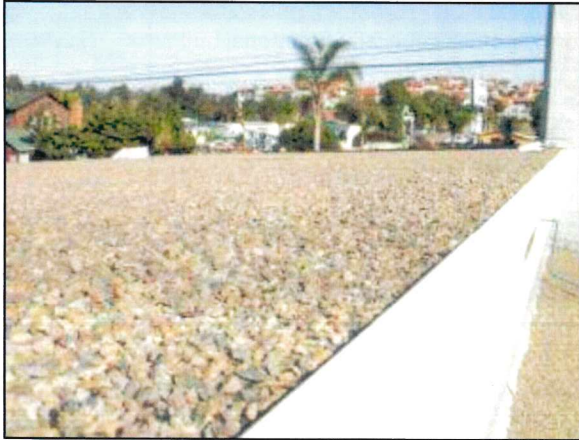
**Photo 1 – Fire Station #1** The fire station exhibits a flat structure built up roof with gravel aggregate.

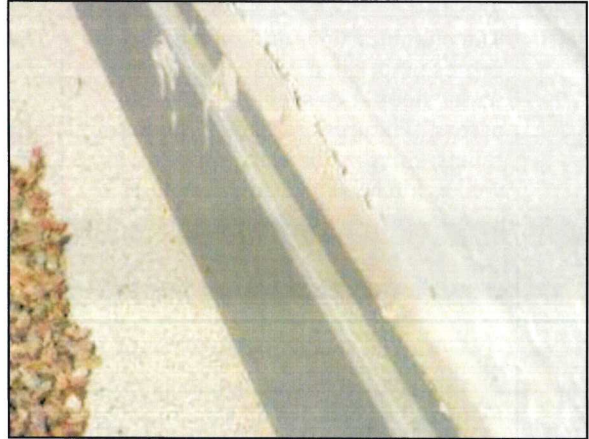
**Photo 2 – Fire Station #1** Caulk repairs are needed at the termination flashing on the roof.

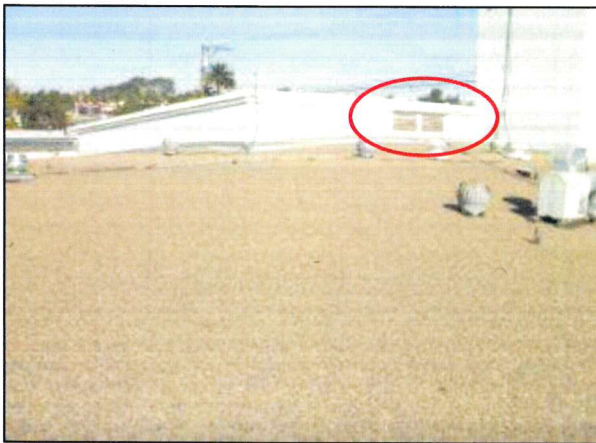
**Photo 3 – Fire Station #1** Wood louvers present at the roof are deteriorating and need to be repainted.

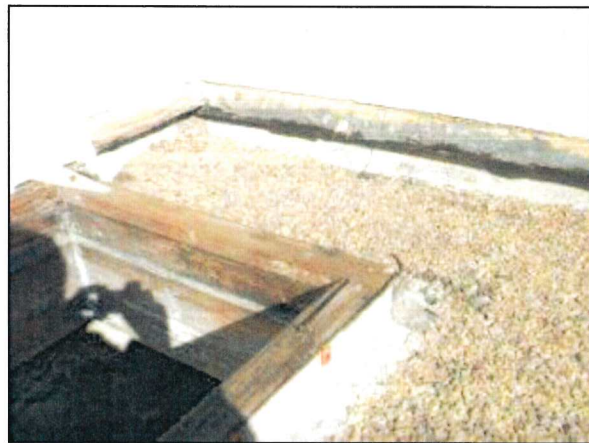
**Photo 4 – Fire Station #1** The hose tower roof requires a new roof hatch and curb.

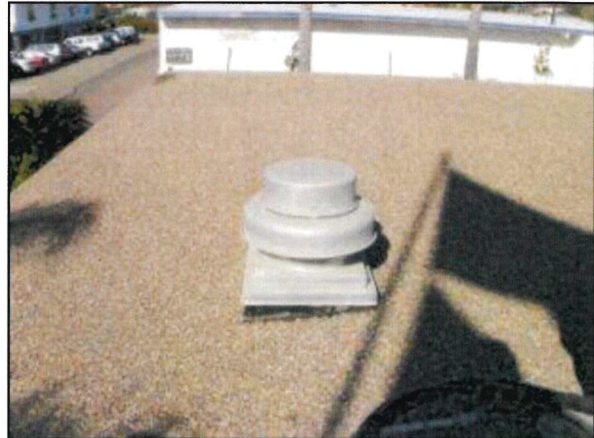
**Photo 6 – Fire Station #1** An exhaust fan (GEF-1) is corroded, in poor condition, and may have been abandoned. Abandoned fans should be removed and their penetrations capped.

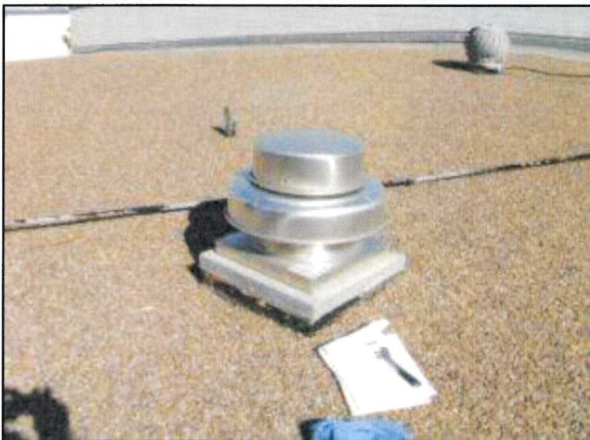
**Photo 7 – Fire Station #1** A newly-installed exhaust fan (GEF-2) is present at the roof and is in good overall condition.

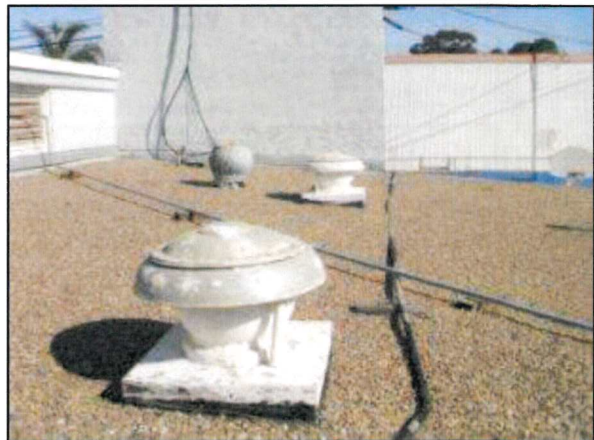
**Photo 8 – Fire Station #1** Another exhaust fan (GEF-4) appears to be abandoned. Abandoned exhaust fans should be removed and permanently capped. Note GEF-5 in the background is also apparently abandoned in place.

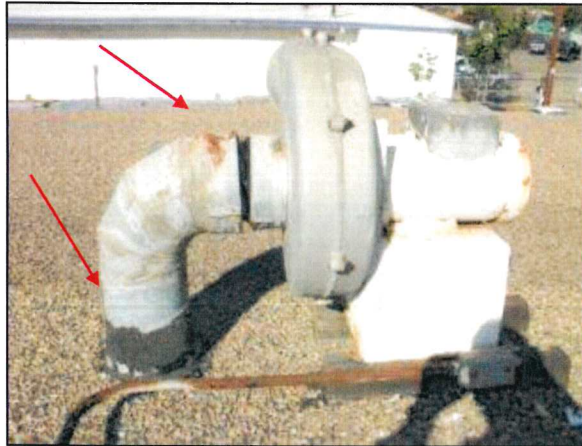
**Photo 9 – Fire Station #1** The outside component of the vehicle exhaust system (GEF-6) is heavily corroded. The ducting requires sealant, and the flex joint requires a sheet metal shroud.

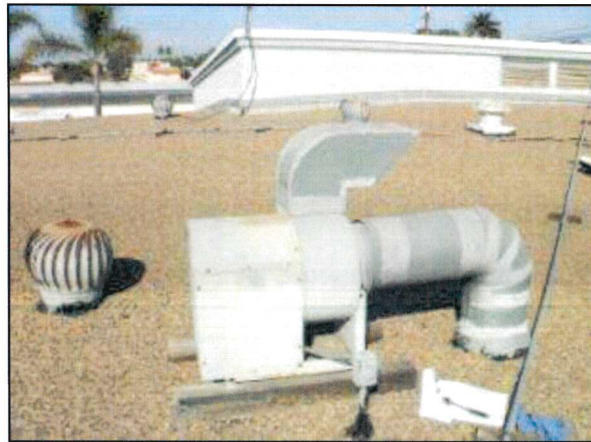
**Photo 10 – Fire Station #1** A belt-driven, centrifugal type exhaust fan (GEF-3) requires sealant at the ducting.

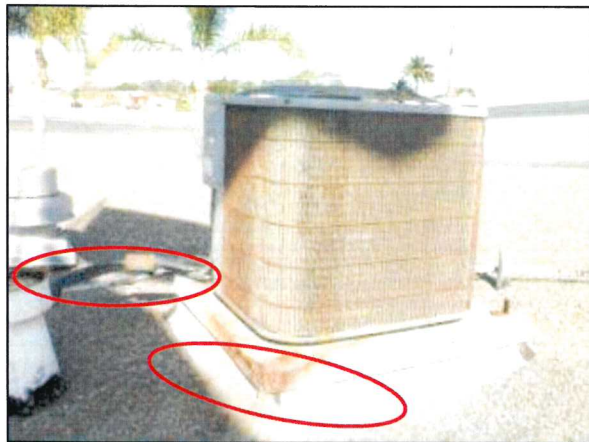
**Photo 11 – Fire Station #1** The condenser portion of the split-system HVAC system located on the roof exhibits a rusted platform cap. The insulation for the refrigeration lines needs replacement.

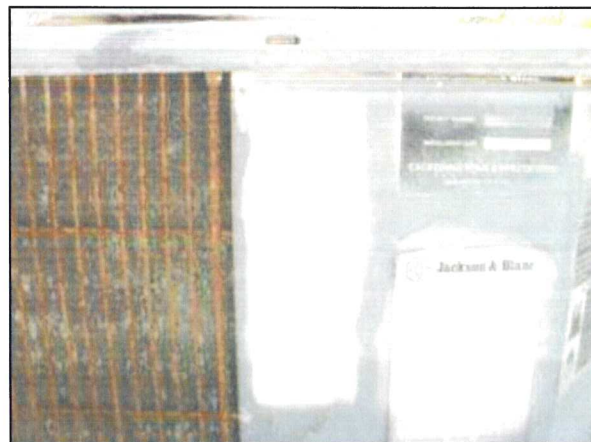
**Photo 12 – Fire Station #1** The condenser coils of the split system condenser unit are heavily corroded.

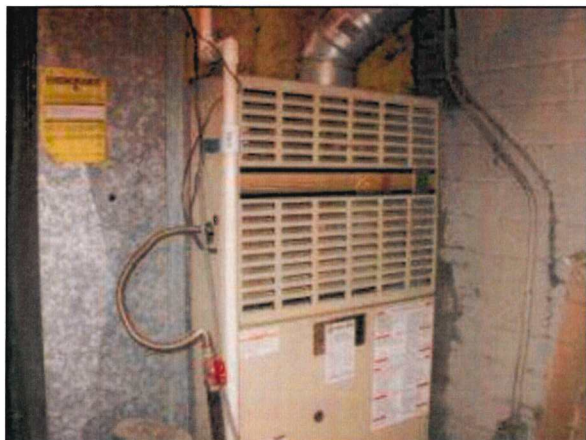
*Photo 13 – Fire Station #1* The inside gas furnace component of the split-system HVAC system requires cleaning and the base of the unit needs caulking.

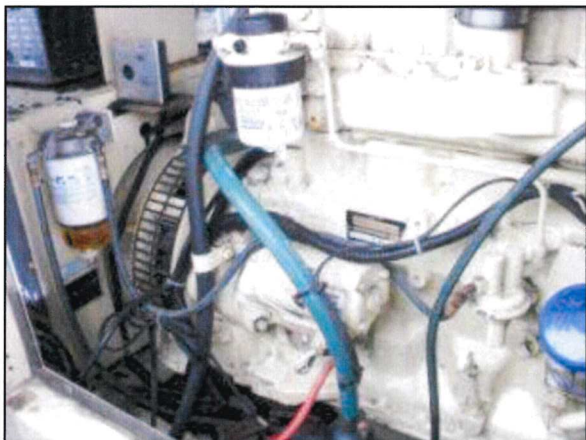
*Photo 15 – Fire Station #1* The John Deere engine portion of the emergency generator system is equipped with a 120-gallon diesel fuel tank. It is in fair overall condition.

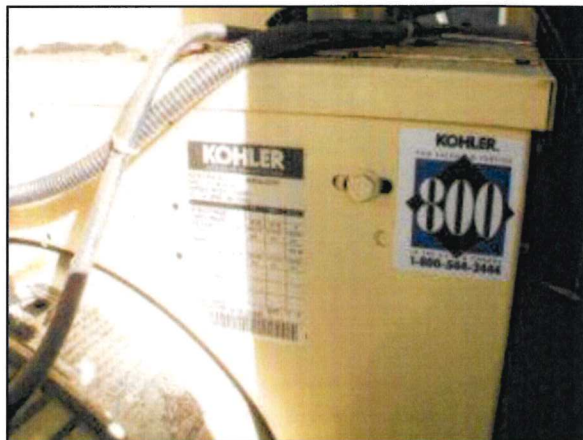
*Photo 16 – Fire Station #1* The Kohler portion of the emergency generator system is also in fair condition.

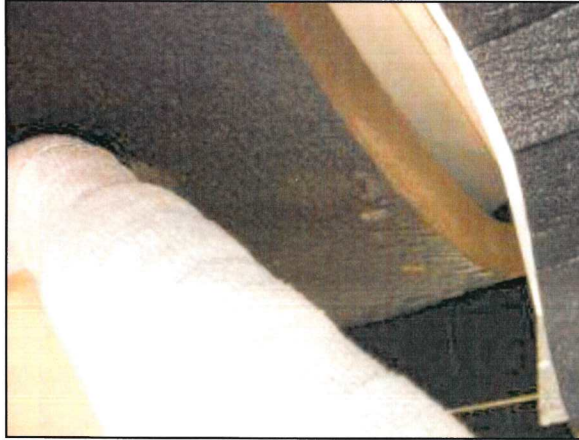
**Photo 17 – Fire Station #1** Acoustical tiles located near the generator exhibit signs of degradation.

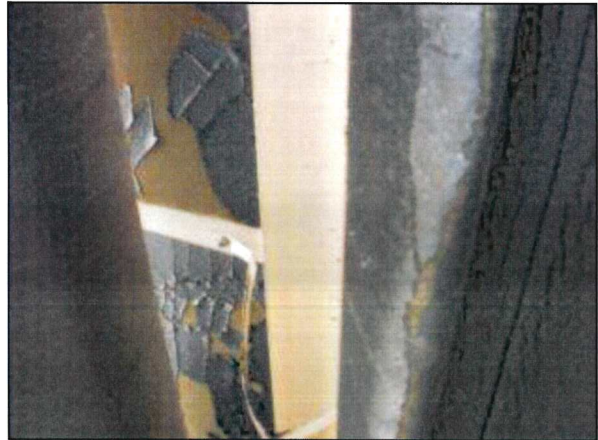
**Photo 18 – Fire Station #1** Acoustical tiles located near the generator show signs of degradation.

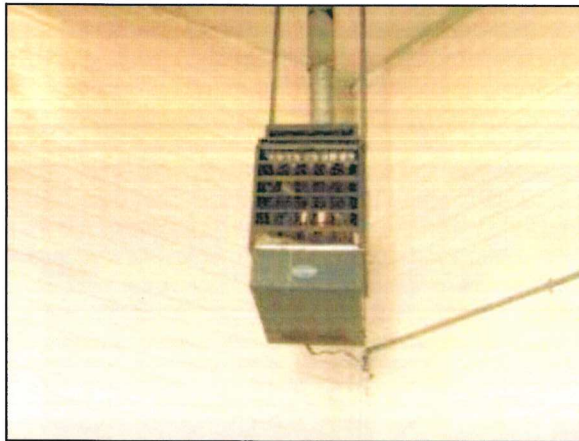
**Photo 19 – Fire Station #1** A gas-powered space heater mounted on the wall of the garage is reported to be out of service, although it appears operational.

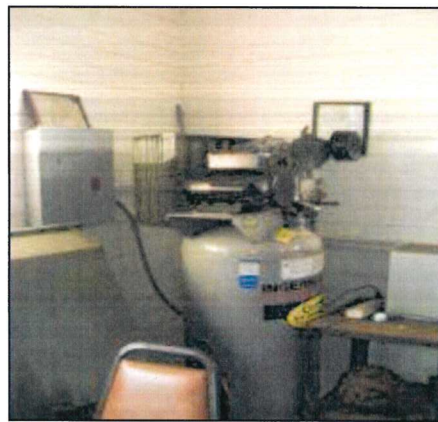
**Photo 20 – Fire Station #1** The Ingersoll-Rand air compressor is in fair overall condition.

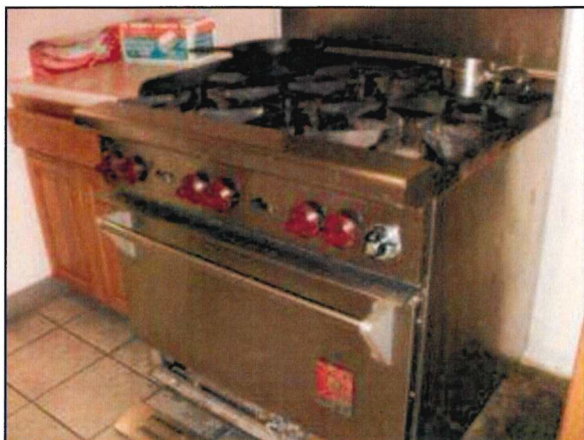
*Photo 21 – Fire Station #1* The commercial-grade gas range and oven unit requires a thorough cleaning. The ceramic tile underneath requires repair in order to address sanitation.

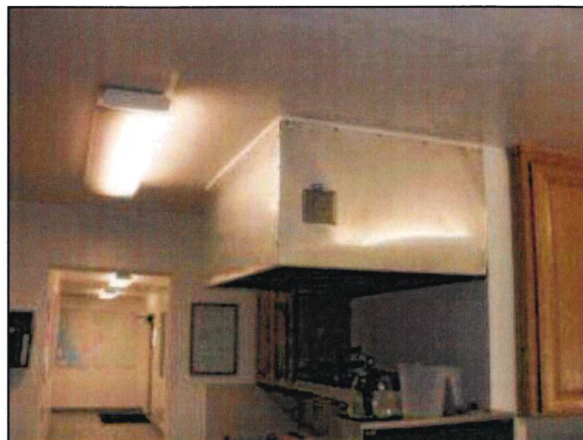
*Photo 22 – Fire Station #1* The commercial-style range hood exhibits poor original construction and poor appearance.

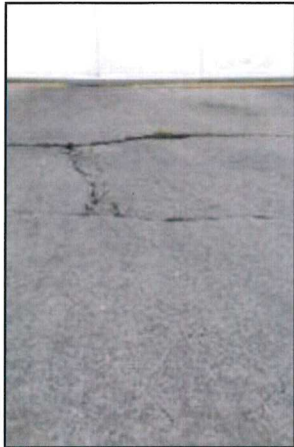
**Photo 29 – Fire Station #1** The concrete at the garage is severely cracked and deteriorated. Loss of underlying support is also evident as a result of possible washout or settling.

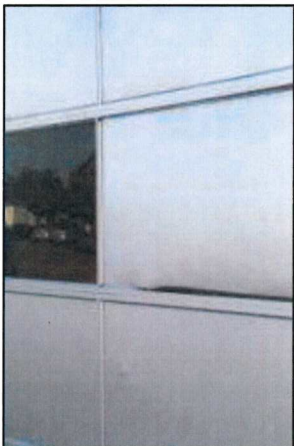
**Photo 31 – Fire Station #1** Garage doors display evidence of impact damage.

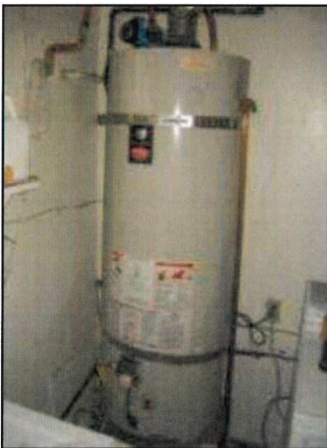
**Photo 3 – Fire Station #4** A 65-gallon gas-fired water heater is present in the laundry room. No significant deficiencies were noted at the time of the inspection.

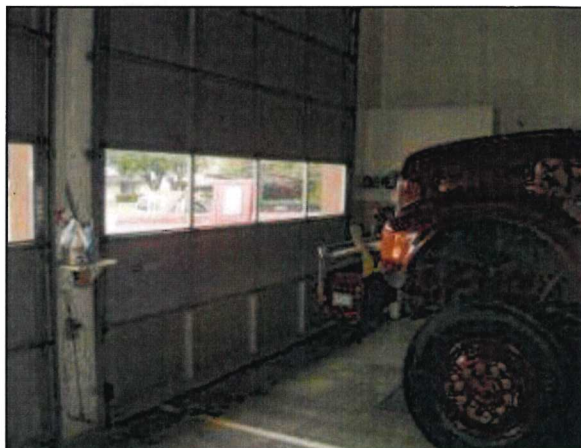
*Photo 10 – Fire Station #4* The garage door is aged and exhibits repairs. Replacement of the door is recommended.

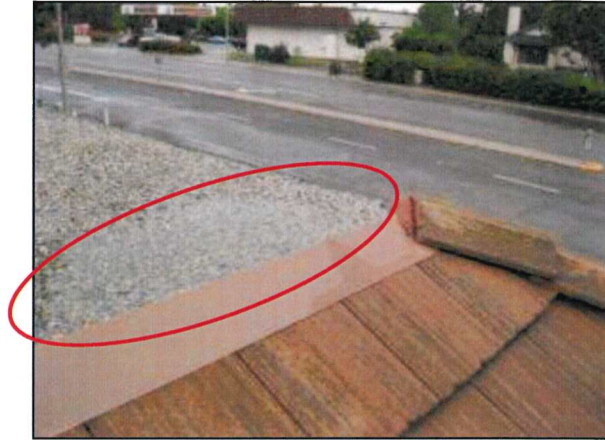
*Photo 18 - Fire Station #4* Standing water was noted on the flat portion of the roof at the time of the inspection.

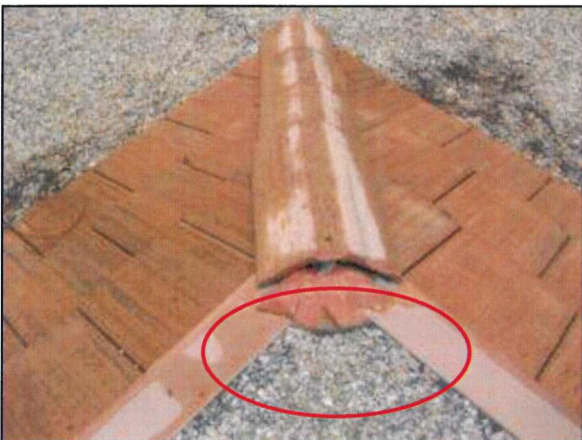
*Photo 19 - Fire Station #4* Separation of the roof tiles from the cement based sealant was noted at various points.

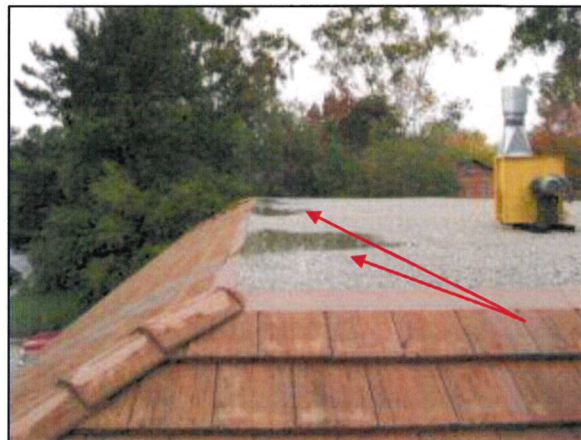
*Photo 20 - Fire Station #4* Standing water was noted on the flat portion of the roof at the time of the inspection.

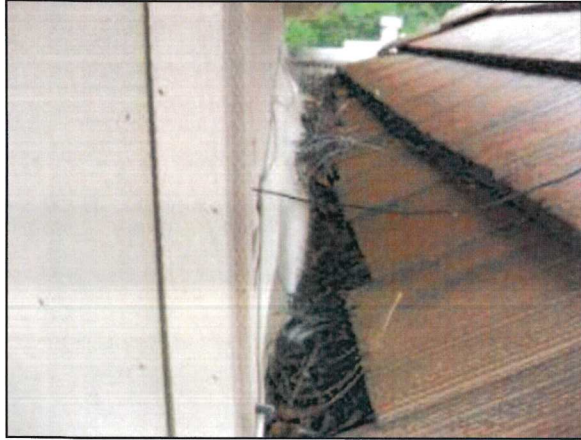
**Photo 21 – Fire Station #4** The condition of the roof flashing is poor and the collection of tree litter will accelerate deterioration.

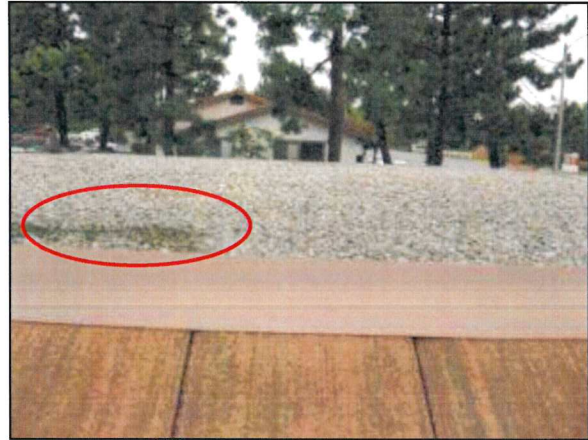
**Photo 22 – Fire Station #4** Standing water was noted on the flat portion of the roof at the time of the inspection.

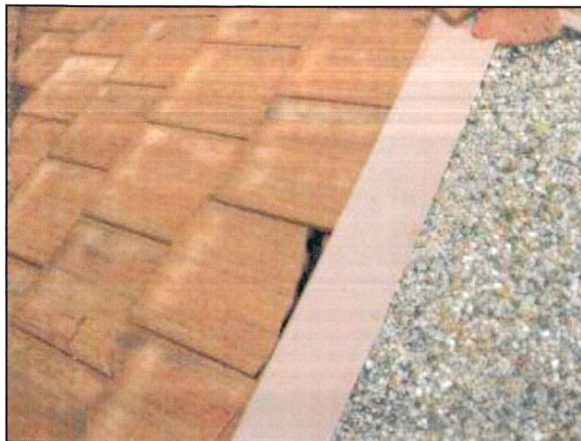
**Photo 23 – Fire Station #4** Breaching of the tile roof was noted.

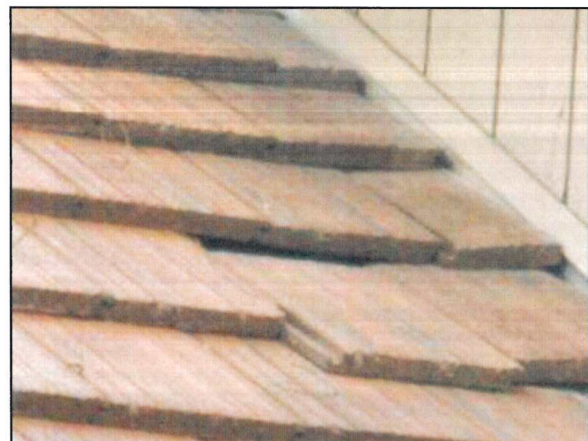
**Photo 24 – Fire Station #4** Dislodged clay tiles were noted.

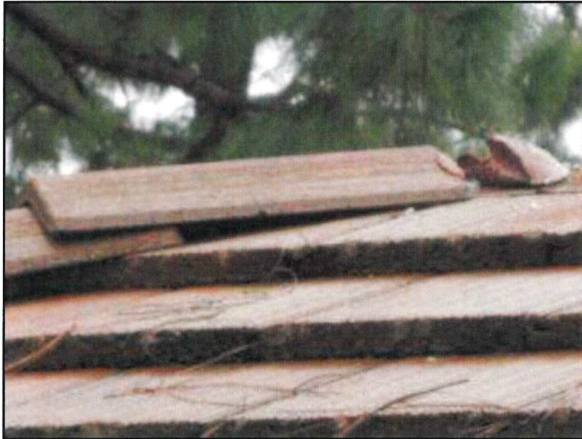
**Photo 25– Fire Station #4** Unsecured roof tiles create points of entry for water as well as safety hazards below.

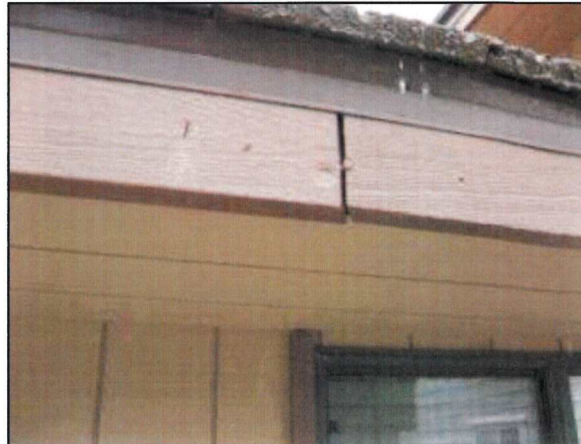
**Photo 28 – Fire Station #4** The absence of a gutter system and separated fascia board was noted at the rear of the fire station.

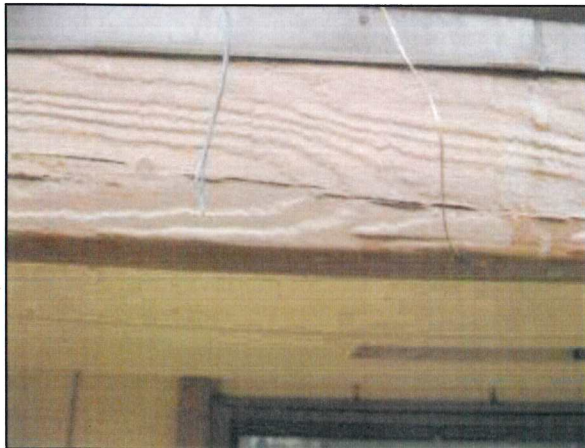
*Photo 29 – Fire Station #4* Peeling paint and loose hanging wires were noted at the rear of the fire station.

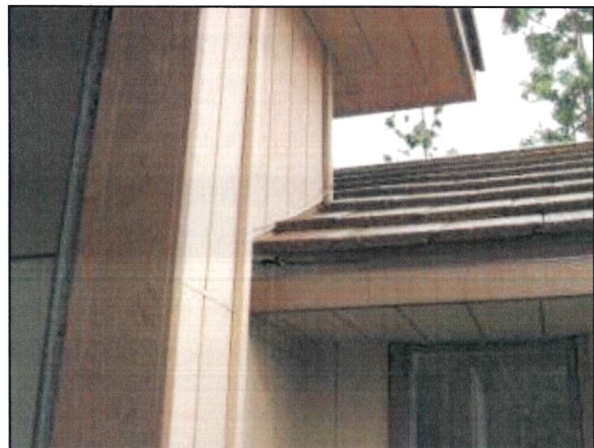
*Photo 30 – Fire Station #4* The section of roof near the front entry exhibits poor flashing.

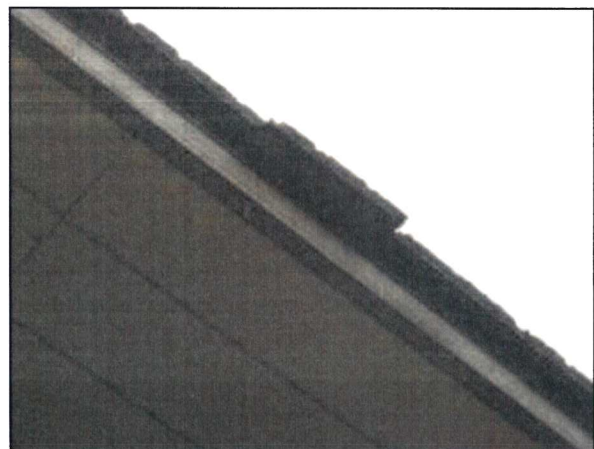
*Photo 32 – Fire Station #4* Sections of roof with loose clay tiles were noted. These may present a hazard to those below.

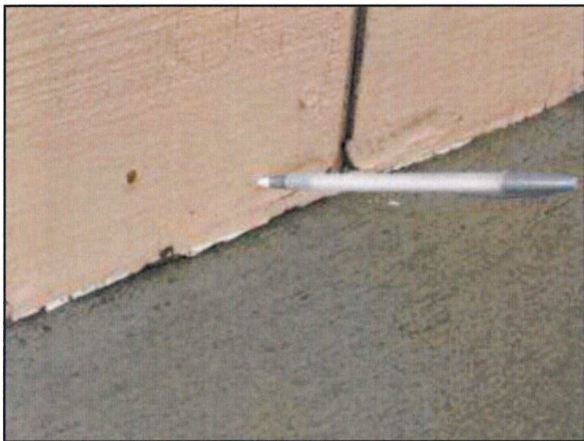
*Photo 35 – Fire Station #4* Degraded T-111 siding is present near the base where it meets the concrete sidewalk slab.

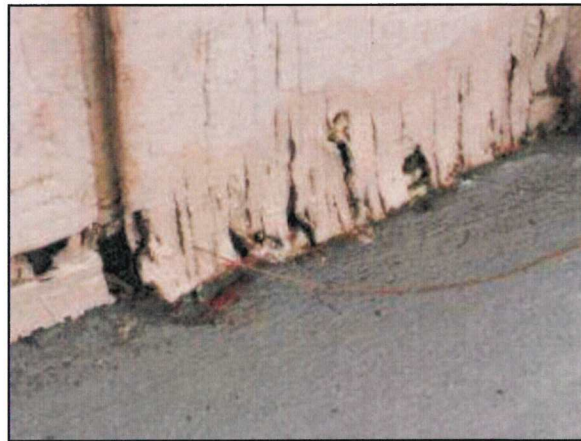
*Photo 36 – Fire Station #4* Degraded T-111 siding is present near the base where it meets the concrete sidewalk slab.

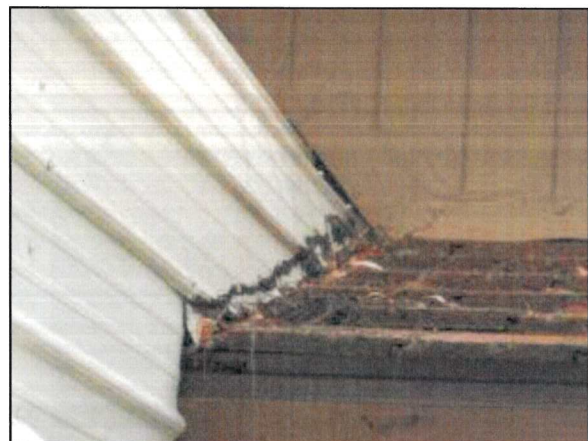
*Photo 40 – Fire Station #4* A general view of the exterior where the steel addition attaches to the main building showing the improper flashing.

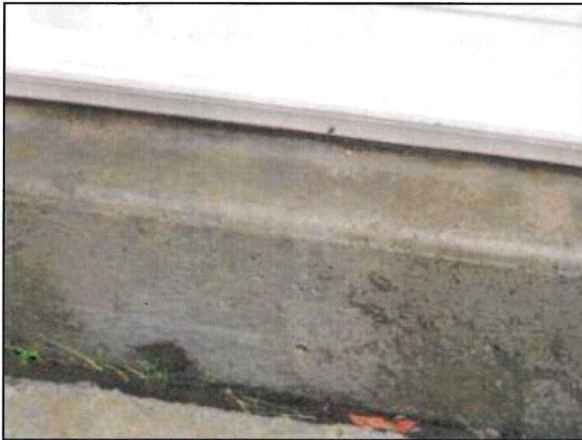
*Photo 41 – Fire Station #4* The steel addition is not properly sealed to the concrete pad.

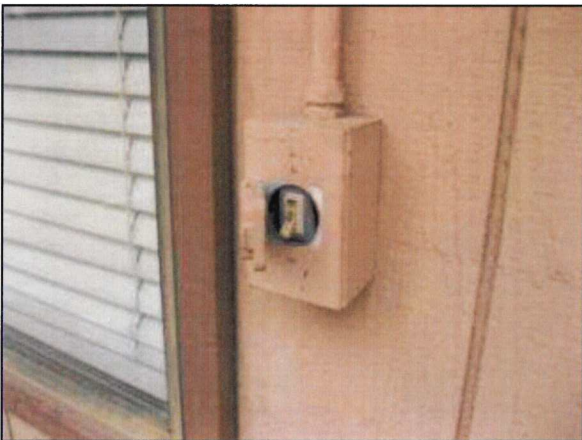
*Photo 43 – Fire Station #4* The gasket to an exterior switch is missing.

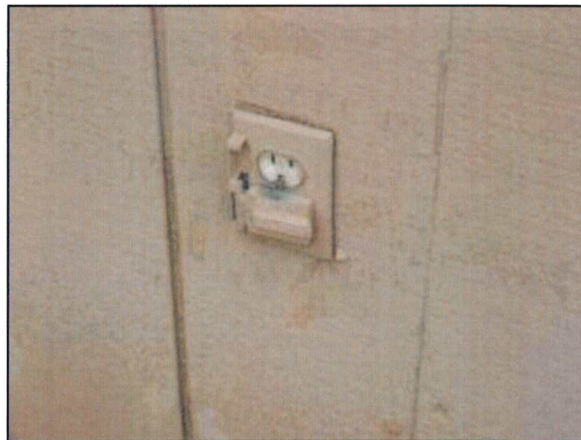
*Photo 44 – Fire Station #4* The cover to an exterior outlet is missing and is not GFCI protected.

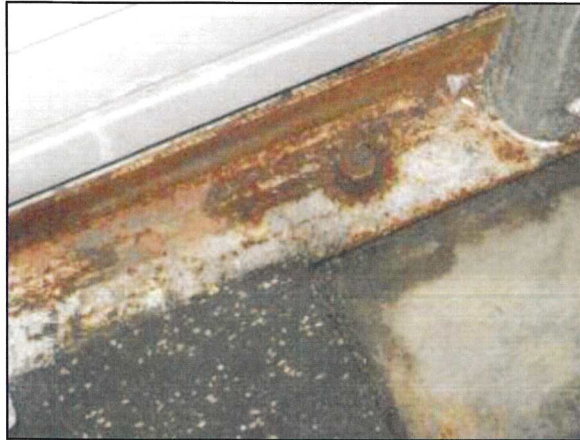
*Photo 45 – Fire Station #4* Corrosion is present on the inside of the steel addition where it meets the slab as a result of poor sealing and lack of regular painting.

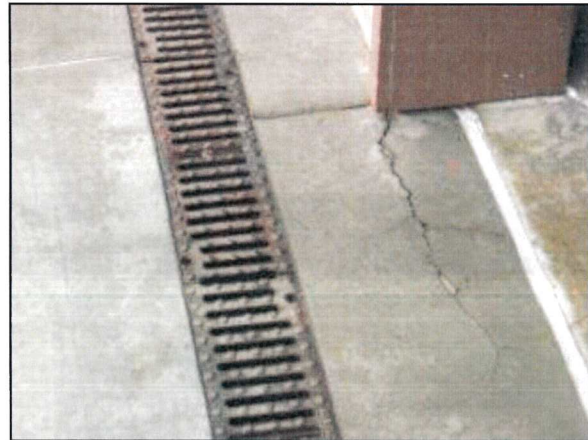
*Photo 46 – Fire Station #4* Cracked concrete is present in front of the right-side garage entrance. Cracks should be sealed to prevent additional damage.

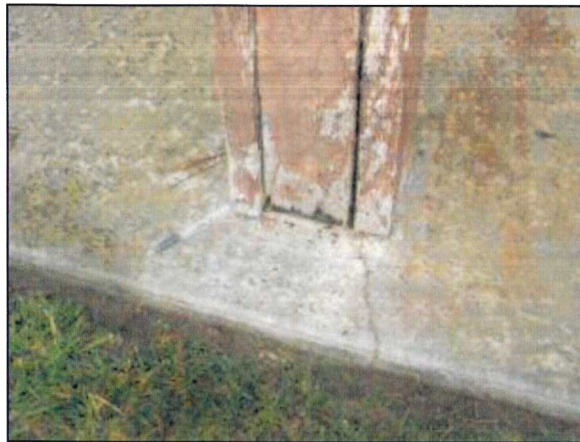
*Photo 47 – Fire Station #4* A structural post located at the front porch is rotted at the base.

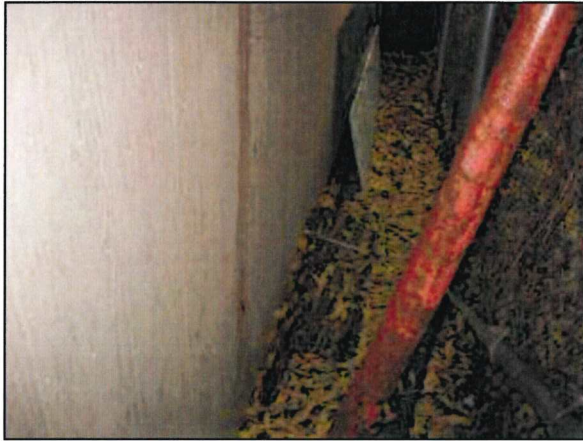
**Photo 49– Fire Station #4** The back side of the storage shed is beginning to rot due to the presence of wet debris.

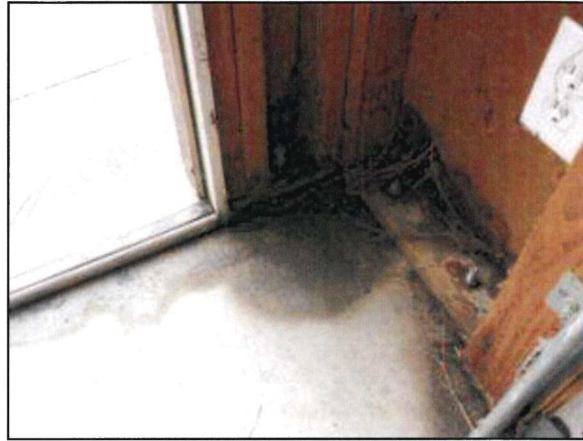
**Photo 50 – Fire Station #4** Leaks are present inside of the storage shed at the entry door and at the wall where it meets the concrete slab.

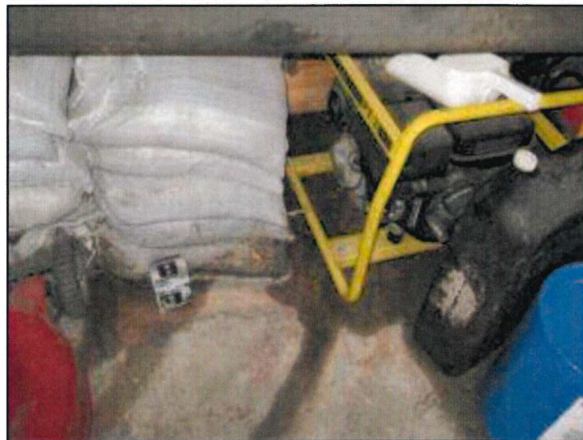
**Photo 52 – Fire Station #4** Major leaks are present on the inside rear of the shed.

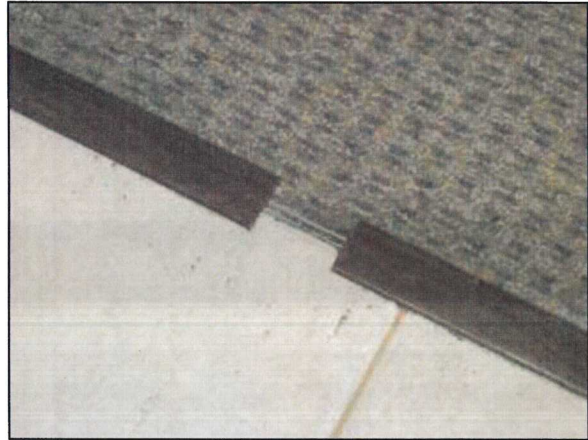
**Photo 62 – Fire Station #4** The carpeting in the lounge area exhibits a damaged transition strip posing a potential trip hazard.

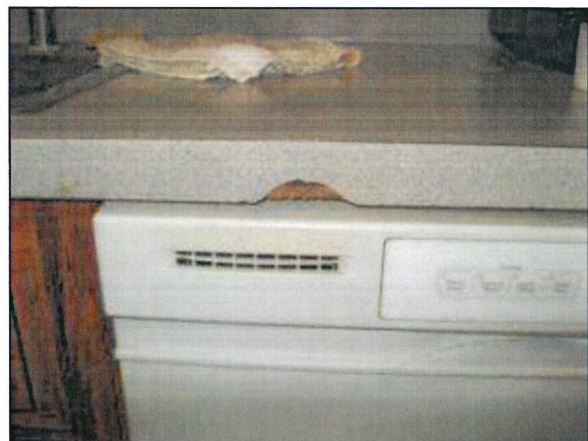
**Photo 64 – Fire Station #4** Damage to the Formica countertops is present in the kitchen.

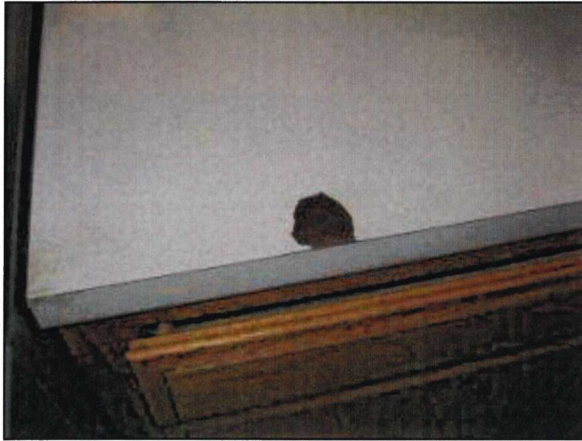
*Photo 65 – Fire Station #4* Damage to the Formica countertops in the kitchen is present.

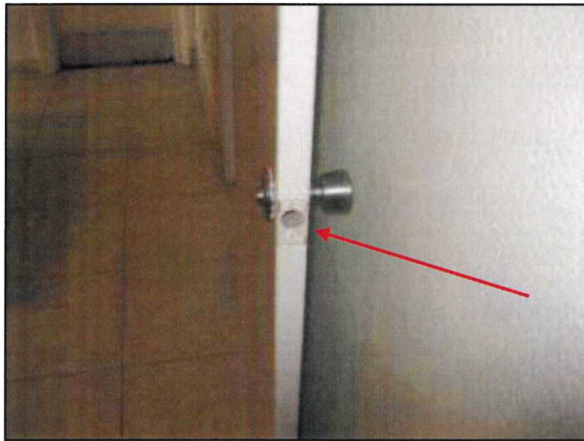
*Photo 67 – Fire Station #4* The latch and knob on the door to the game room is missing.
