CITY OF ENCINITAS INFRASTRUCTURE TASK FORCE

MEETING NOTICE
MONDAY, JUNE 26, 2023

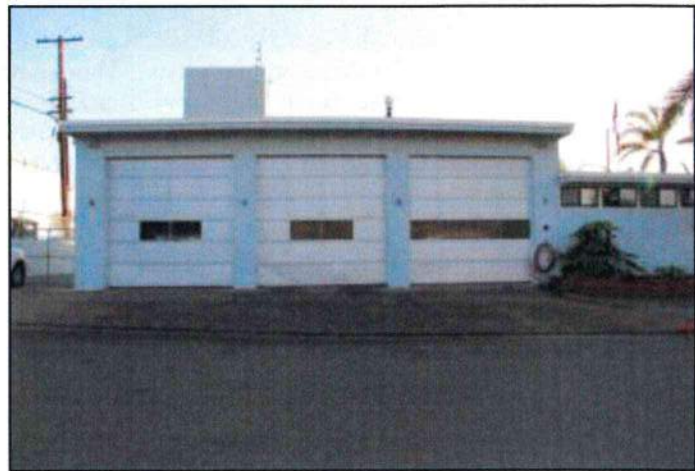
Construction/Renovation History:

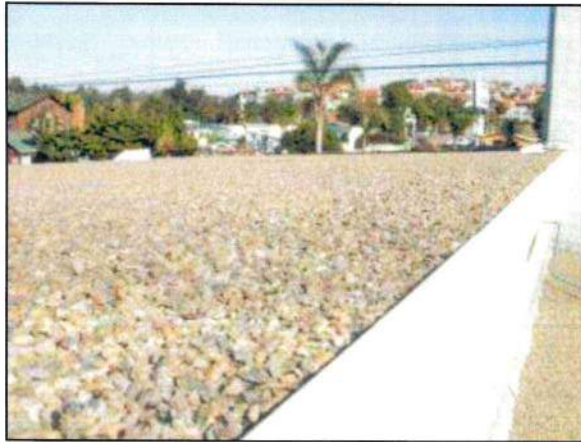
Photo 1 – Fire Station #1 The fire station exhibits a flat structure built up roof with gravel aggregate.

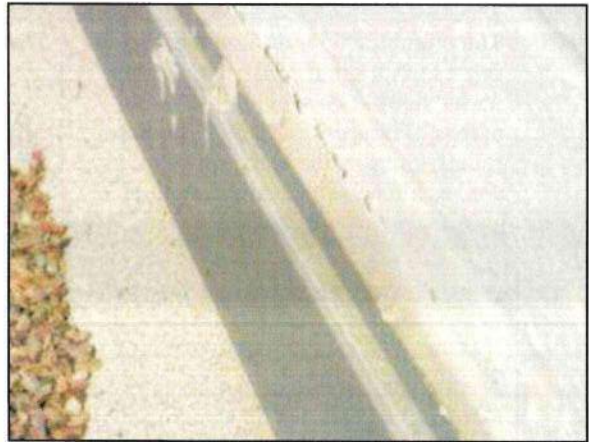
Photo 2 – Fire Station #1 Caulk repairs are needed at the termination flashing on the roof.

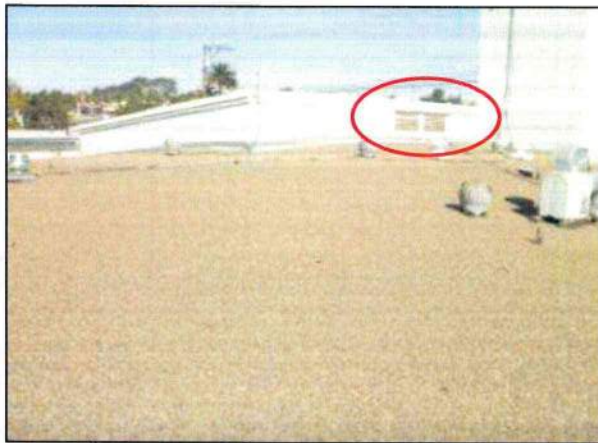
Photo 3 – Fire Station #1 Wood louvers present at the roof are deteriorating and need to be repainted.

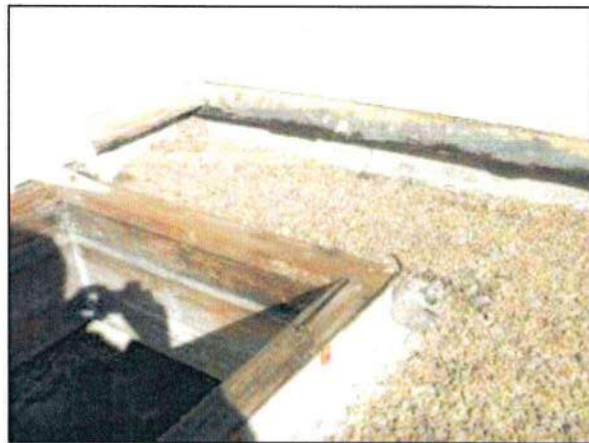
Photo 4 – Fire Station #1 The hose tower roof requires a new roof hatch and curb.

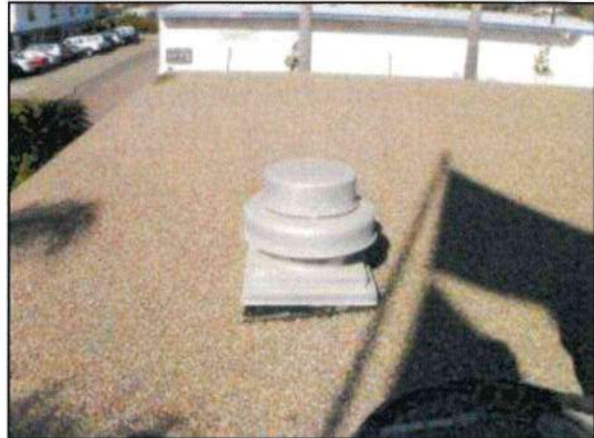
Photo 6 – Fire Station #1 An exhaust fan (GEF-1) is corroded, in poor condition, and may have been abandoned. Abandoned fans should be removed and their penetrations capped.

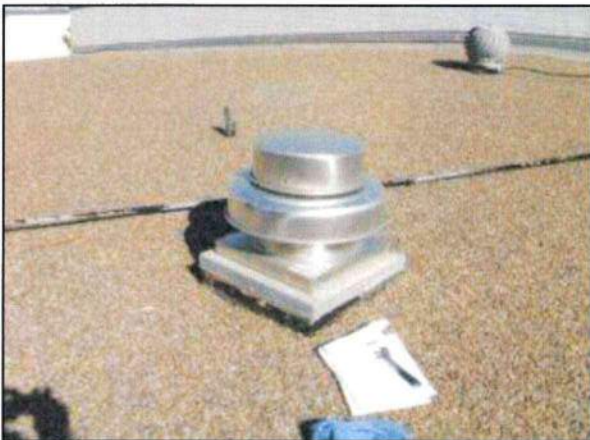
Photo 7 – Fire Station #1 A newly-installed exhaust fan (GEF-2) is present at the roof and is in good overall condition.

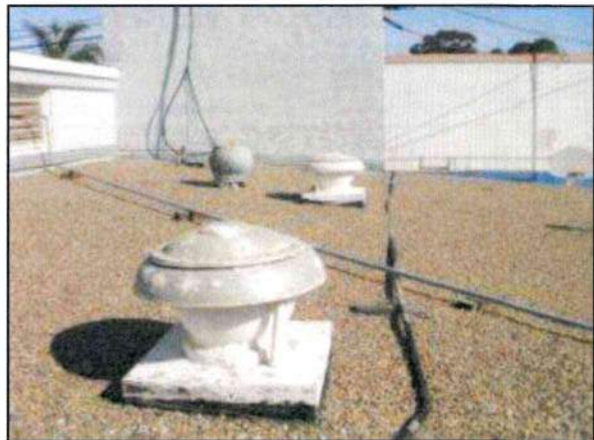
Photo 8 – Fire Station #1 Another exhaust fan (GEF-4) appears to be abandoned. Abandoned exhaust fans should be removed and permanently capped. Note GEF-5 in the background is also apparently abandoned in place.

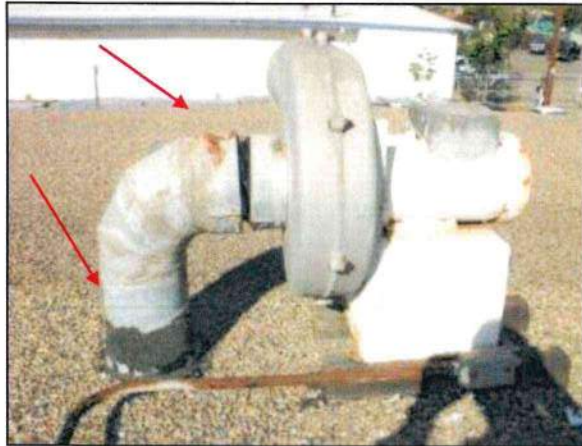
Photo 9 – Fire Station #1 The outside component of the vehicle exhaust system (GEF-6) is heavily corroded. The ducting requires sealant, and the flex joint requires a sheet metal shroud.

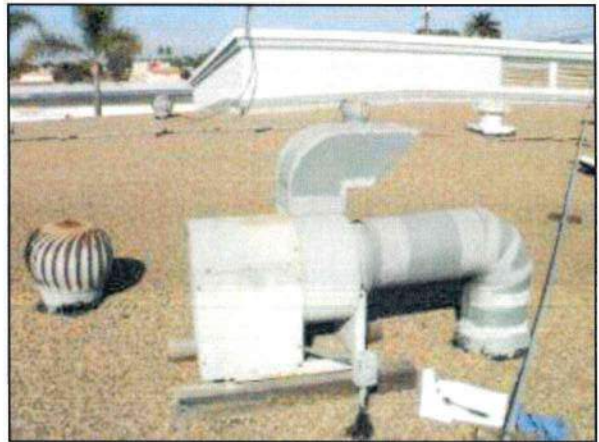
Photo 10 – Fire Station #1 A belt-driven, centrifugal type exhaust fan (GEF-3) requires sealant at the ducting.

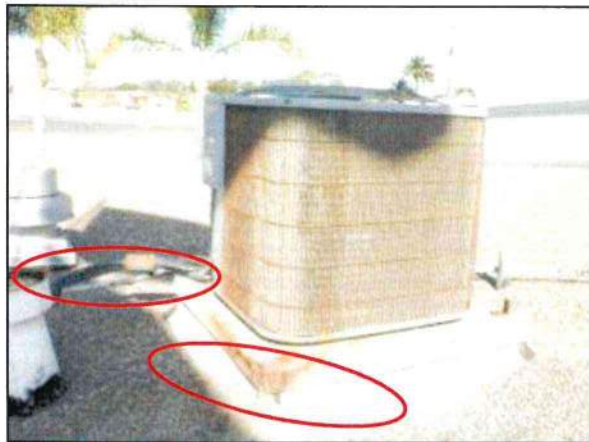
Photo 11 – Fire Station #1 The condenser portion of the split-system HVAC system located on the roof exhibits a rusted platform cap. The insulation for the refrigeration lines needs replacement.

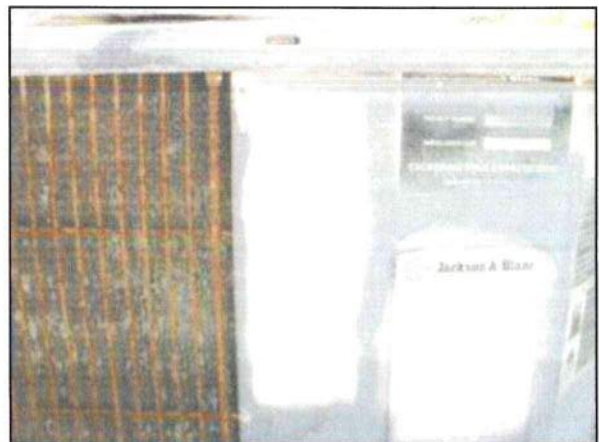
Photo 12 – Fire Station #1 The condenser coils of the split system condenser unit are heavily corroded.

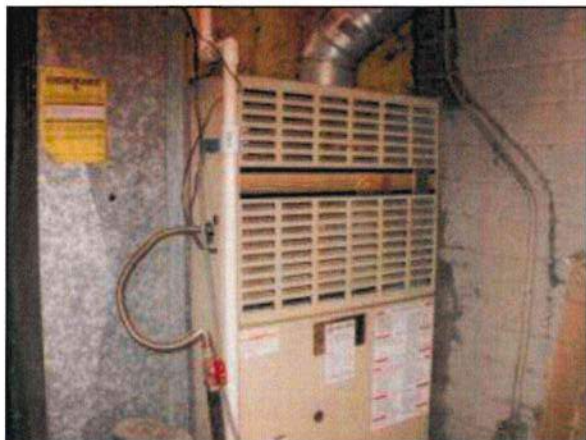
Photo 13 – Fire Station #1 The inside gas furnace component of the split-system HVAC system requires cleaning and the base of the unit needs caulking.

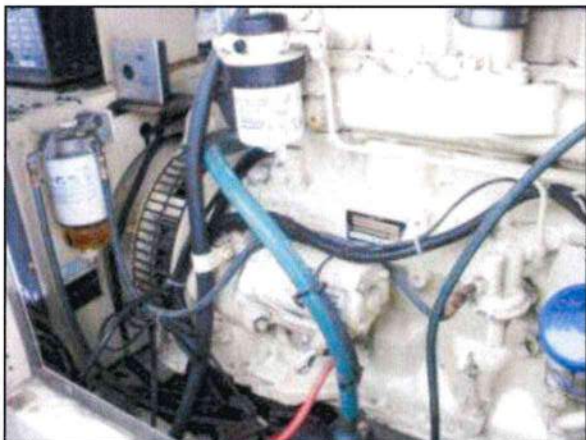
Photo 15 – Fire Station #1 The John Deere engine portion of the emergency generator system is equipped with a 120-gallon diesel fuel tank. It is in fair overall condition.

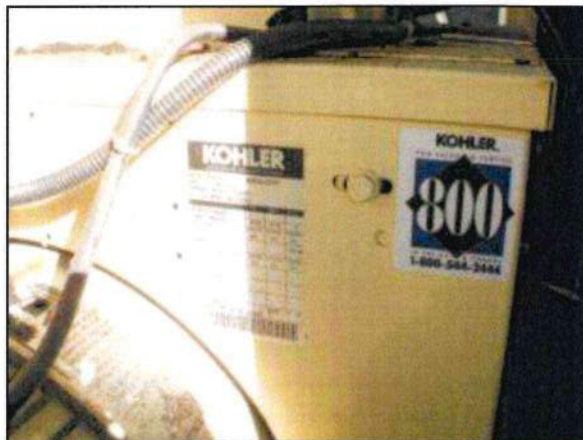
Photo 16 – Fire Station #1 The Kohler portion of the emergency generator system is also in fair condition.

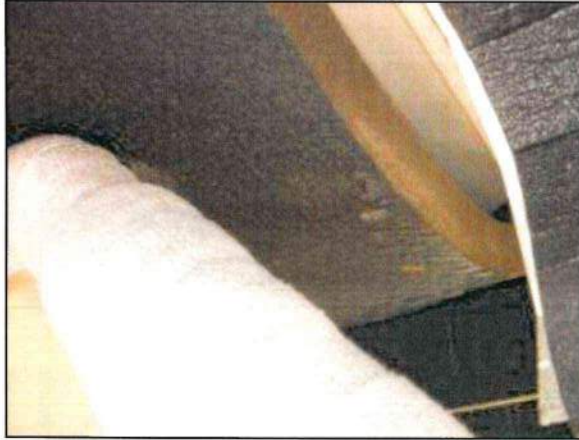
Photo 17 – Fire Station #1 Acoustical tiles located near the generator exhibit signs of degradation.

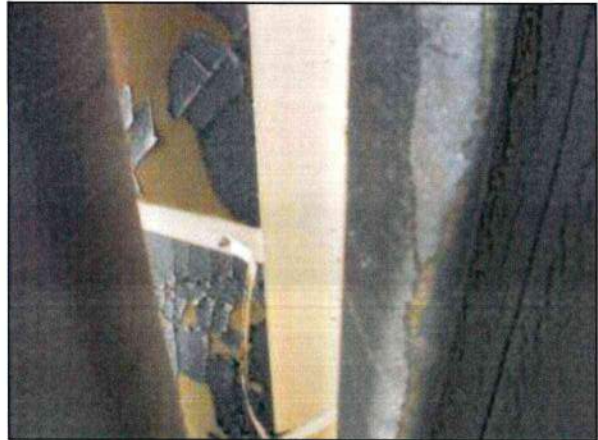
Photo 18 – Fire Station #1 Acoustical tiles located near the generator show signs of degradation.

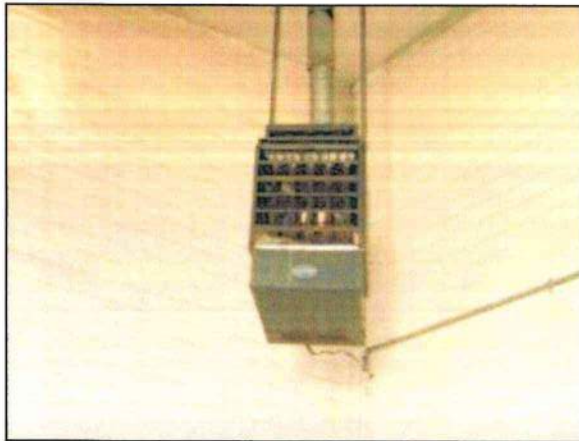
Photo 19 – Fire Station #1 A gas-powered space heater mounted on the wall of the garage is reported to be out of service, although it appears operational.

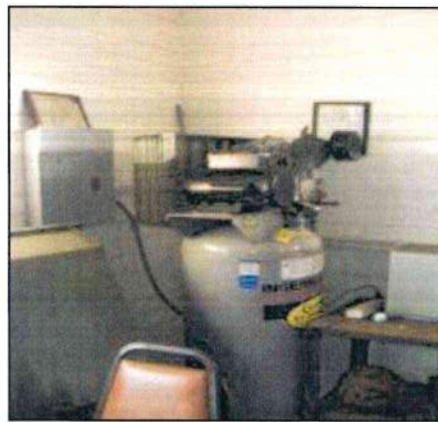
Photo 20 – Fire Station #1 The Ingersoll-Rand air compressor is in fair overall condition.

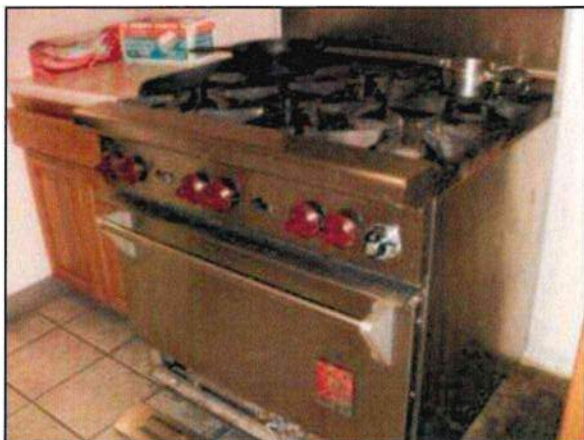
Photo 21 – Fire Station #1 The commercial-grade gas range and oven unit requires a thorough cleaning. The ceramic tile underneath requires repair in order to address sanitation.

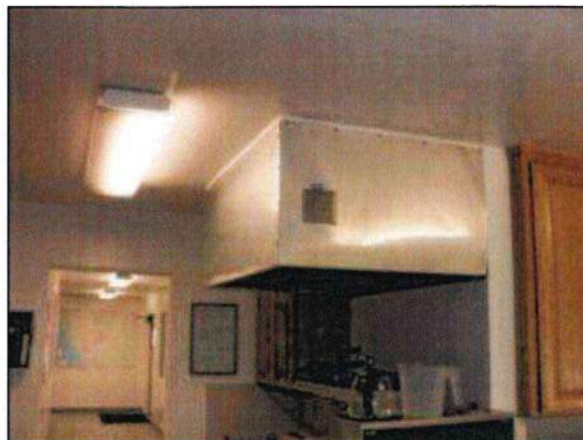
Photo 22 – Fire Station #1 The commercial-style range hood exhibits poor original construction and poor appearance.

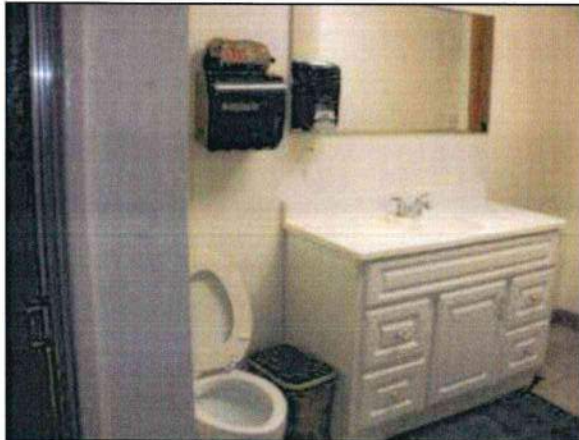
Photo 25 – Fire Station #1 A general view of the captain’s restroom and general conditions.

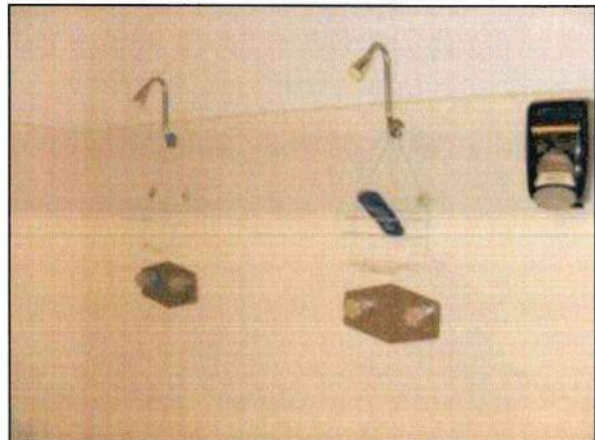
Photo 26 – Fire Station #1 A general view of the shower station in the locker room and general conditions.

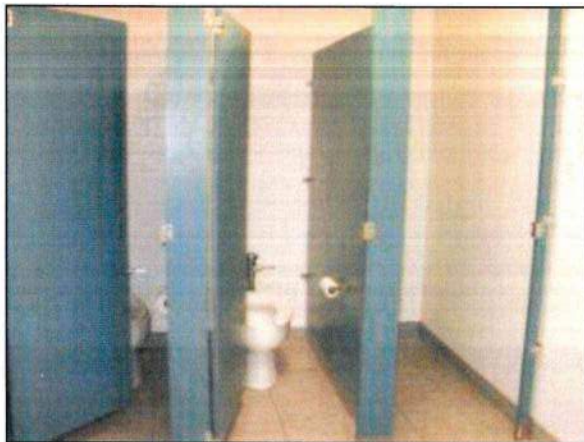
Photo 27 – Fire Station #1 A general view of the commodes in the locker room and general conditions.

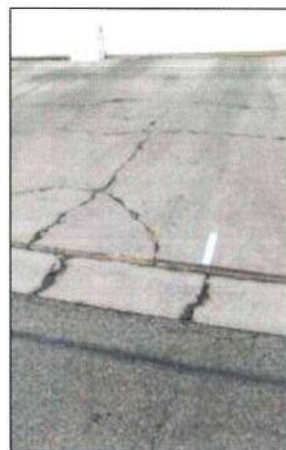
Photo 28 – Fire Station #1 The concrete at the garage is severely cracked and deteriorated. Loss of underlying support is also evident.

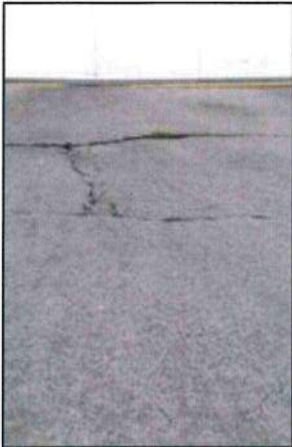
Photo 29 – Fire Station #1 The concrete at the garage is severely cracked and deteriorated. Loss of underlying support is also evident as a result of possible washout or settling.

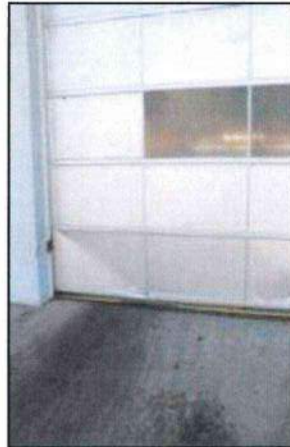
Photo 30 – Fire Station #1 Garage doors display evidence of impact damage.

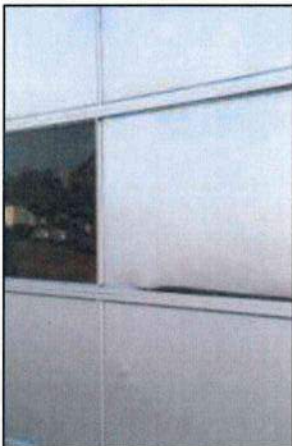
Photo 31 – Fire Station #1 Garage doors display evidence of impact damage.

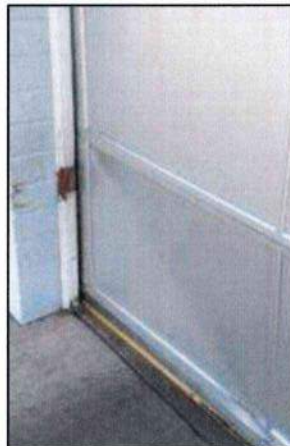
Photo 32 – Fire Station #1 Garage doors display evidence of impact damage.

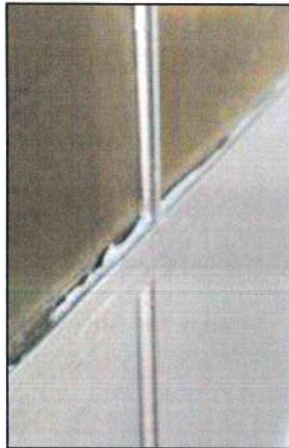
Photo 33 – Fire Station #1 Garage doors exhibit peeling and chipping of frame paint..

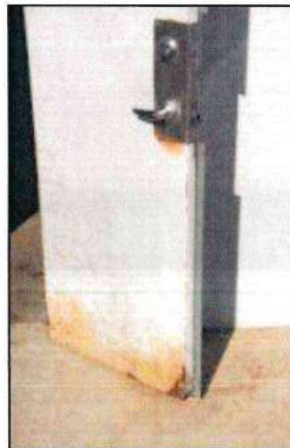
Photo 34 – Fire Station #1 The exterior door to the hose tower is significantly rusted.

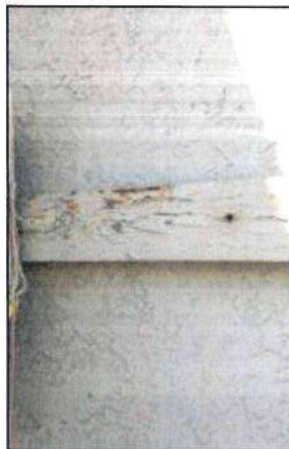
Photo 35 – Fire Station #1 Exterior wood trim exhibits cavitations, heavy rot and peeling of paint, and possible termite damage.

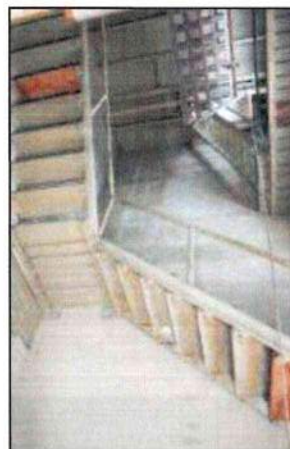
Photo 36 – Fire Station #1 Stairs in the hose tower have deteriorated and have been patched over time. Other sections require repairs.

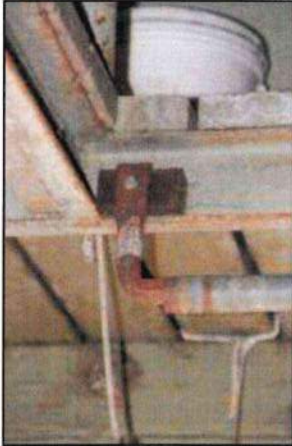
Photo 37 – Fire Station #1 Steel structural members of the stairways show significant rust.

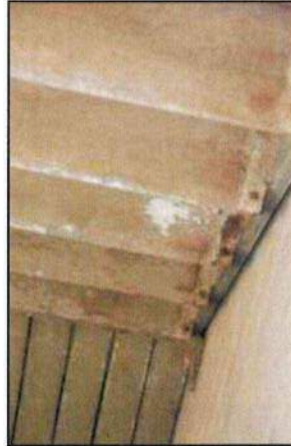
Photo 38 – Fire Station #1 Paint at the stairway shows severe peeling and flaking. Stair brackets are corroded.

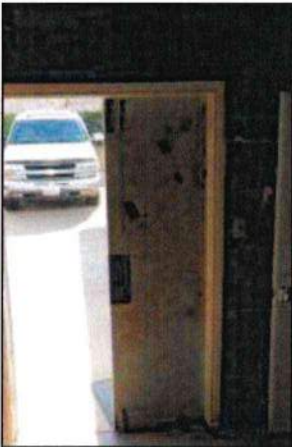
Photo 39 – Fire Station #1 The door from the hose tower interior to the exterior is heavily rusted.

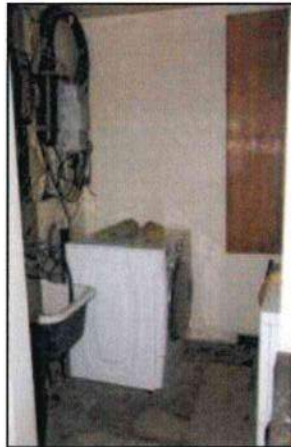
Photo 40 – Fire Station #1 The laundry room floor is completely deteriorated with missing sections and staining. The washer and dryer are not fitted with seismic straps.

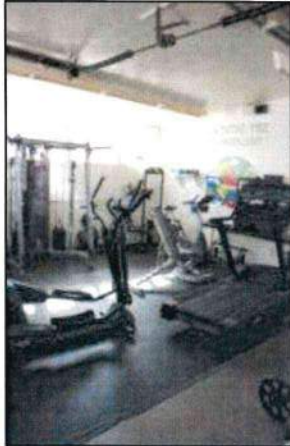
Photo 41 – Fire Station #1 A general view of the gym area.

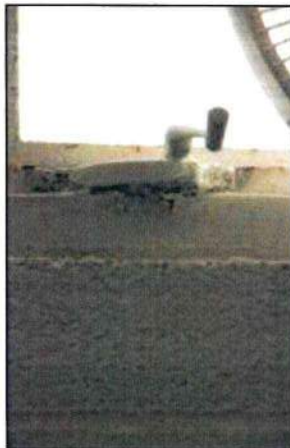
Photo 43 – Fire Station #1 Significant deterioration of window crank handles and frames is present.

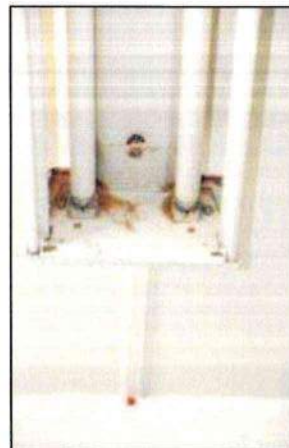
Photo 44 – Fire Station #1 Faulty light ballasts were noted.

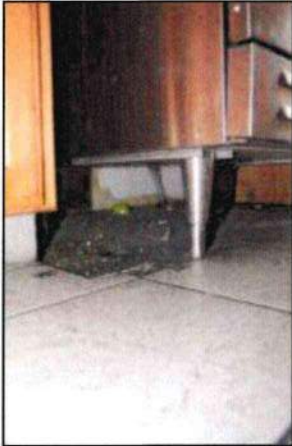
Photo 45 – Fire Station #1 Flooring around the kitchen range is missing and debris has accumulated.

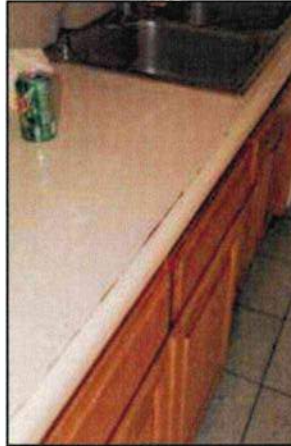
Photo 46 – Fire Station #1 Kitchen countertops are deteriorated.

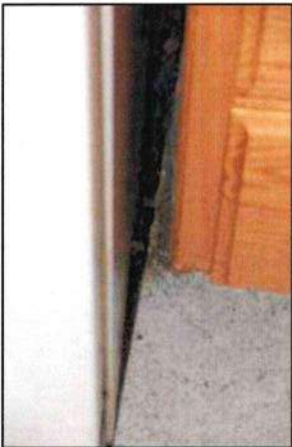
Photo 47 – Fire Station #1 Heavy debris has accumulated beside the refrigerator. The debris may attract pests.

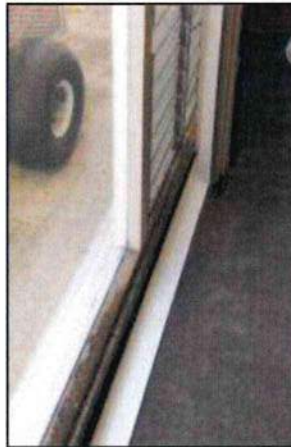
Photo 48 – Fire Station #1 Floor to ceiling windows exhibit deterioration of frames and water damage.

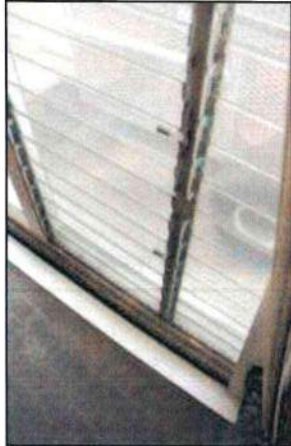
Photo 49 – Fire Station #1 Windows show deteriorated frames. The outdated louver windows allow air and moisture intrusion.

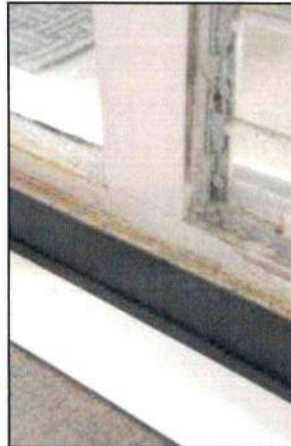
Photo 50 – Fire Station #1 Windows show deteriorated frames. The outdated louver windows allow air and moisture intrusion.

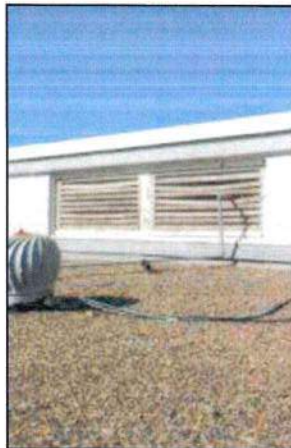
Photo 51 – Fire Station #1 Rooftop vent wood is buckled and rotted. The loose wiring should be run through conduit.

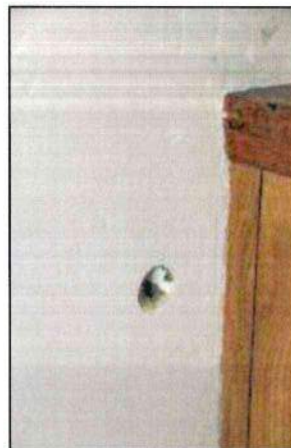
Photo 52 – Fire Station #1 Damage to the walls is present due to lack of door stoppers.

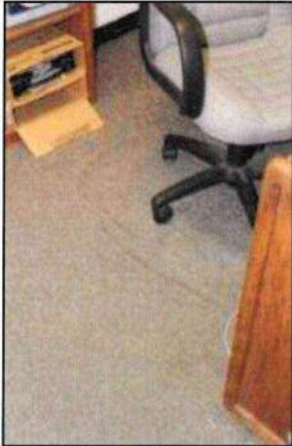
Photo 53 – Fire Station #1 Carpet generally lacks proper adhesion.

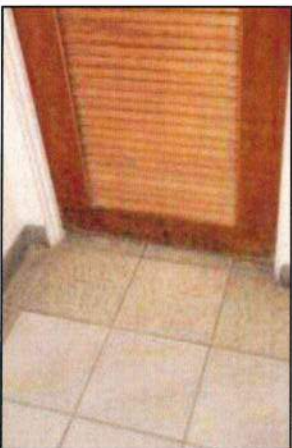
Photo 55 – Fire Station #1 The wood vented door to the restroom is stained and deteriorated. The floor is mismatched as a result of previous repairs of underground plumbing.

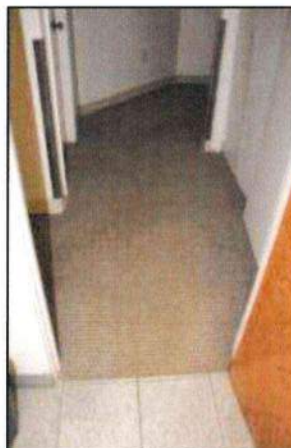
Photo 56 – Fire Station #1 Carpet in the living area hallway is worn and stained.

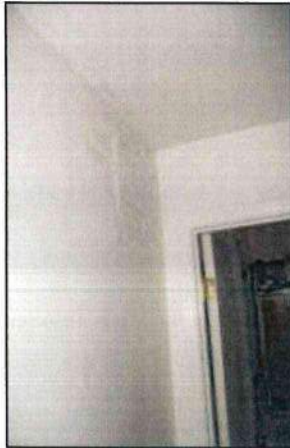
Photo 57 – Fire Station #1 Sections of wall patched with tape are present in the facility.

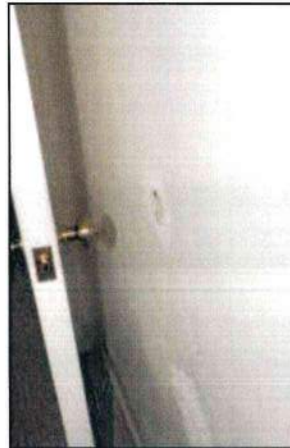
Photo 58 – Fire Station #1 The wall is damaged as a result of impacts from door handles.

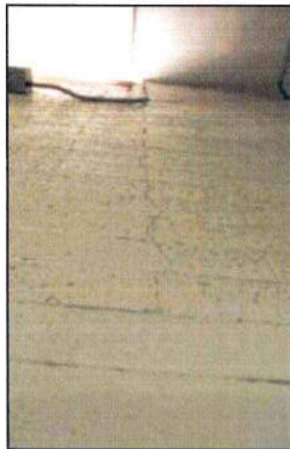
Photo 59 – Fire Station #1 Cracking of the block walls is present in some locations.

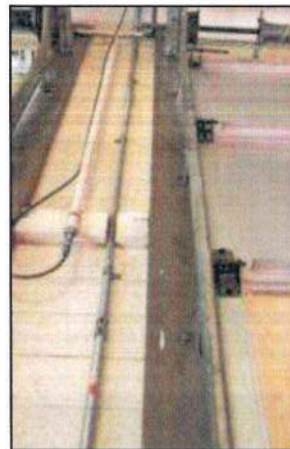
Photo 60 – Fire Station #1 Overhead door frames are deteriorated and have split as a result of age.

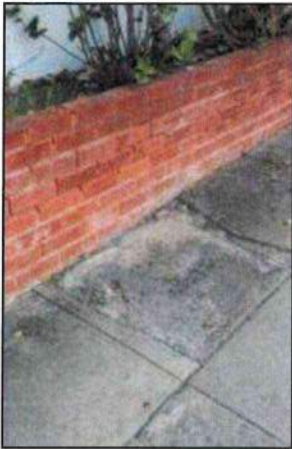
Photo 61 – Fire Station #1 Concrete sidewalk exhibits deterioration through scaling and spalling.

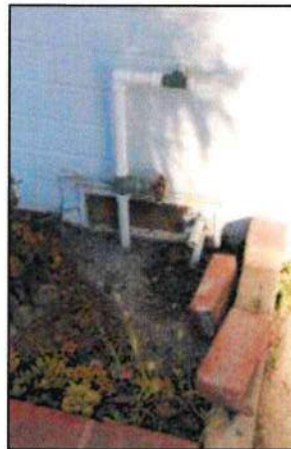
Photo 62 – Fire Station #1 Planters show some deterioration and loose bricks.

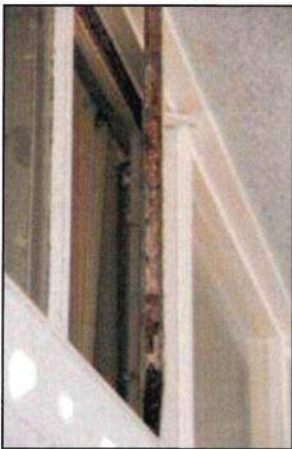
Photo 63 – Fire Station #1 Windows are significantly deteriorated with corrosion and peeling paint.

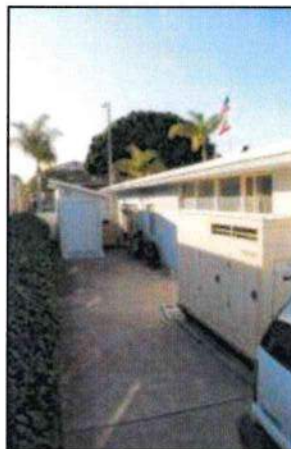
Photo 64 – Fire Station #1 An overall image of the backyard area.

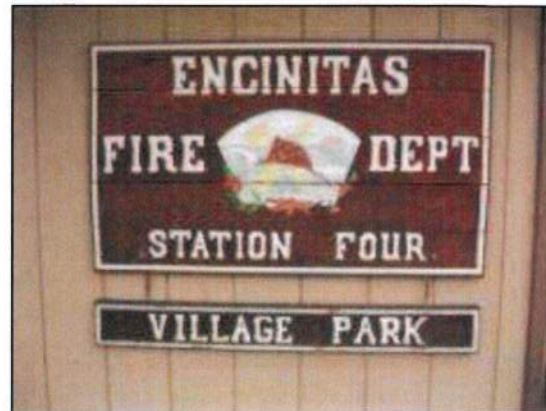
Construction/Renovation History:

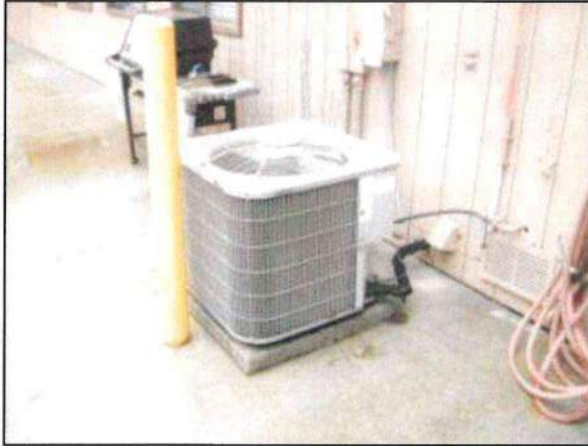
Photo 1 – Fire Station #4 The 3.5-ton condensing section is located at the rear of the facility and is paired with the furnace located in the bedroom closet.

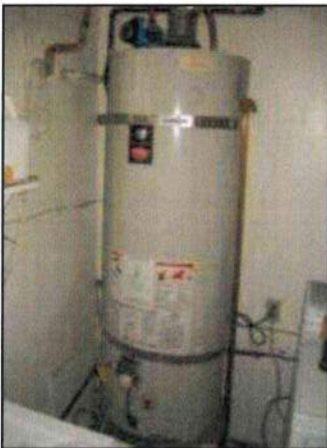
Photo 3 – Fire Station #4 A 65-gallon gas-fired water heater is present in the laundry room. No significant deficiencies were noted at the time of the inspection.

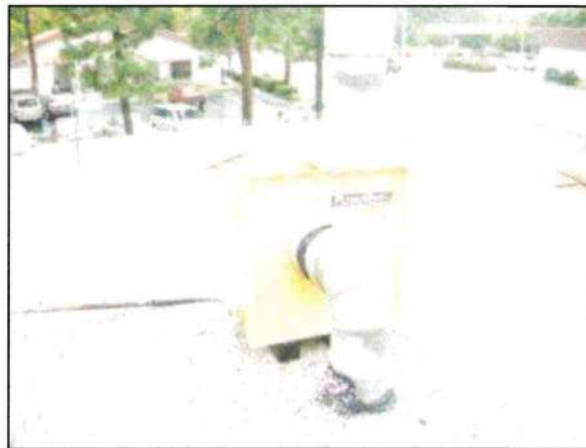
Photo 4 – Fire Station #4 The garage is ventilated by means of a vehicle exhaust system that is mounted on the roof. The system is similar to that present in Fire Station #5.

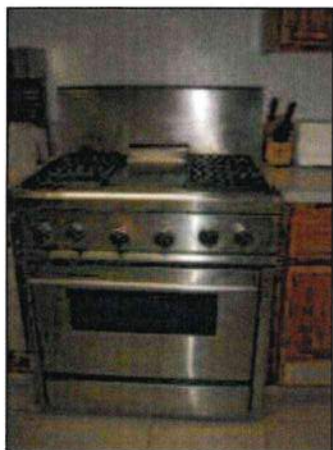
Photo 9 – Fire Station #4 A commercial kitchen range is located in the kitchen area. The unit was in good condition at the time of the inspection.

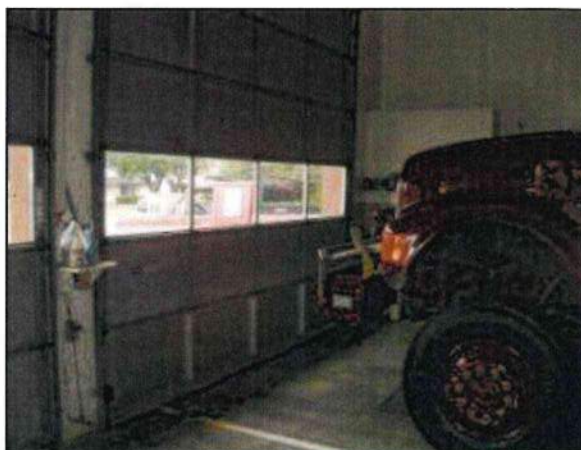
Photo 10 – Fire Station #4 The garage door is aged and exhibits repairs. Replacement of the door is recommended.

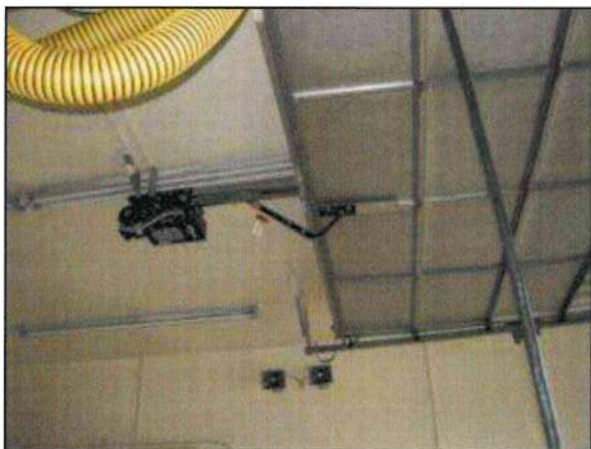
Photo 11 – Fire Station #4 The garage door is powered by an electronic Liftmaster opener.

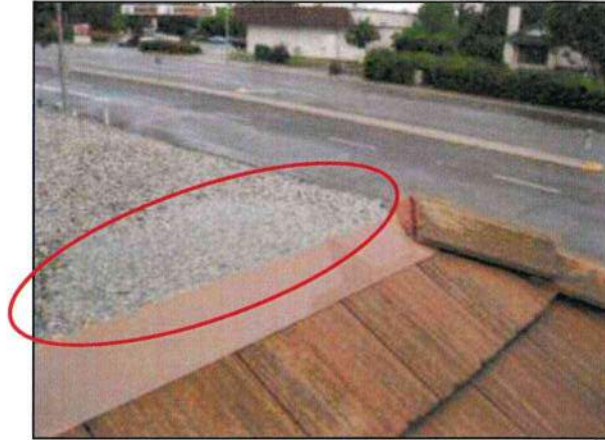
Photo 18 - Fire Station #4 Standing water was noted on the flat portion of the roof at the time of the inspection.

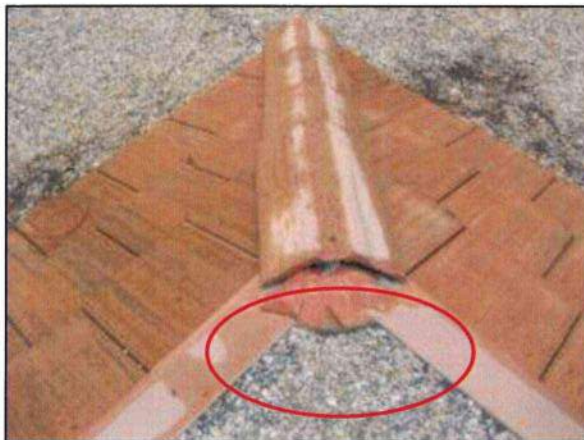
Photo 19 - Fire Station #4 Separation of the roof tiles from the cement based sealant was noted at various points.

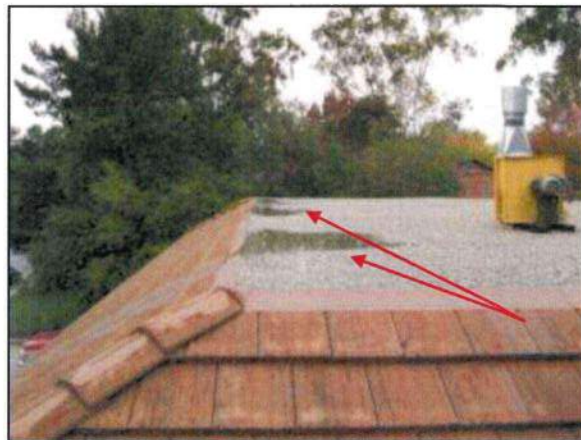
Photo 20 - Fire Station #4 Standing water was noted on the flat portion of the roof at the time of the inspection.

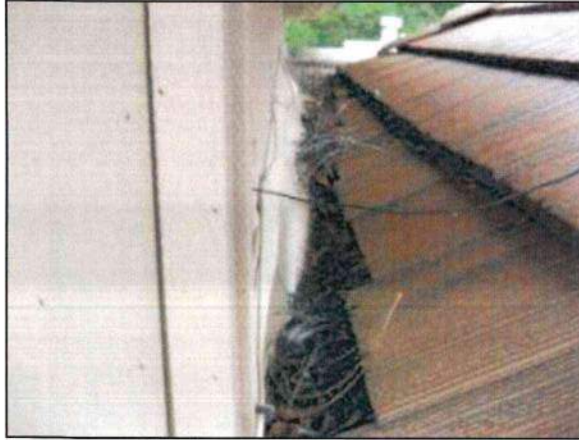
Photo 21 – Fire Station #4 The condition of the roof flashing is poor and the collection of tree litter will accelerate deterioration.

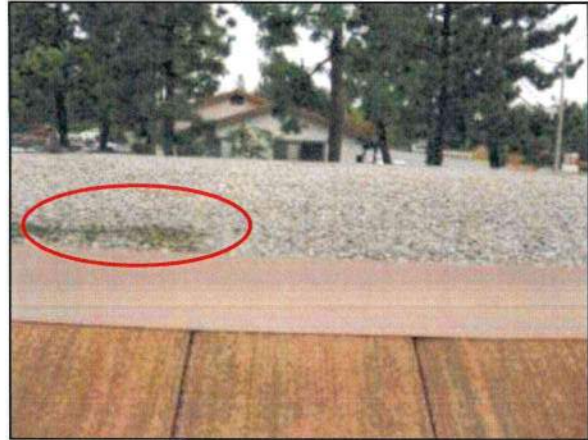
Photo 22 – Fire Station #4 Standing water was noted on the flat portion of the roof at the time of the inspection.

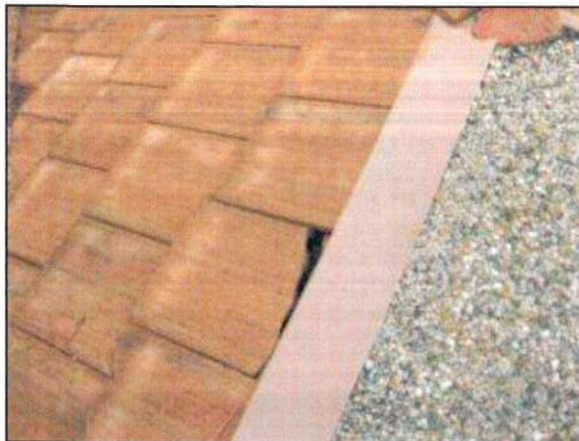
Photo 23 – Fire Station #4 Breaching of the tile roof was noted.

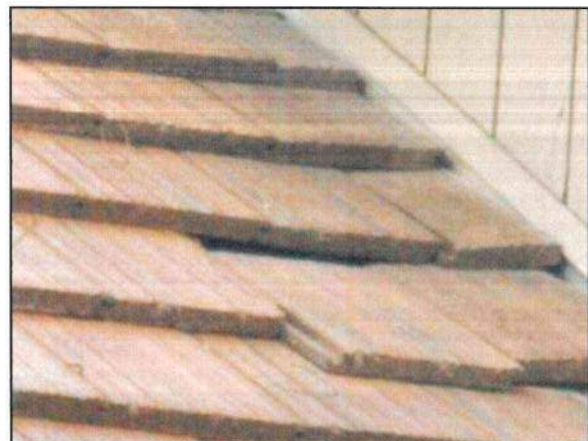
Photo 24 – Fire Station #4 Dislodged clay tiles were noted.

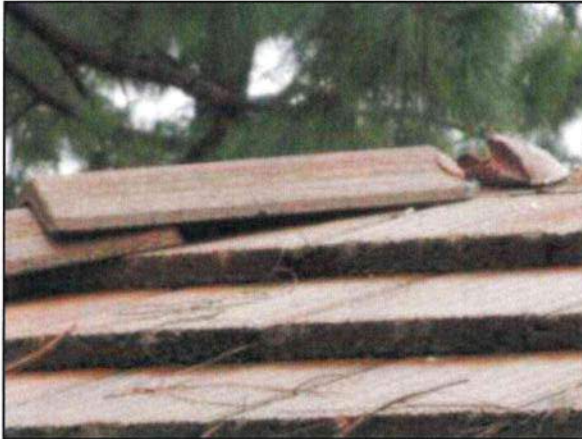
Photo 25– Fire Station #4 Unsecured roof tiles create points of entry for water as well as safety hazards below.

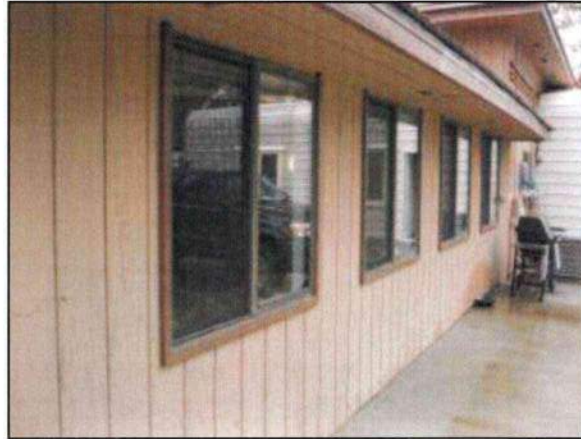
Photo 26– Fire Station #4 A general view of the rear of the fire station showing the aluminum window frames with insulated glass.

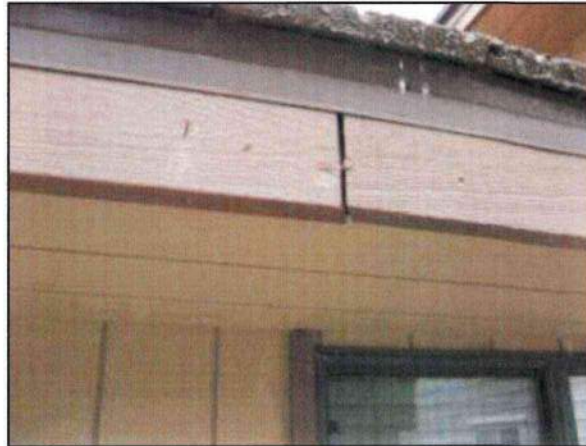
Photo 28 – Fire Station #4 The absence of a gutter system and separated fascia board was noted at the rear of the fire station.

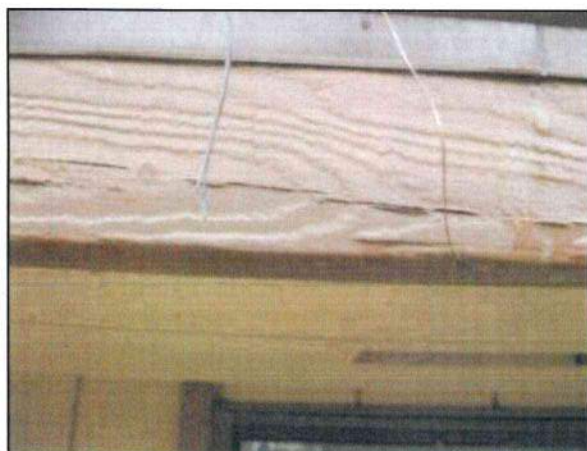
Photo 29 – Fire Station #4 Peeling paint and loose hanging wires were noted at the rear of the fire station.

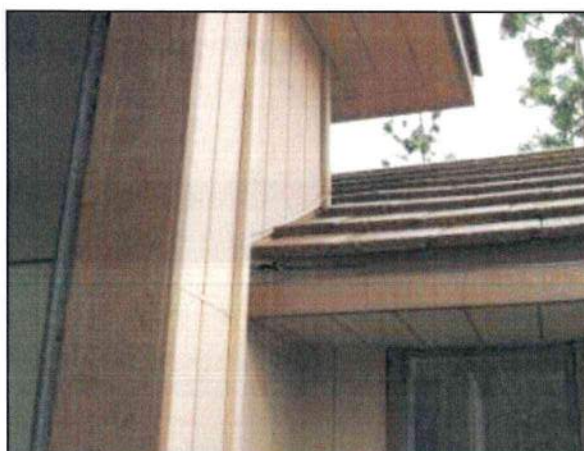
Photo 30 – Fire Station #4 The section of roof near the front entry exhibits poor flashing.

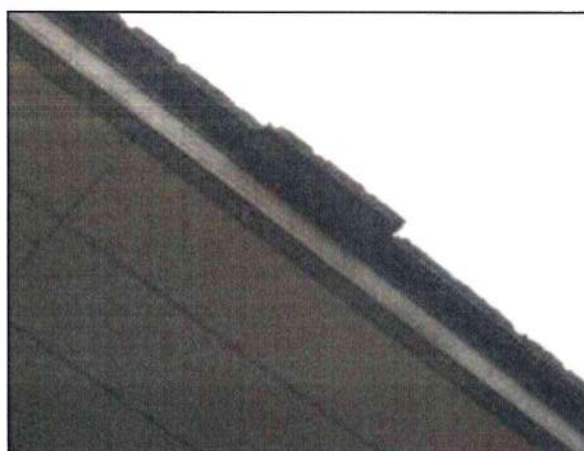
Photo 32 – Fire Station #4 Sections of roof with loose clay tiles were noted. These may present a hazard to those below.

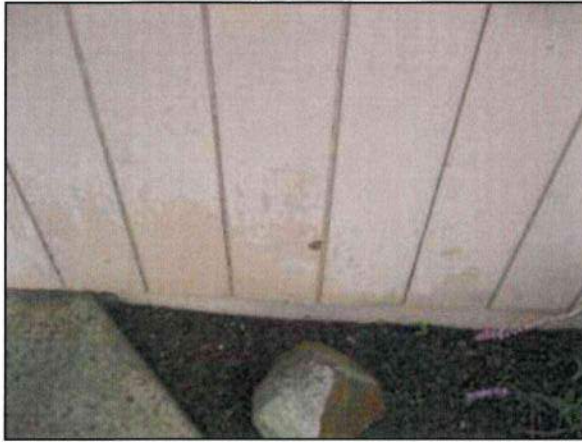
Photo 33 – Fire Station #4 The fire station structure is sheathed in 5/8" T-111 plywood siding.

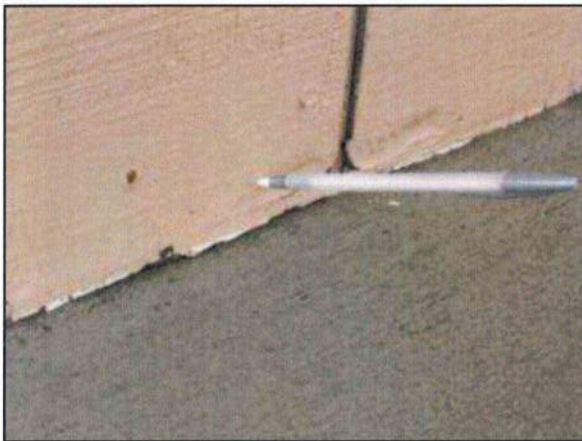
Photo 35 – Fire Station #4 Degraded T-111 siding is present near the base where it meets the concrete sidewalk slab.

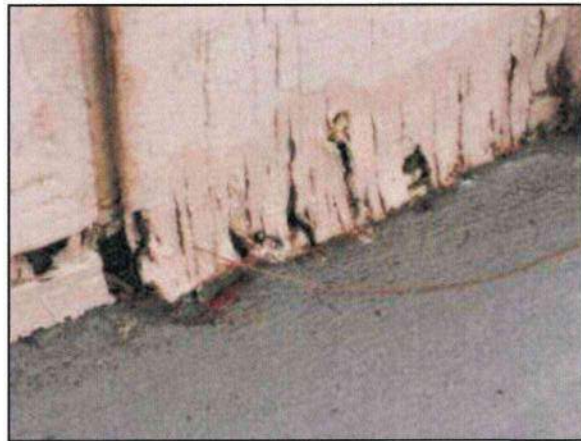
Photo 36 – Fire Station #4 Degraded T-111 siding is present near the base where it meets the concrete sidewalk slab.

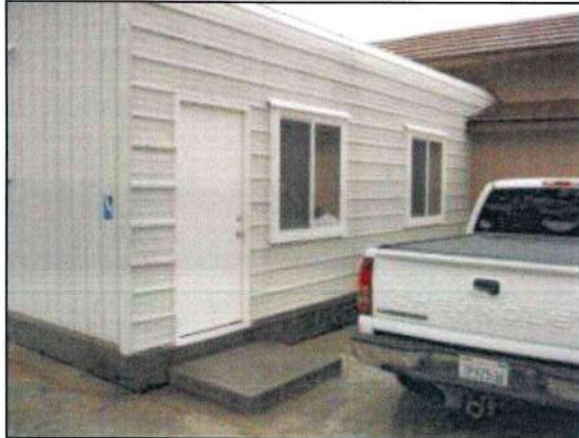
Photo 37– Fire Station #4 A general view of the steel metal addition attached to the rear of the building.

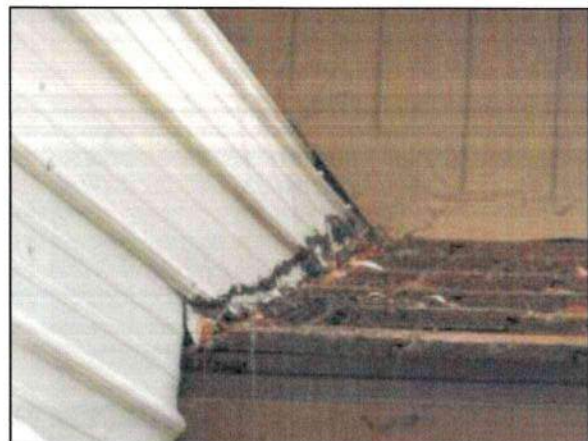
Photo 40 – Fire Station #4 A general view of the exterior where the steel addition attaches to the main building showing the improper flashing.

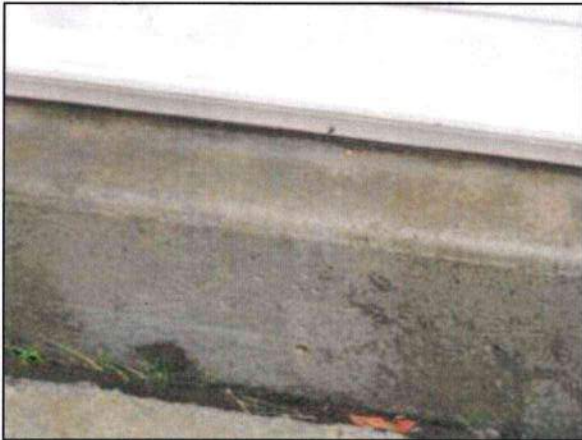
Photo 41 – Fire Station #4 The steel addition is not properly sealed to the concrete pad.

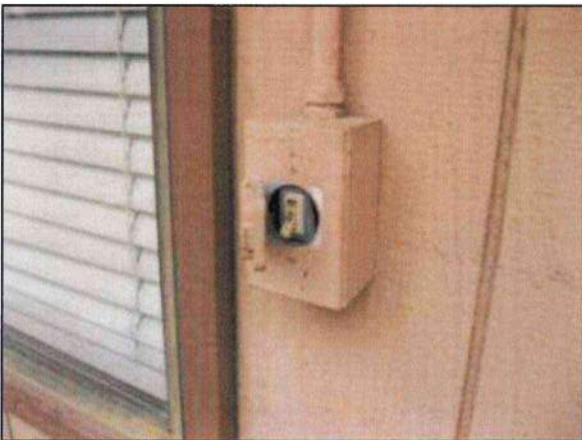
Photo 43 – Fire Station #4 The gasket to an exterior switch is missing.

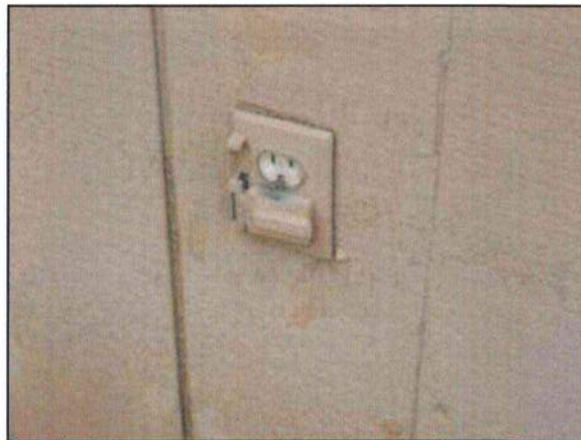
Photo 44 – Fire Station #4 The cover to an exterior outlet is missing and is not GFCI protected.

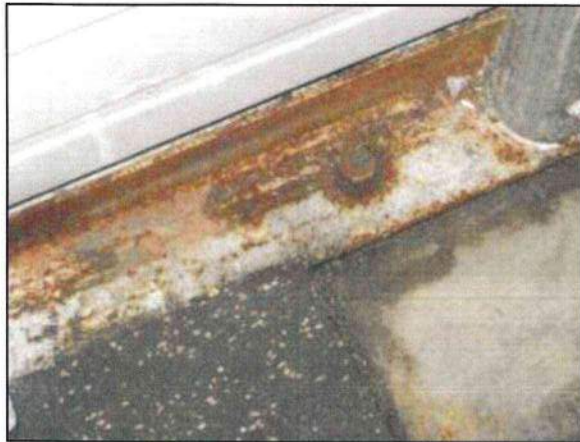
Photo 45 – Fire Station #4 Corrosion is present on the inside of the steel addition where it meets the slab as a result of poor sealing and lack of regular painting.

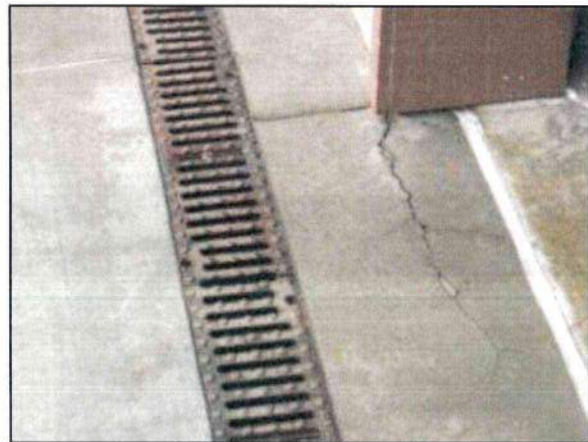
Photo 46 – Fire Station #4 Cracked concrete is present in front of the right-side garage entrance. Cracks should be sealed to prevent additional damage.

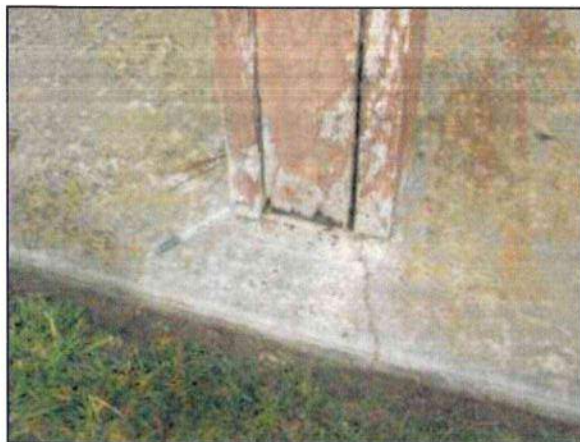
Photo 47 – Fire Station #4 A structural post located at the front porch is rotted at the base.

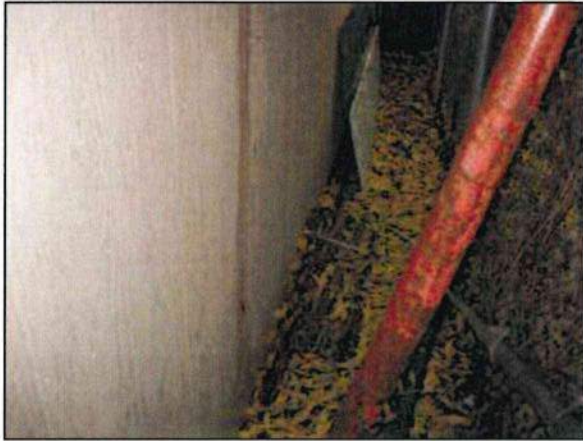
Photo 49– Fire Station #4 The back side of the storage shed is beginning to rot due to the presence of wet debris.

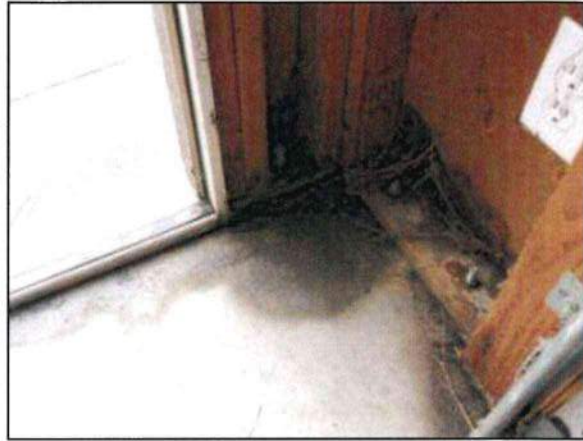
Photo 50 – Fire Station #4 Leaks are present inside of the storage shed at the entry door and at the wall where it meets the concrete slab.

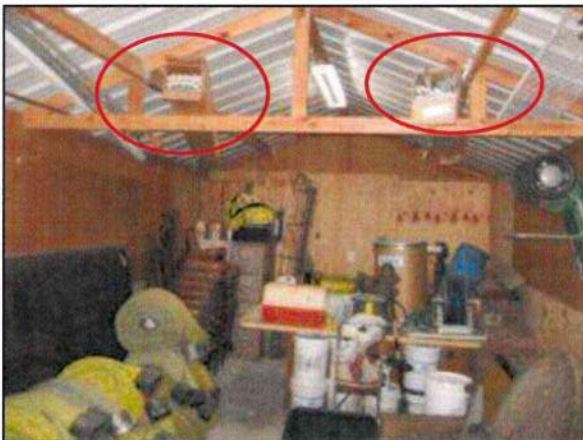
Photo 51 – Fire Station #4 No electrical sub panels are present in the storage shed. The electrical feed is from the main building. Note the fluorescent tube storage in the rafters.

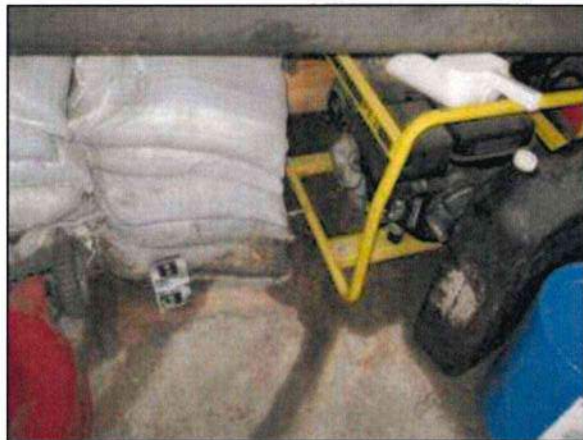
Photo 52 – Fire Station #4 Major leaks are present on the inside rear of the shed.

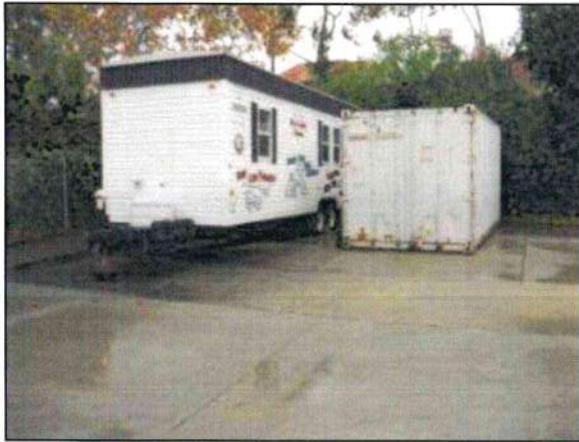
Photo 53 – Fire Station #4 A trailer and storage shed are present at the rear corner of the fire station lot.
