CITY OF ENCINITAS INFRASTRUCTURE TASK FORCE

MEETING NOTICE
MONDAY, JUNE 26, 2023

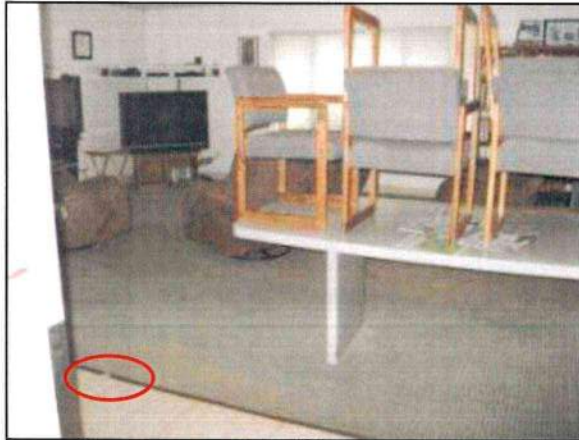
Photo 61 – Fire Station #4 A general view of the lounge area with a damaged carpet transition strip.

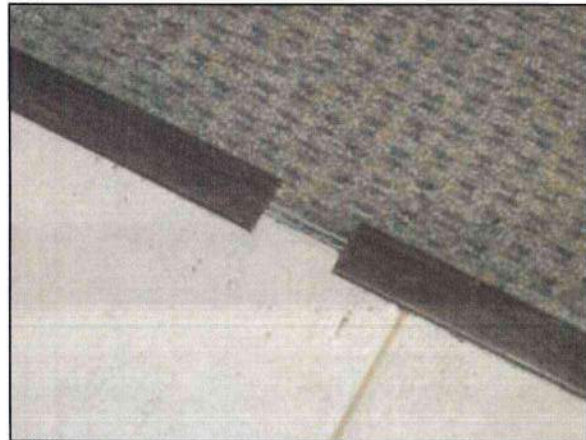
Photo 62 – Fire Station #4 The carpeting in the lounge area exhibits a damaged transition strip posing a potential trip hazard.

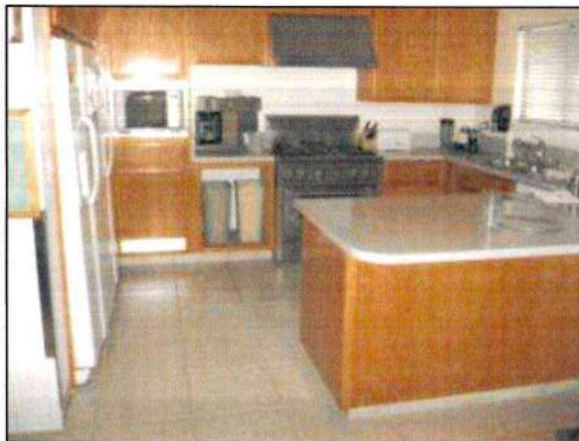
Photo 63 – Fire Station #4 A general view of the kitchen showing the wood cabinets and Formica countertops.

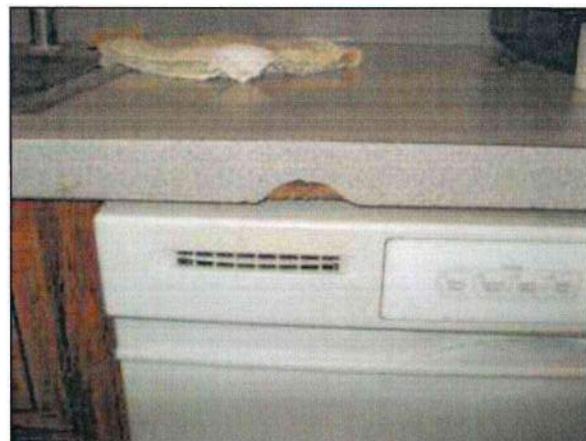
Photo 64 – Fire Station #4 Damage to the Formica countertops is present in the kitchen.

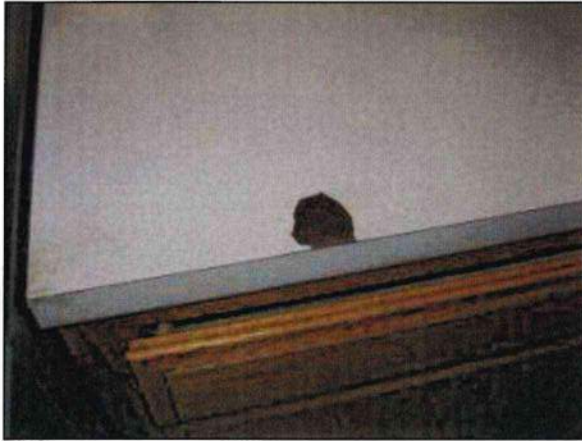
Photo 65- Fire Station #4 Damage to the Formica countertops in the kitchen is present.

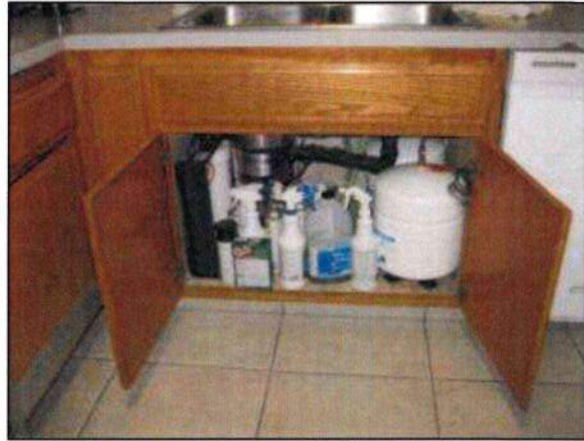
Photo 66 - Fire Station #4 The kitchen sink is equipped with a garbage disposal and reverse osmosis water filtration system.

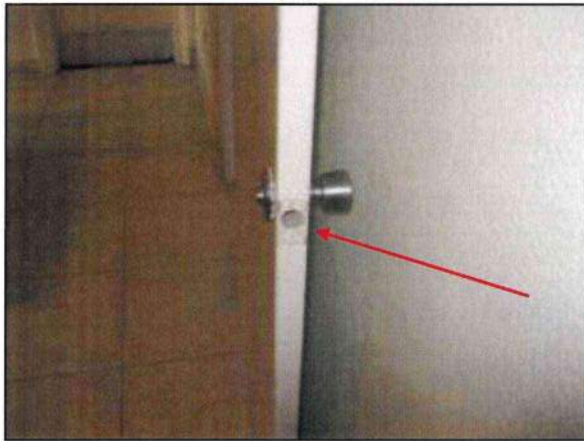
Photo 67 - Fire Station #4 The latch and knob on the door to the game room is missing.

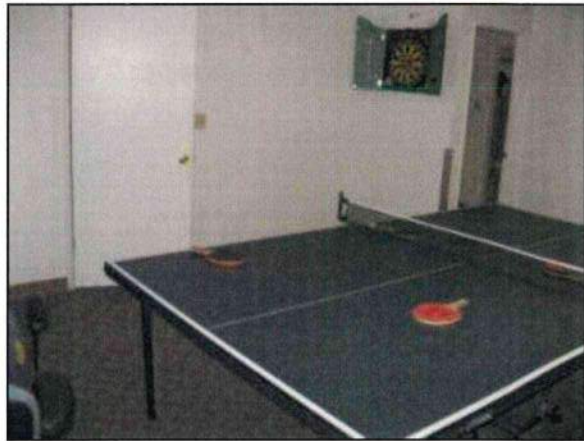
Photo 68 - Fire Station #4 A general view of the game room.
