City of Encinitas

3.29.17 Assessment of Ficus Tree At 682 Second Street (Front-1)

MARCH 29, 2017

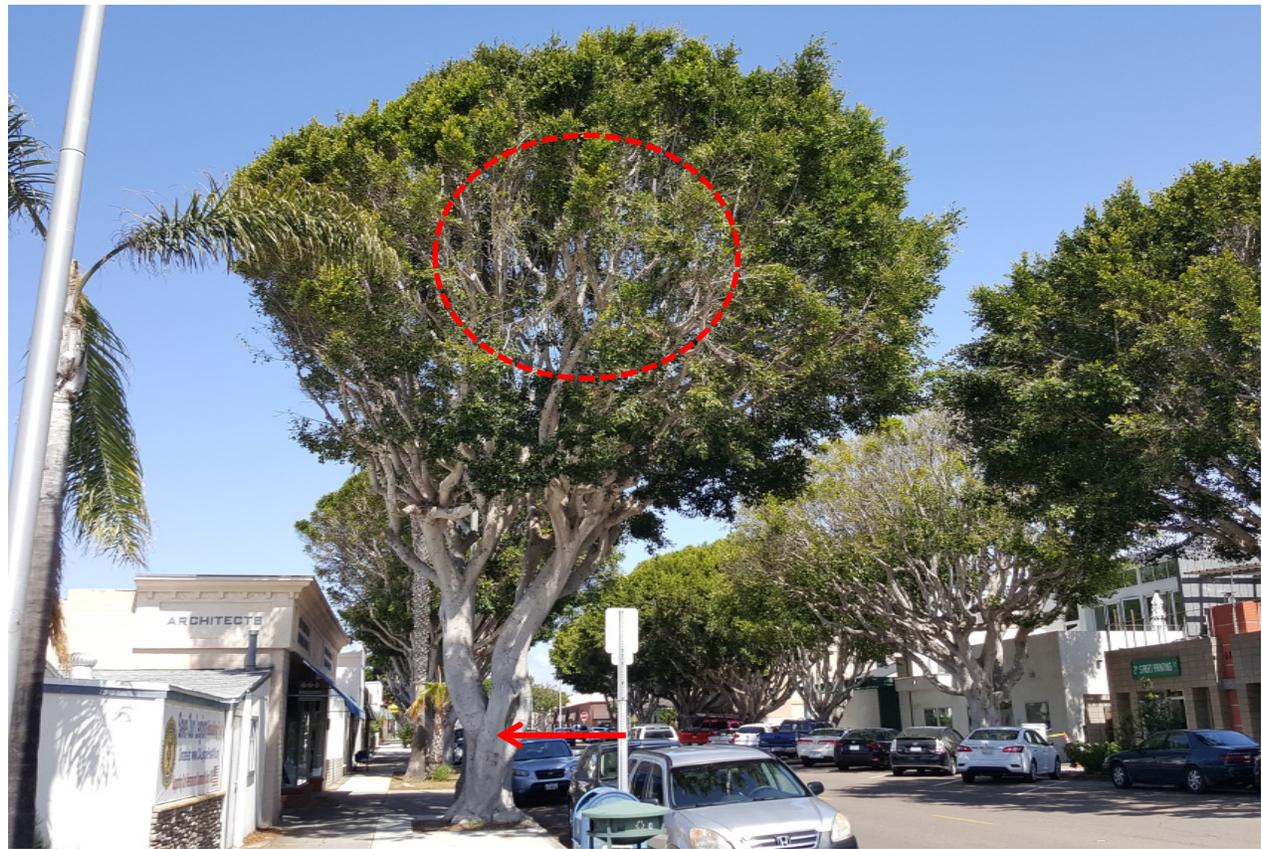
- The tree was growing in a 6.5 foot wide tree well on the west side of 2nd St. in front of the 682 business address (see Photo #1 in Appendix A).
- Judging by the color and density of the foliage, the tree appeared to be in fair health for the species and time of year. There was an area showing dieback on the south side of tree. The tree had a moderate **live crown ratio** of approximately 50% which is common for street trees necessitating raised crowns for vehicle clearance (see Photo #1 in Appendix A).

- The tree had two large codominant stems with multiple overextended branches, contributing to an overall slight canopy imbalance towards 2nd Street (see Photo #1 in Appendix A).

- The tree (red arrow) was growing in a 6.5 foot wide tree well on the west side of 2nd St. in front of the 682 business address.
- Judging by the color and density of the foliage, the tree appeared to be in fair health for the species and time of year. There was an area showing dieback on the south side of tree (red dotted area). The tree had a moderate **live crown ratio** of approximately 50% which is common for street trees necessitating raised crowns for vehicle clearance.
- The tree had two large codominant stems followed by multiple overextended branches with an overall slight canopy imbalance towards 2nd Street.

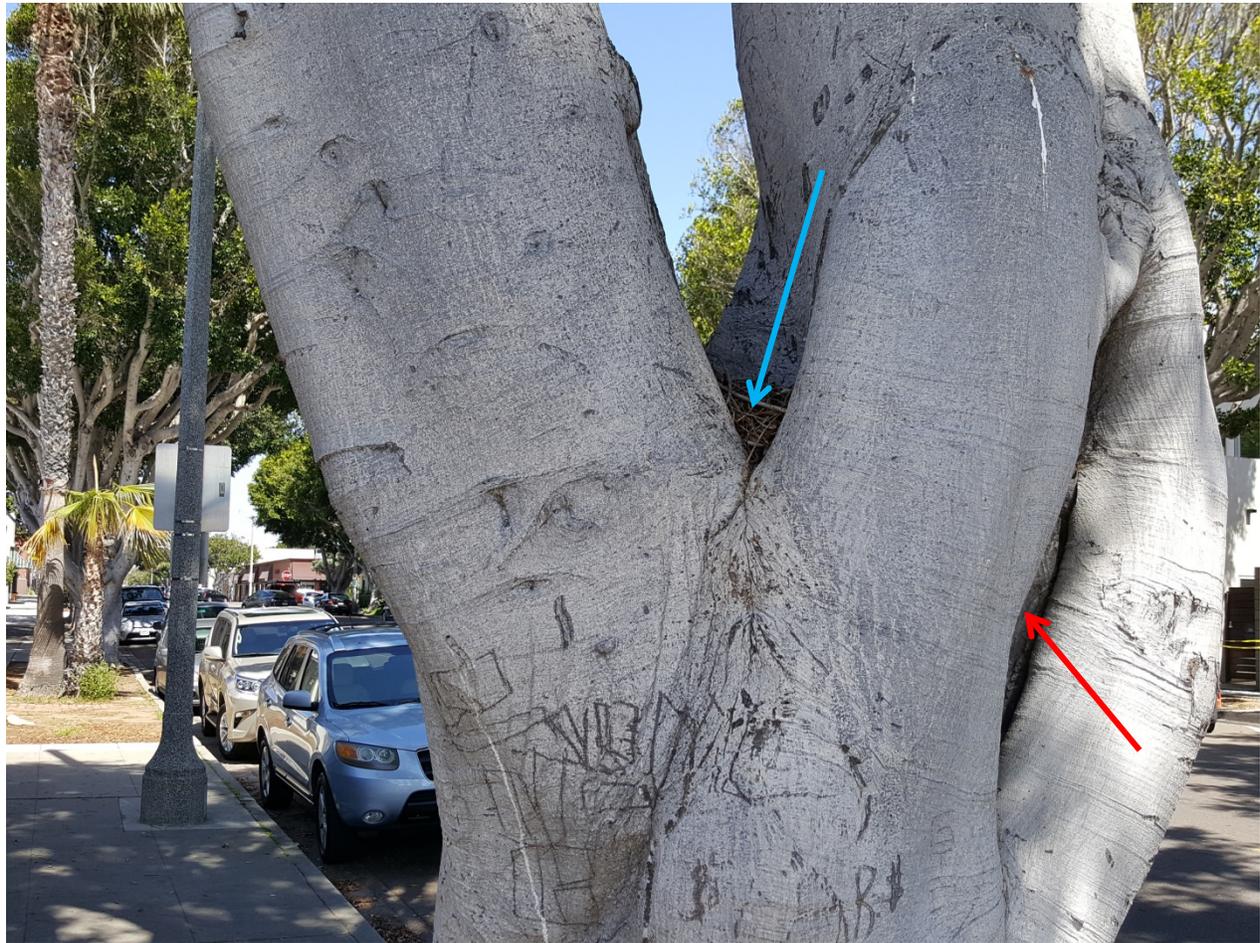
- The tree had a DSH² measurement of 35 inches and a height of about 50 feet (measured with a TruPulse laser).
- The tree had a debris filled cavity between the two codominant stems. A probe was easily inserted into the cavity to indicate an approximate depth of 12 inches (see Photo #2 in Appendix A).

- There were multiple older wounds that were likely associated with vehicular impacts and or overextended growth with included bark (see Photo #2 in Appendix A).

- The tree had a debris filled cavity between the two codominant stems (see [blue arrow](#)). A probe was easily inserted into the cavity to indicate an approximate depth of 12 inches.
- There were multiple older wounds that were likely associated with vehicular impacts and or overextended growth with included bark. The largest of these wounds is illustrated above (see [red arrow](#)).

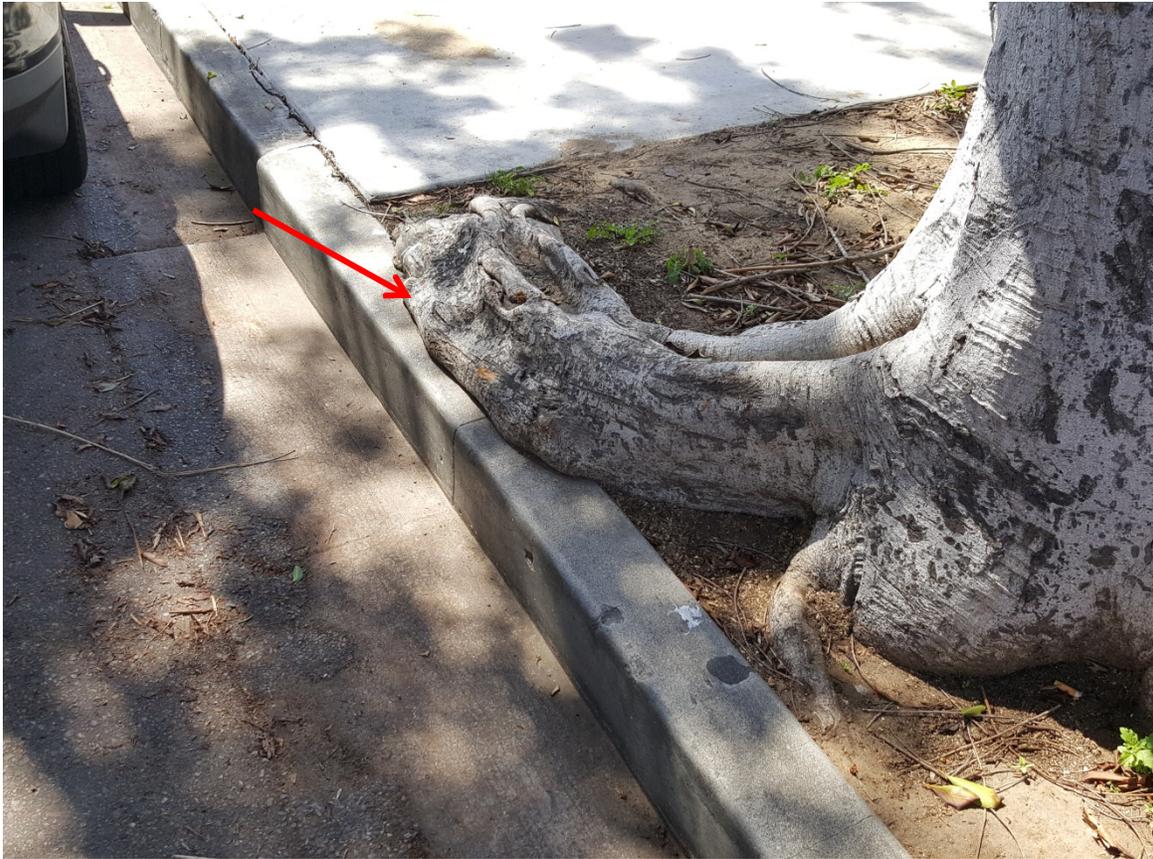
- One of the larger buttress roots was showing a **contact stress response** to growing next to the curb face. This phenomenon occurs when trees grow in close contact with infrastructure. Trunk and root tissues mold and grow over the infrastructure element providing a level of structural support to the tree. There may be an increase in failure potential if the infrastructure element is removed or replaced (see Photo #3 in Appendix A).

- One of the larger buttress roots were showing a **contact stress response** to growing next to the curb face (see **red arrow**). This phenomenon occurs when trees grow in close contact with infrastructure. Trunk and root tissues mold, and grow over the infrastructure element providing a level of structural support. There may be an increase in failure potential if the infrastructure element is removed or replaced.

Hardscape Repairs – It appears evident that hardscape repairs and potential root pruning have occurred around the base of the tree. If future conflicts between roots and infrastructure occur, I recommend looking into alternative mitigation strategies such as **elevated root bridging**, or meandering sidewalks to minimize further damages to the tree’s health and stability.

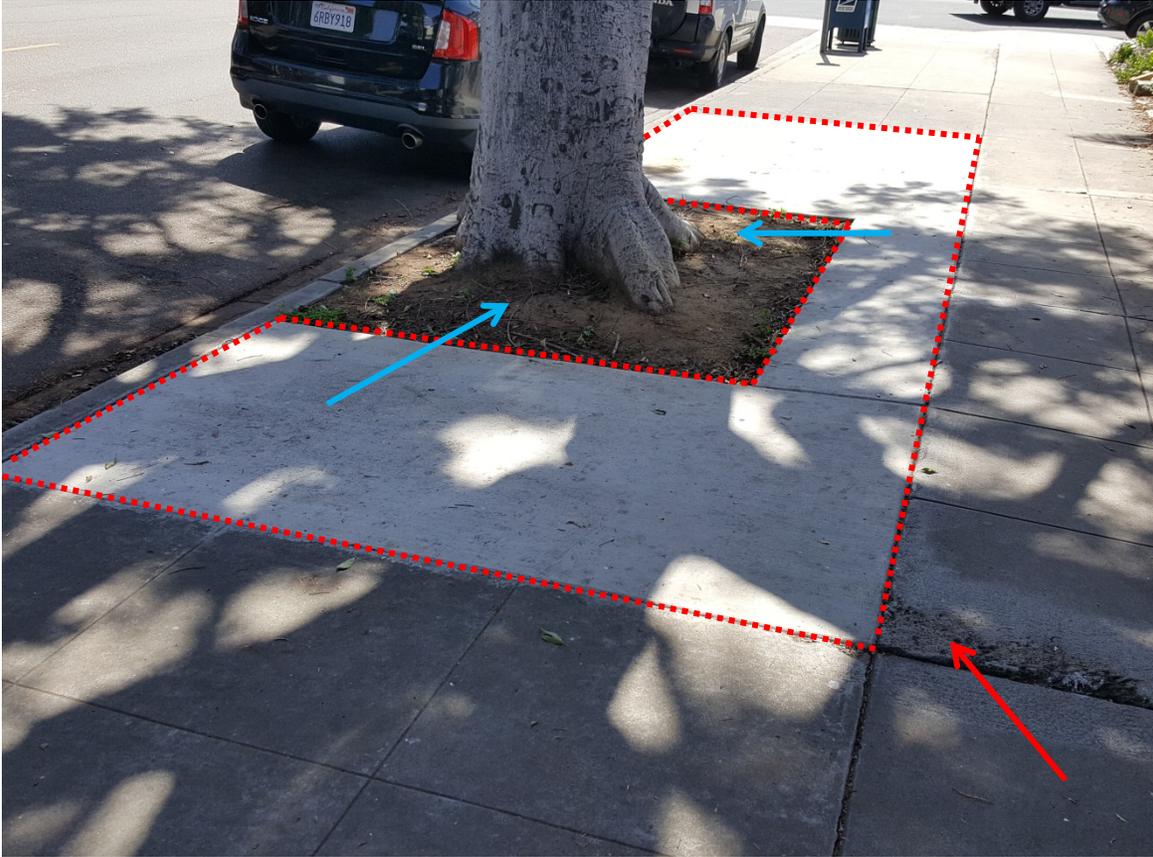
- The sidewalk on three sides of the tree had a lighter tone indicating that it was likely replaced to reduce trip hazards. Given the site history, it is likely that some root pruning occurred around the tree; however, evidence of root pruning was not observed during this level 2 inspection (see Photo #4 in Appendix A)

- The sidewalk on three sides of the tree had a lighter tone indicating that it was likely replaced to reduce trip hazards (see **red dotted area**). Given the site history, it is likely that some root pruning occurred around the tree; however, evidence of root pruning was not observed during this Level 2 inspection.
- There was evidence of concrete grinding to reduce deflections in the sidewalk near the tree (see **red arrow**).
- Shallow cracking was observed on the north and south-west side of the tree (see **blue arrows** and photos #5- #8).

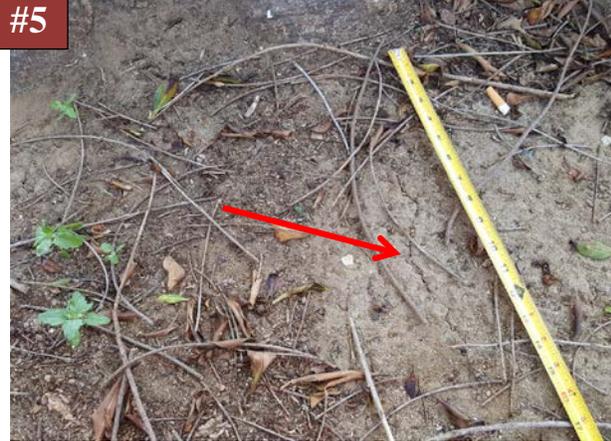
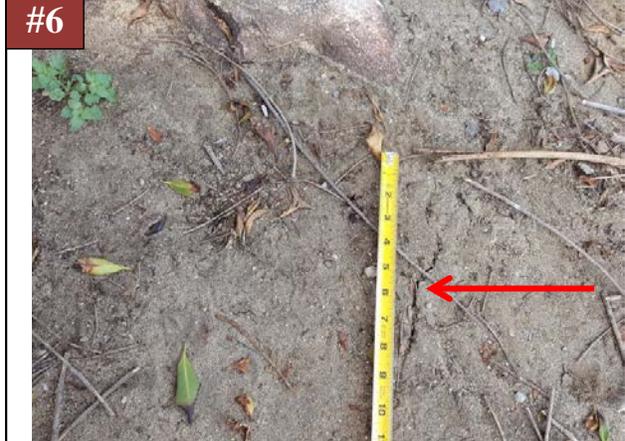
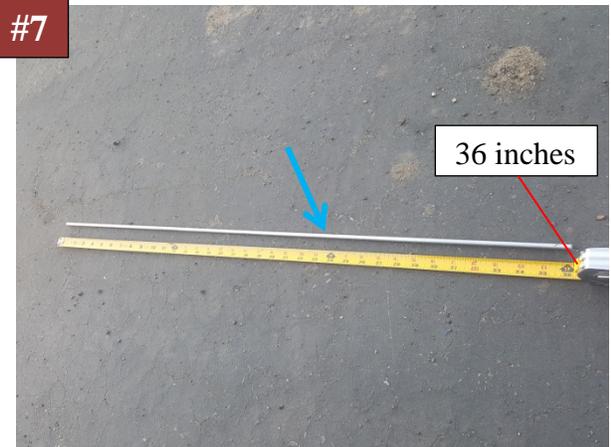
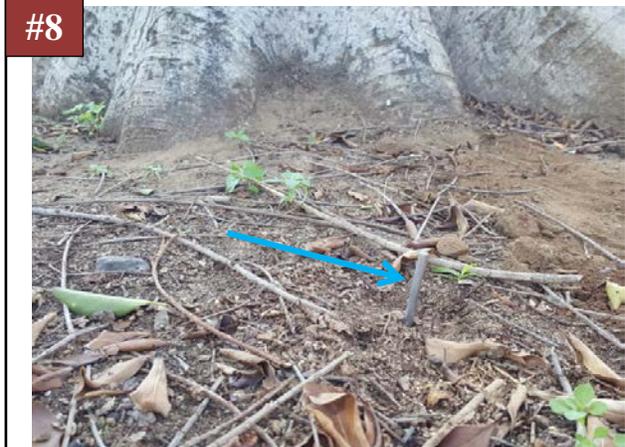
Photos #5, #6, #7, and #8

- There was evidence of concrete grinding to reduce deflections in the sidewalk near the tree (see Photo #4 in Appendix A).
- During the inspection, there were two shallow cracks in the soil observed around the base of the tree (see Photo #5- #8 in Appendix A). A shallow excavation, probing, and sounding were performed to try and determine the depth of the soil cracks, as well as if heaving of the tree was creating them (see photo #7 and #8). They seemed to disappear a few inches down; however, on the north side of the tree the soil probe was inserted with relative ease to its full length of 36 inches (see photo #8) in multiple locations indicating very loose soil or air pockets below the surface. Sounding the soil with a nylon mallet in this area also gave off a deep hollow resonance that differed from other regions around the tree, further confirming air pockets (see Photo #5- #8 in Appendix A).

The defect of greatest concern was the light cracking and air pockets in the soil indicating the potential of a windthrow/ root failure event within the next year. The *likelihood of failure* was assessed to being **probable** and would be most likely to occur during abnormal or extreme weather conditions.

- During the inspection, there were two shallow cracks in the soil observed around the base of the tree (see **red arrows** in Photo #5 and #6).
- A shallow excavation, probing, and sounding were performed to try and determine the depth of the soil cracks, as well as if heaving of the tree was creating them (see photo #7 and #8). The cracks seemed to disappear a few inches down; however, on the north side of the tree the soil probe (**blue arrows**) was inserted with relative ease its full length of 36 inches (see photo #8) in multiple locations indicating very loose soil or air pockets below the surface. Sounding the soil with a nylon mallet in this area also gave off a deep hollow resonance that differed from other regions around the tree further confirming air pockets.

1. Remove the tree and replace it with a healthy site adequate species.
2. Reducing the overall canopy height by approximately 30% with the structure and canopy balance of the tree in mind (see Figure 3 and Appendix B for more details). This recommended pruning should be done in compliance to ANSI A300 Arboricultural Standards and will need to be applied over multiple spaced out pruning doses to minimize health impacts on the tree. Pruning techniques such as **reduction pruning**, and **removal pruning cuts** should be used (not **topping**) to achieve this overall squattier appearance and are further explained in Appendix B. The end outcome should be a reduction of **mechanical stress** from overextended loads. It will likely take multiple spaced out pruning doses (taking up to 5 years) to achieve a residual risk of “Low” without topping or creating large injurious removal pruning cuts. This is also recommended to allow time for interior growth to further develop and broaden the options for new branches to prune back to. A routine monitoring plan to look for signs of heaving should be implemented as part of this preservation plan.
