City of Encinitas

4.10.17 Assessment of Ficus Tree At 687 2nd Street (Side-2)

APRIL 10, 2017

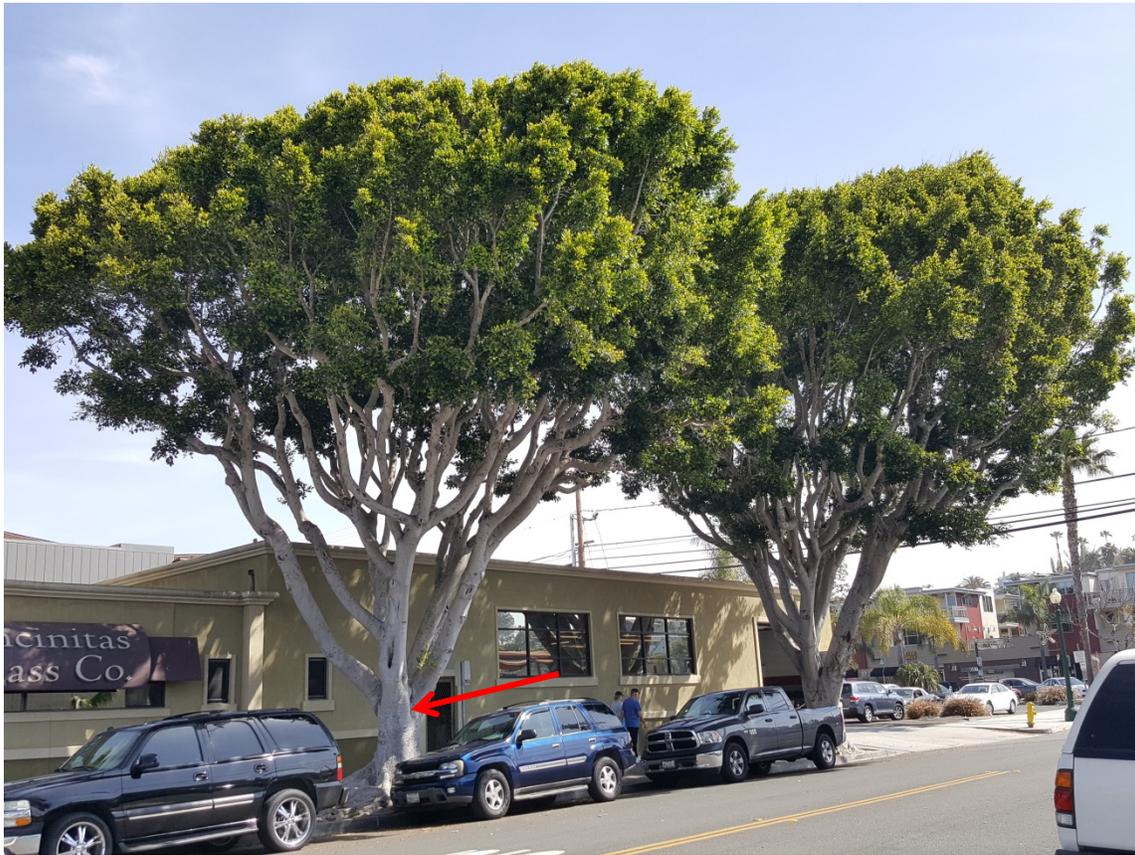
- The tree was growing in a tree well on the north side of F St (see Figure 1 and Photo #1 in Appendix A).
- Judging by the color and density of the foliage, the tree appeared to be in fair health for the species and time of year. The tree had a moderate-low **live crown ratio** of approximately 40% which is common for street trees necessitating raised crowns for vehicle and building clearance (see Photo #1 in Appendix A).

- The tree had a DSH² measurement of 31 inches and a height of about 45 feet (measured with a TruPulse laser).
- The tree had multiple codominant stems and overextended scaffold branches which are indicative of poor structure yet fairly common among this species. There were signs of considerable responsive growths to these defects (see Photo #1 in Appendix A).

- The tree had a slight canopy unbalance because of pruning for building clearance (see Photo #1 in Appendix A).
- Some of the stems and scaffold branches had presence of included bark as well as a small debris cavity between the branch unions (see Photo #2 in Appendix A).

- The tree (**red arrow**) was growing in a tree well on the north side of F St.
- Judging by the color and density of the foliage, the tree appeared to be in fair health for the species and time of year. The tree had a moderate- poor **live crown ratio** of approximately 40% which is common for street trees necessitating raised crowns for vehicle and building clearance.
- The tree had multiple codominant stems and overextended scaffold branches which are indicative of poor structure yet fairly common among this species.
- The tree had a slight canopy unbalance because of pruning for building clearance.

Risk and Mitigation – After performing a **Level 2 Basic Assessment**⁴, the subject tree was assessed to have an overall moderate risk rating. In regards to mitigating these risks, I recommend applying an approximate 25% overall crown reduction with the structure and canopy balance of the tree in mind (see Appendix B as well as Figure 3 below). This recommended pruning should be done in compliance to ANSI A300 Arboricultural Standards and will need to be applied over multiple spaced out pruning doses (taking up to 5 years) to minimize health impacts on the tree. This is also recommended to allow time for interior growth to further develop and broaden the options for new branches to prune back to. Pruning techniques such as **reduction pruning**, and **removal pruning cuts** should be used (not topping) to achieve this overall squattier appearance and are further explained in Appendix B. The end outcome should be a reduction of **mechanical stress** from overextended growth. A residual risk of “Low” should be achieved after implementing these recommended pruning strategies.

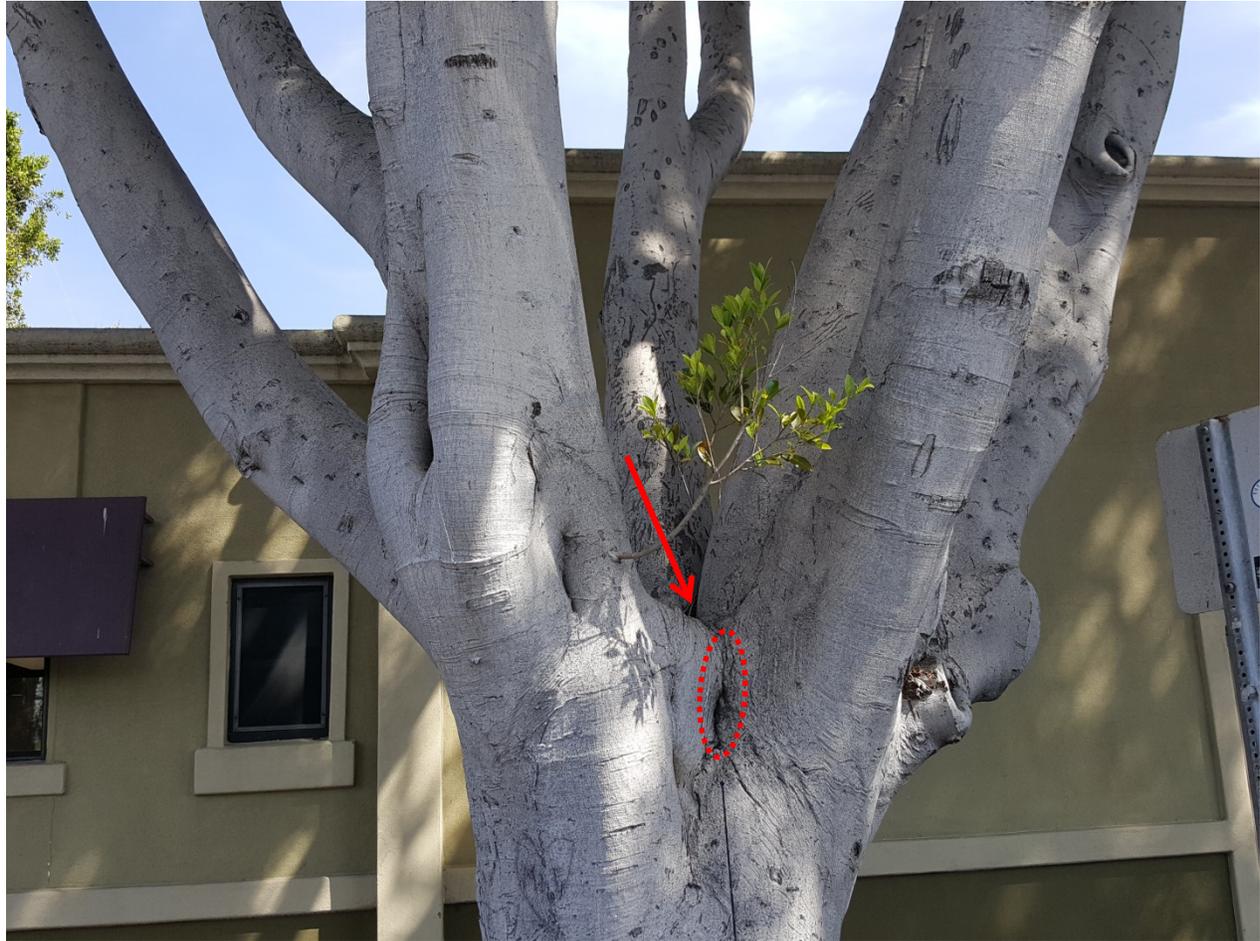
Photo #2

- Some of the stems and scaffold branches had presence of included bark (**red dotted oval**) as well as a shallow debris cavity between the branch unions (**red arrow**). There were signs of considerable responsive growth to these defects.

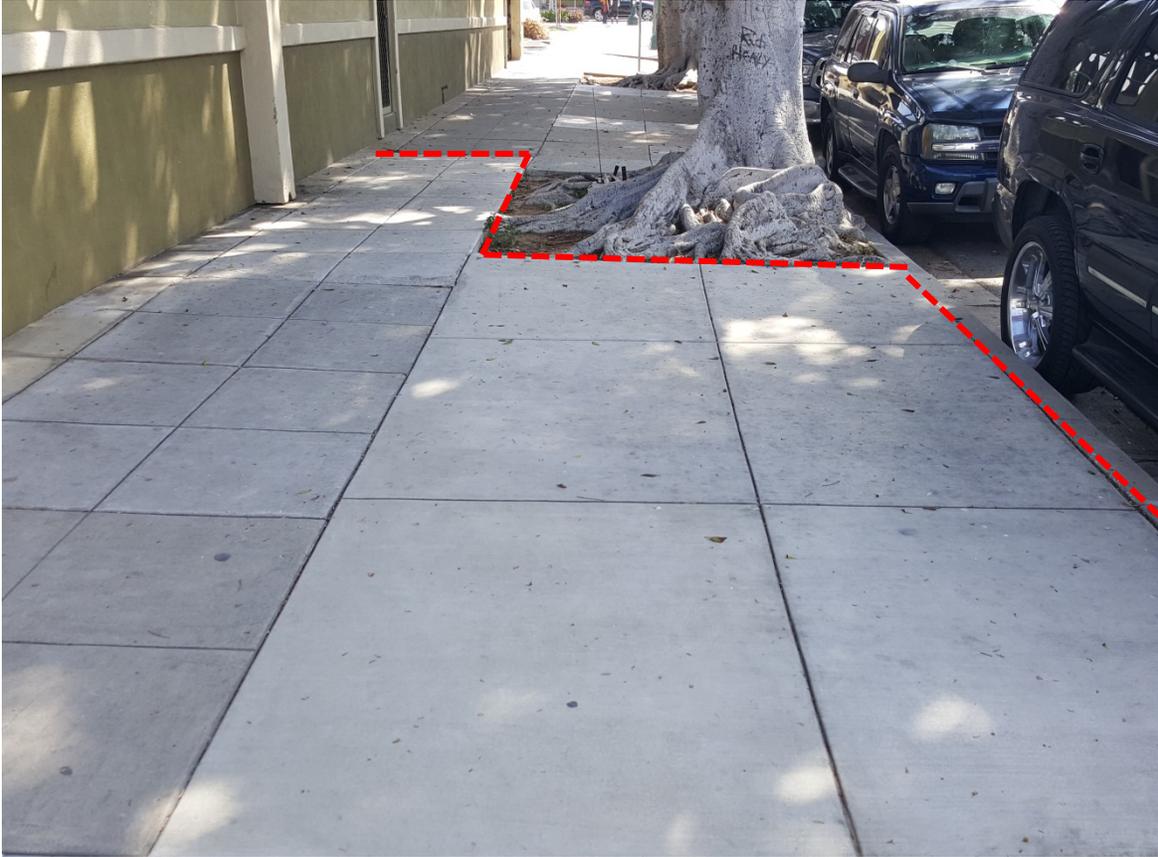
- Judging by the lighter tone of concrete, it appeared that a significant area of sidewalk had been replaced around the tree (see Photo #3 in Appendix A).

- Judging by the lighter tone of concrete, it appeared that a large area of sidewalk had been replaced around the tree (see red dotted area).

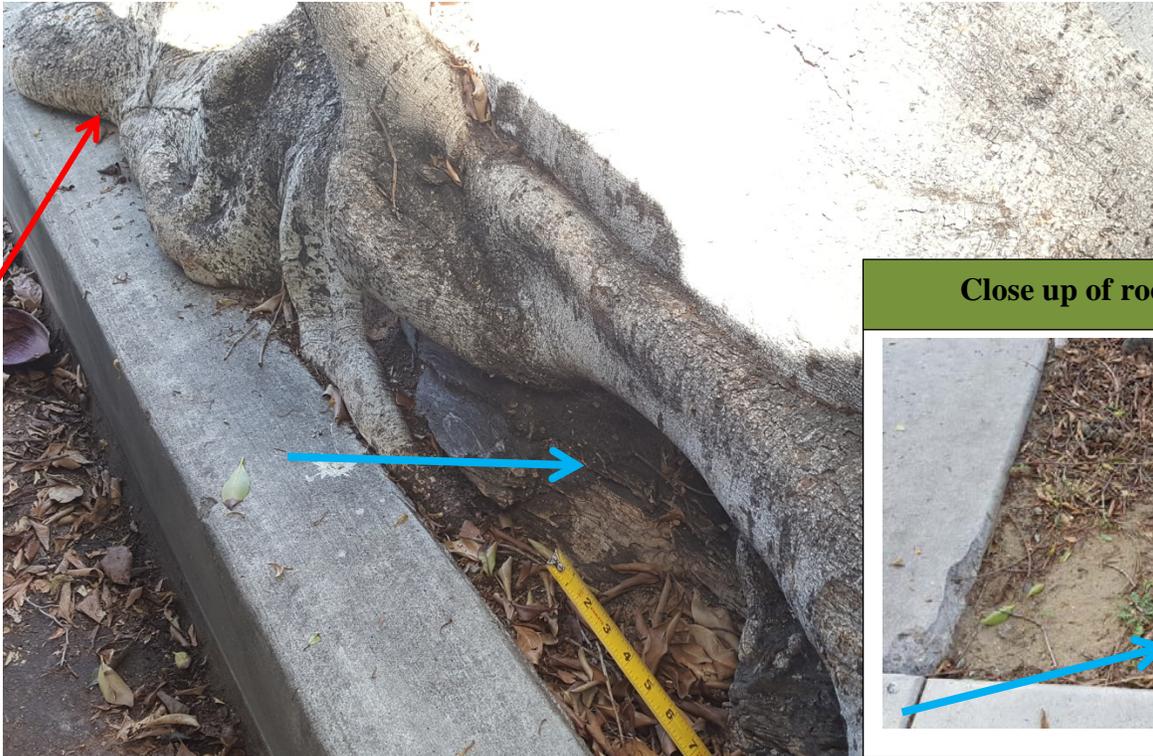
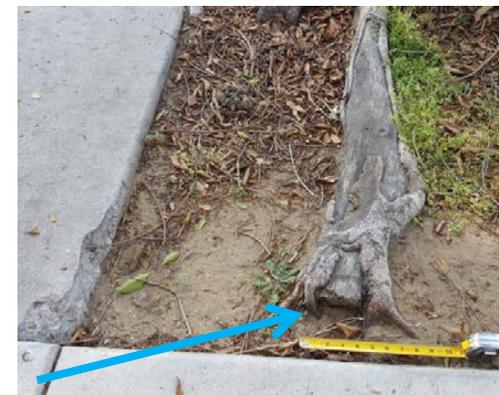
- There were several significant root injuries around the tree likely associated with root pruning for hardscape repairs. Signs of callusing and epicormic root growth gave indication that these injuries were several years old (see Photo #4 in Appendix A).
- Some of the buttress roots were showing a **contact stress response** to growing next to the curb face. This phenomenon occurs when trees grow in close contact with infrastructure. Trunk and root tissues mold, and grow over the infrastructure element providing a level of structural support. There may be an increase in failure potential if the infrastructure element is removed or replaced. (see Photo #4 in Appendix A).
- There was what appeared to be a bird's nest in the top of the canopy on the south side.
- Vehicles appeared to use this area of 2nd Street frequently throughout the day.

Close up of root injuries

- Some of the buttress roots were showing a **contact stress response** to growing next to the curb face (see **red arrow**). This phenomenon occurs when trees grow in close contact with infrastructure. Trunk and root tissues mold, and grow over the infrastructure element providing a level of structural support. There may be an increase in failure potential if the infrastructure element is removed or replaced. There also appeared to be some older damage to the living tissues on the top of the root.
- There were several significant root injuries around the tree (**blue arrows**) likely associated with root pruning for hardscape repairs. Signs of callusing and epicormic root growth gave indication that these injuries were several years old.
