City of Encinitas

4.4.17 Assessment of Ficus Tree At 965 Second Street (Front-1)

John Ugrob
Utility & Maintenance Supervisor
Street/ NPDES Division
City of Encinitas

APRIL 4, 2017

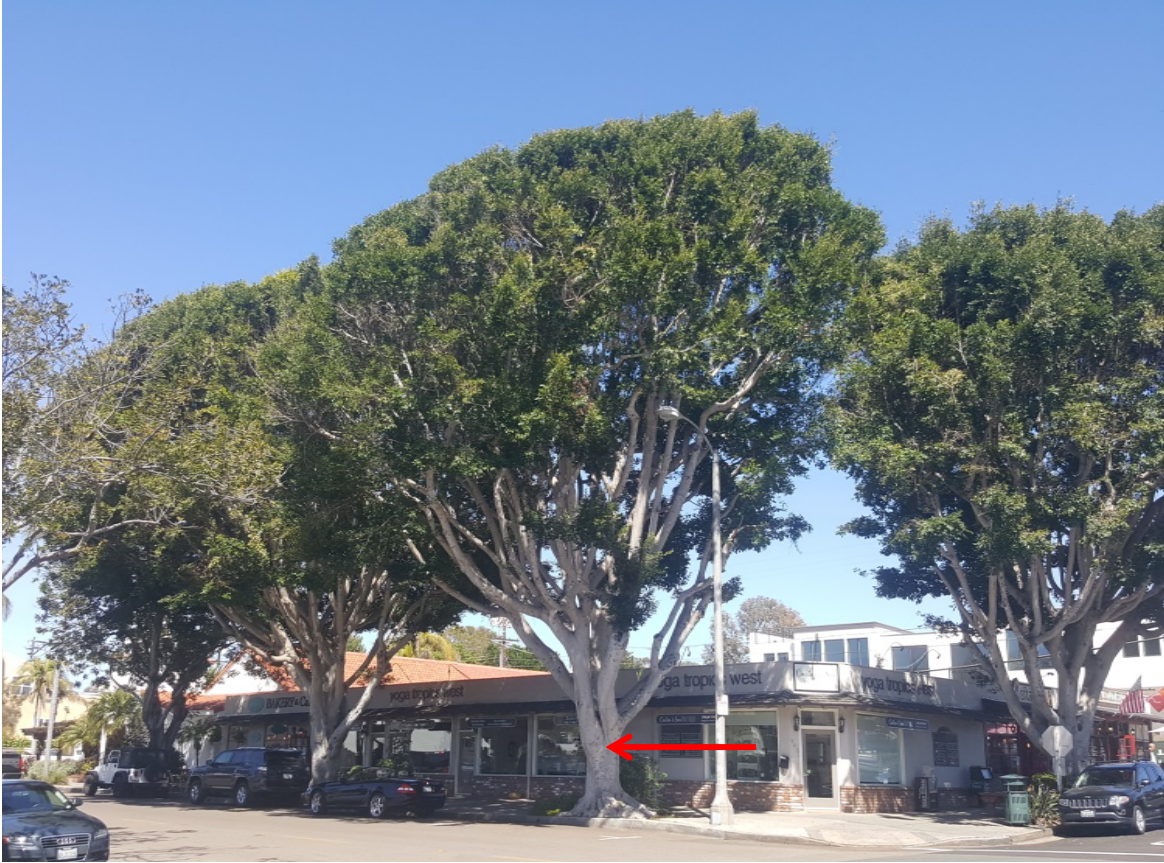
- The tree was growing in a 7.5 foot wide tree well on the east side of 2nd St. and in front of the 965 business address (see Photo #1 in Appendix A).
- Judging by the color and density of the foliage, the tree appeared to be in fair health for the species and time of year. The tree had a low **live crown ratio** of approximately 50% which is common for street trees necessitating raised crowns for vehicle/ building clearance (see Photo #1 in Appendix A).

- The tree (**red arrow**) was growing in a 7.5 foot wide tree well on the east side of 2nd St. and in front of the 965 business address.
- Judging by the color and density of the foliage, the tree appeared to be in fair health for the species and time of year. The tree had a low **live crown ratio** of approximately 50% which is common for street trees necessitating raised crowns for vehicle/ building clearance.

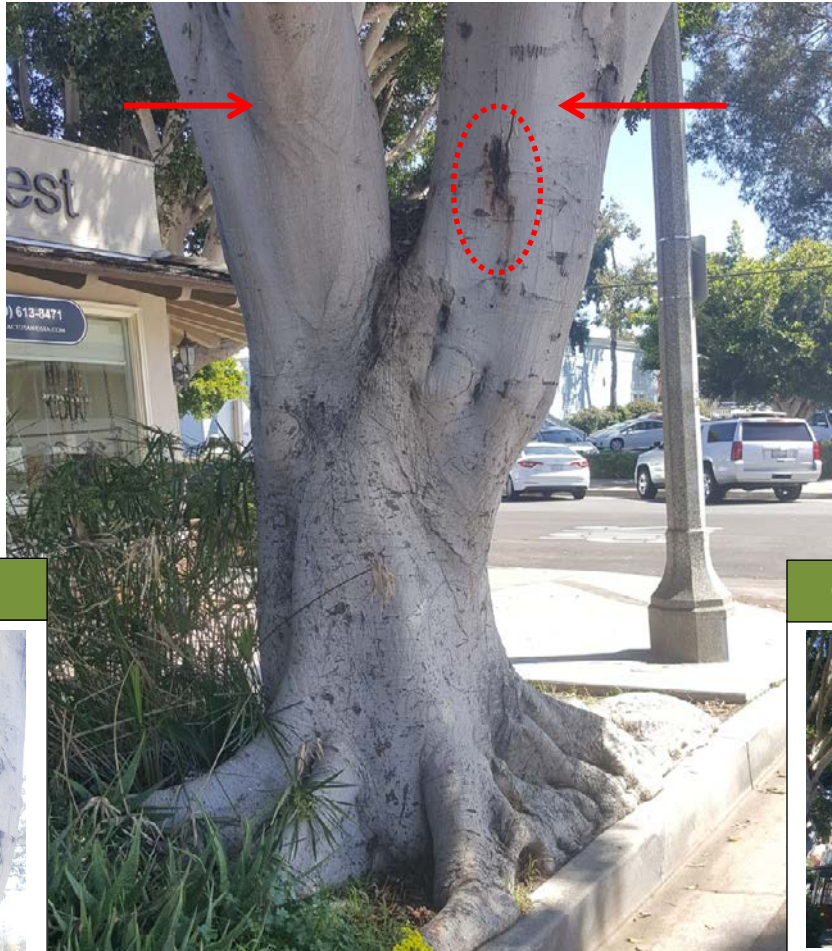
- The tree had a DSH² measurement of 35 inches and a height of about 55 feet (measured with a TruPulse laser).
- The tree had multiple overextended **codominant stems** and branches with included bark which is indicative of poor structure (see Photo #2 in Appendix A).

- There appeared to be an injury/ **canker** about 7 feet up on the west facing stem (see Photo #2 in Appendix A).
- Some of the buttress roots were showing a **contact stress response** to growing next to the curb face. This phenomenon occurs when trees grow in close contact with infrastructure. Trunk and root tissues mold, and grow over the infrastructure element providing a level of structural support. There may be an increase in failure potential if the infrastructure element is removed or replaced (see Photo #3 in Appendix A).

- The tree had multiple overextended **codominant stems** (**red arrows**) and branches with included bark (**green arrow**) which is indicative of poor structure.
- There appeared to be an injury/ **canker** about 7 feet up on the west facing stem (see **2 red dotted ovals**).

Risk and Mitigation – After performing a **Level 2 Basic Assessment**⁴, the subject tree was assessed to have an overall high risk rating. This is likely an unacceptable risk for the City and action is suggested to reduce it. In regards to mitigating these risks, I present two options:

1. Remove the tree and replace it with a healthy site adequate species.
2. Reducing the overall canopy height by approximately 30% with the structure and canopy balance of the tree in mind. This recommended pruning should be done in compliance to ANSI A300 Arboricultural Standards and will need to be applied over multiple spaced out pruning doses to minimize health impacts on the tree. Pruning techniques such as **reduction pruning**, and **removal pruning cuts** should be used (not **topping**) to achieve this overall squattier appearance. If there are not suitable laterals meeting the 1/3rd size correlation, pruning other reduction cuts may only be considered under the direction of an ISA Certified Arborist. Some of these reduction pruning cuts will be done to a shoot, branch, or stem that extends nearly as far as the removed parent branch; if this is the case then additional subordination pruning cuts back to a bud or young growth may be acceptable in order to maintain a point of **apical dominance** and to achieve the reduction goal (further explained in Appendix B). The end outcome should be a reduction of **mechanical stress** from overextended loads. It will likely take multiple spaced out pruning doses (3-5) to achieve a residual risk of "Low" without topping or creating large injurious removal pruning cuts. A routine monitoring plan to look for signs of heaving should be implemented as part of this preservation plan. If the tree begins to go into decline despite efforts and care for preservation, then removal should be considered.

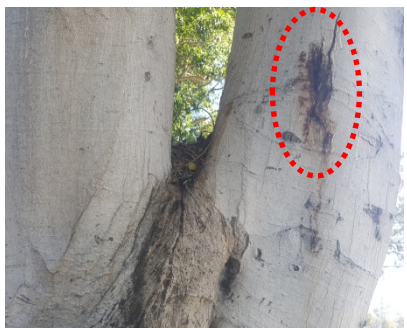
Canker – The subject tree was observed to have a canker/ injury on the large west facing stem. This species of tree is highly susceptible to a fungal disease called ficus canker (*Botryosphaeria* spp.) This disease generally attacks mature ficus trees growing in unfavorable conditions such as paved over or compacted root systems and inadequate irrigation. The main symptoms of progression are: leaf yellowing, premature leaf drop, branch dieback, crown thinning, and eventual death when found in trunk sections (as on this tree). To manage this disease, it is recommended to prune off cankered or dying limbs at least 6 inches below any canker; as well as reducing stresses such as poor soil health, inadequate irrigation, and excessive pruning. A sustainable/ long term solution is to plant less susceptible species that are well adapted to the local soil conditions and adequately matched with the growing space. Due to the location along the lower section of a large stem on the subject tree, removal of the infected area would not be a practical or advisable solution likely leading to decay and/or decline. WCA can send out tissue samples for lab testing at the City's request to identify the pathogen and help develop appropriate management options.

Close up of canker

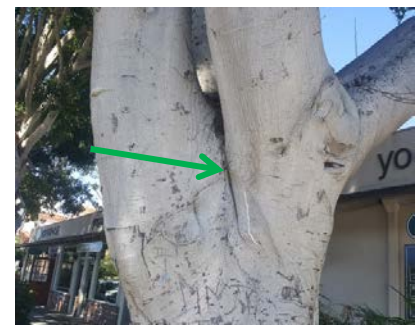
Close up of included bark

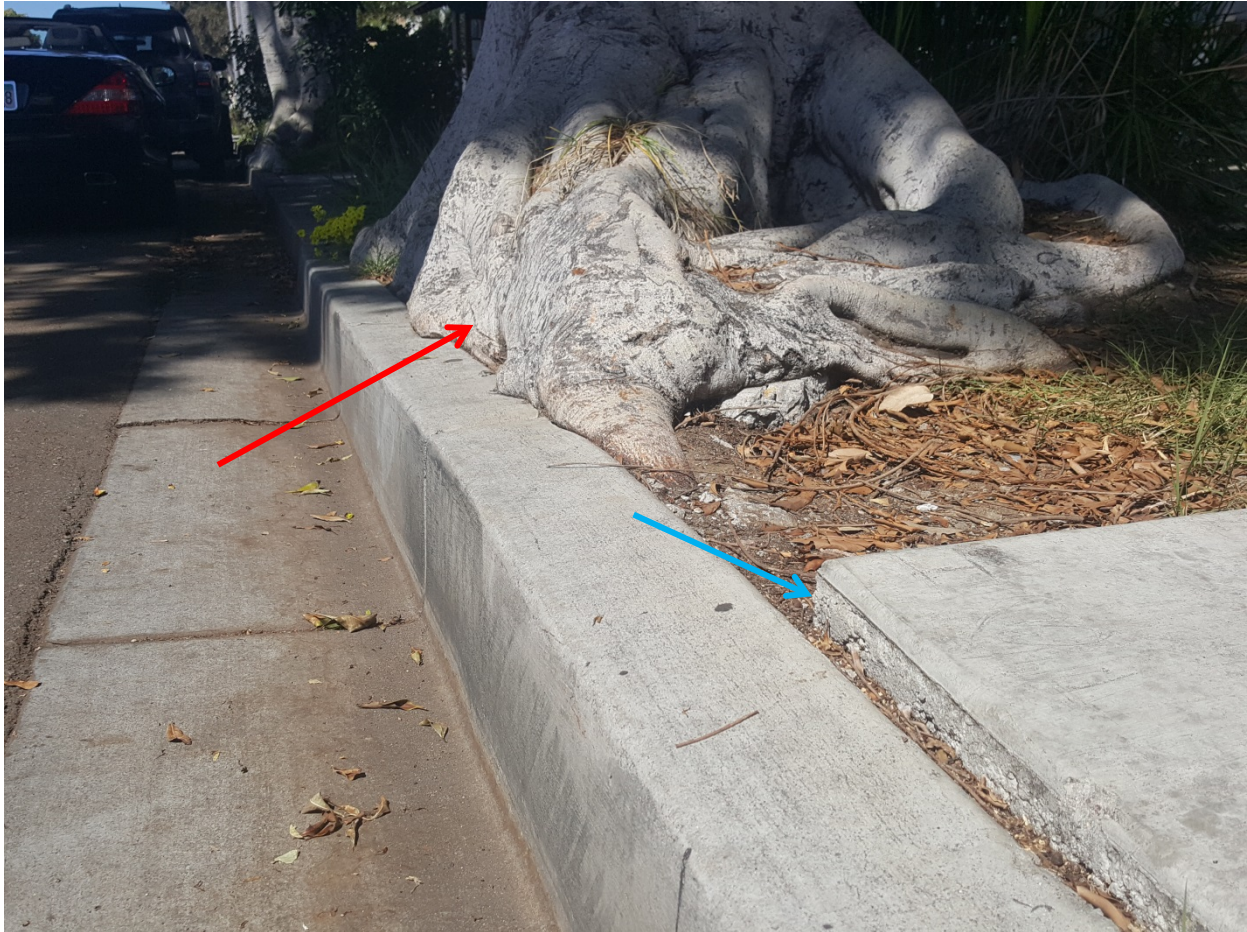
- There was a sidewalk deflection on the south-west side of the tree (see Photo #3 in Appendix A).

- Some of the buttress roots were showing a **contact stress response** to growing next to the curb face (see **red arrow**). This phenomenon occurs when trees grow in close contact with infrastructure. Trunk and root tissues mold, and grow over the infrastructure element providing a level of structural support. There may be an increase in failure potential if the infrastructure element is removed or replaced.
- There was a sidewalk deflection on the south-west side of the tree (see **blue arrow**).

Hardscape Repairs – It appears evident that hardscape repairs and potential root pruning have occurred around the base of the tree. If future conflicts between roots and infrastructure occur, I recommend looking into alternative mitigation strategies such as **elevated root bridging**, or meandering sidewalks to minimize further damages to the tree's health and stability. I present these recommendations with the health and safety of the community in mind.

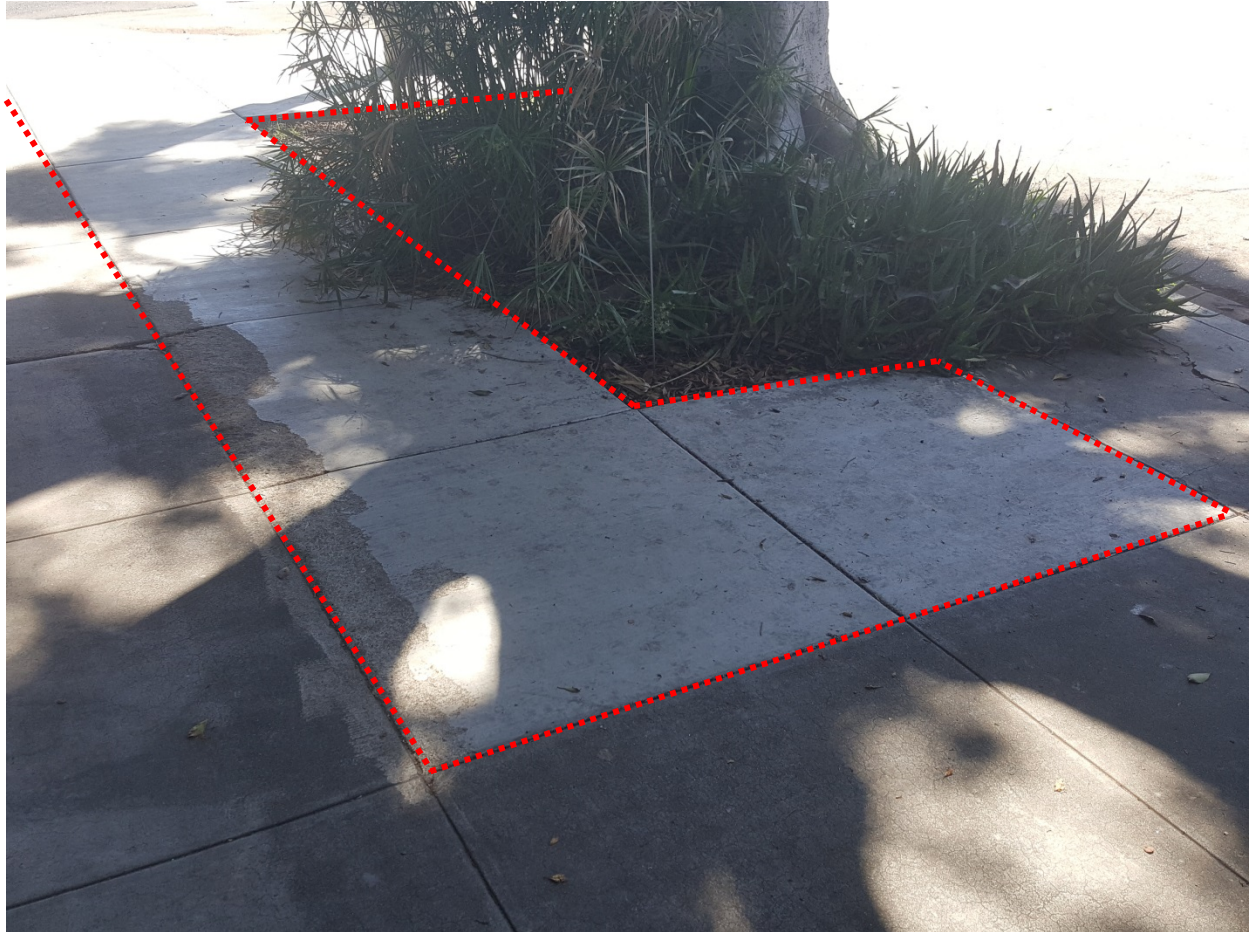
- Judging by the lighter tone of concrete, it appeared that the sidewalk on 3 sides of the tree had been replaced within the last couple of years (see Photo #4 in Appendix A).
- On the south-east side of the tree, the 36 inch probe was inserted with relative ease its full length in multiple locations indicating very loose soil or air pockets below the surface (see Photo #5 in Appendix A).
- There was occasional bird activity (ravens) surrounding the tree as well as a large nest in the tree's upper canopy. Birds were not observed entering the nest during the time of visit.

- Judging by the lighter tone of concrete, it appeared that the sidewalk on 3 sides of the tree had been replaced within the last couple of years (see **red dotted area**).

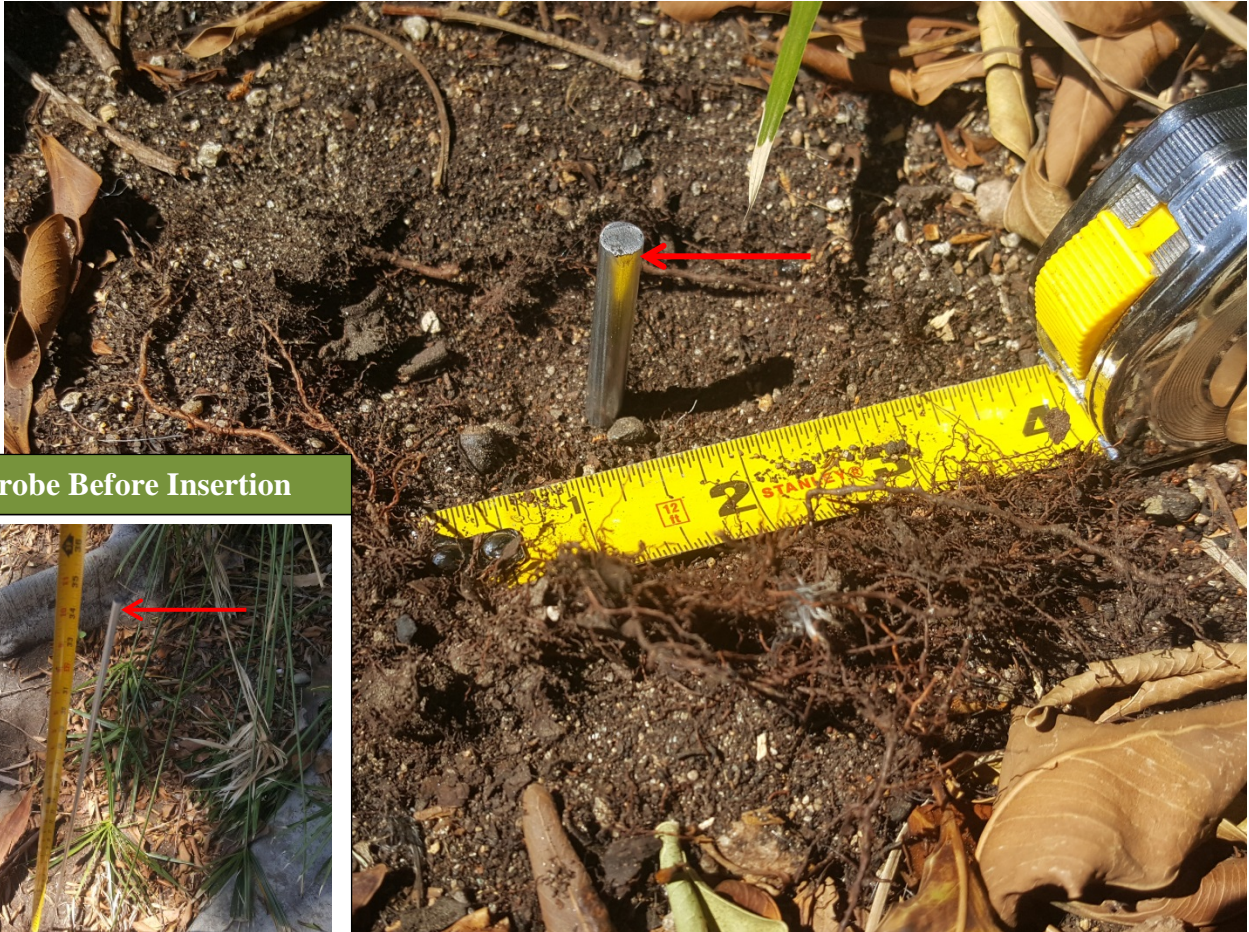
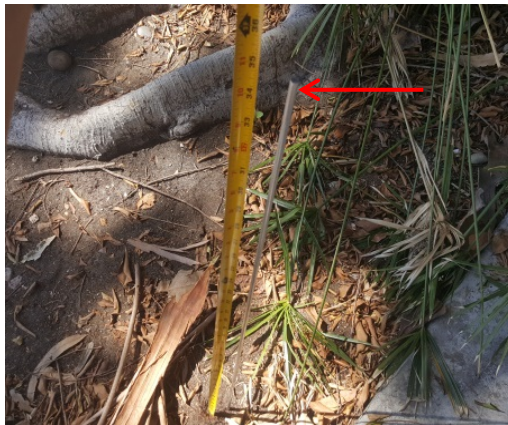
Photo #5

The defects of greatest concern were the signs of air pockets in the soil near potential root pruning in combination with the overextended growths among the canopy. These defects were assessed to give the tree a **probable** *likelihood of failure* for a windthrow/ root failure. This potential failure event would be most likely to occur during abnormal or extreme weather conditions.

36 Inch Probe Before Insertion

- On the south-east side of the tree, the 36 inch probe (red arrows) was inserted with relative ease its full length in multiple locations indicating very loose soil or air pockets below the surface.
