# City of Encinitas

## 3.23.16 Assessment of Ficus Trees

MARCH 23, 2016

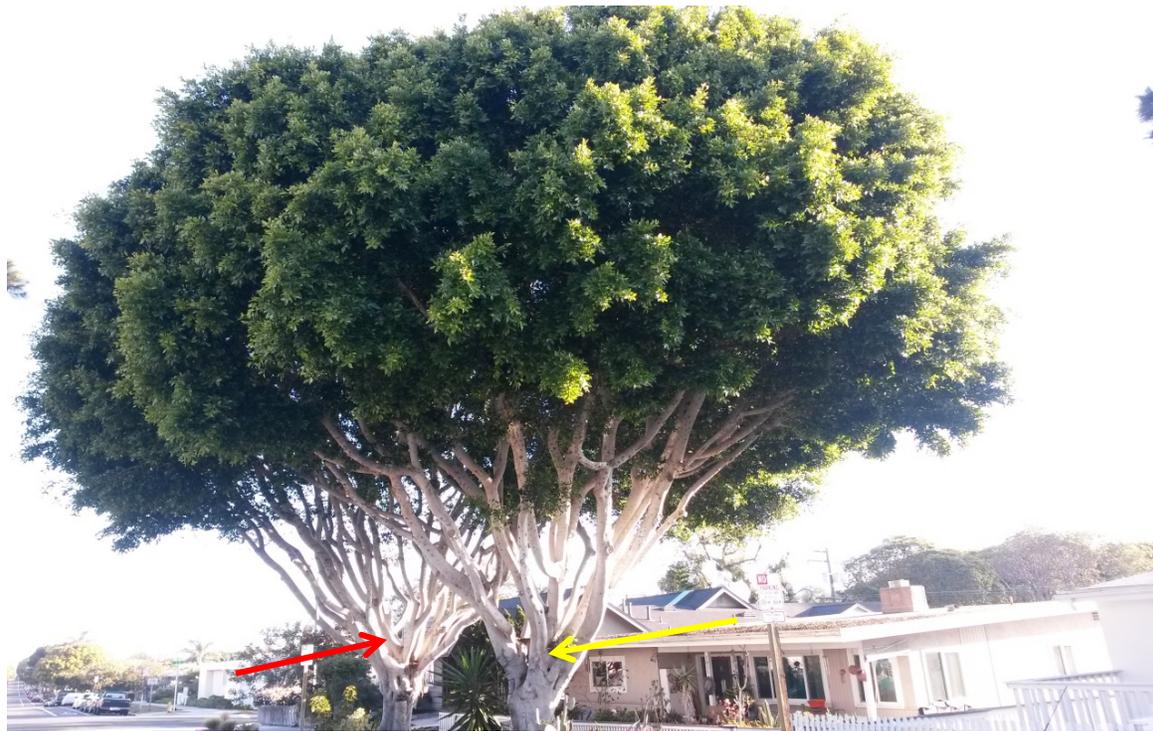
- The tree was in fair condition based on the color and density of the foliage for the given species at this time of year (see Photo #1 in Appendix A).

Shown are the two Indian Laurel Figs F-1 (**red arrow**) and F-2 (**yellow arrow**) you can also see the trees are in fair health from the color and density of the foliage.

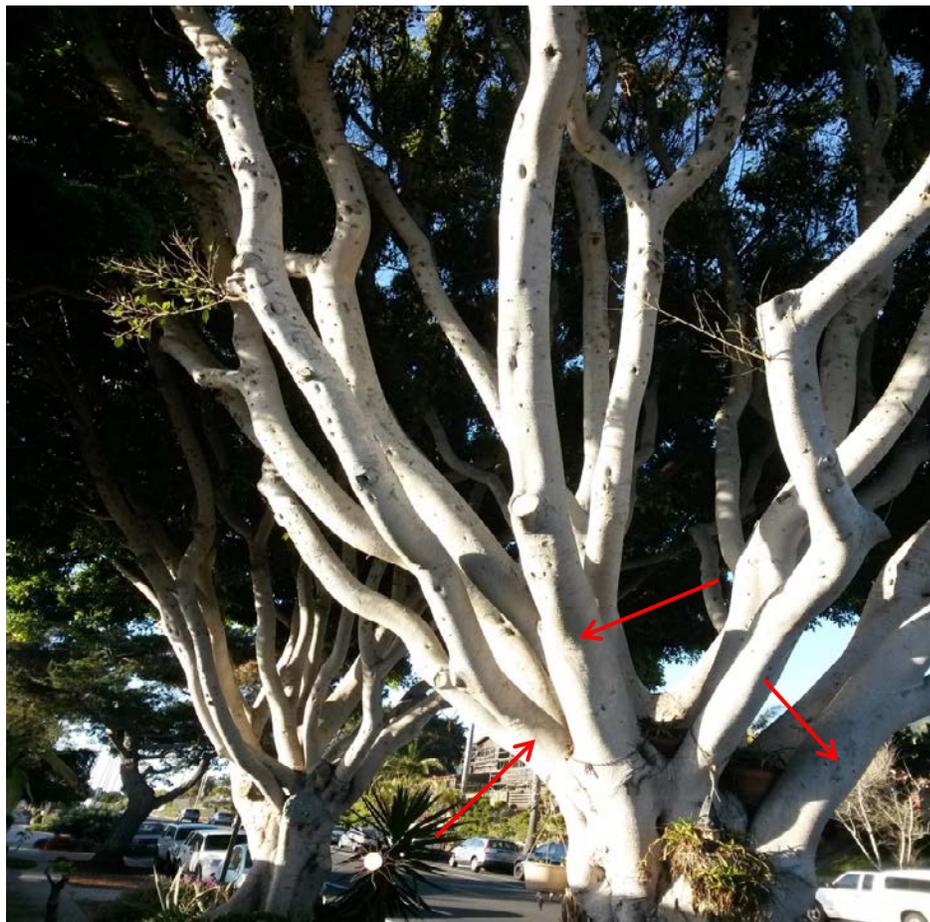
- The tree had a DSH<sup>2</sup> of 31 inches and an approximate height of 50 feet.
- The tree had multiple stems coming out of the main trunk indicating attributes of poor structure but not uncommon to this species (see Photo #2 in Appendix A).

Shown are some of the multiple stems growing from the main trunk (**red arrows**) indicating poor structure.

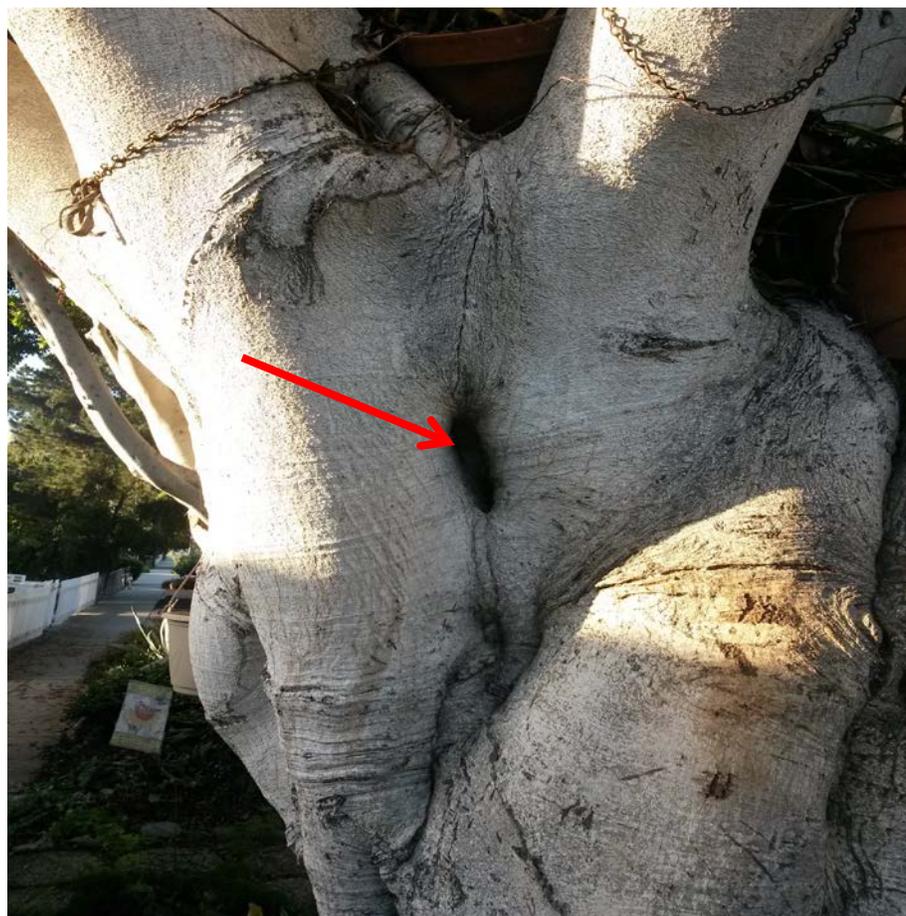
- There were a number of smaller cavities on the trunk but the decay appeared to be **compartmentalized** (see Photo #3 in Appendix A).
- Some of the stems growing from the trees trunk had included bark showing signs of a more weakly attached growth (see Photo #4 in Appendix A).

In the picture above you can see an example of one of the cavities around the trunk of the tree (red arrow).

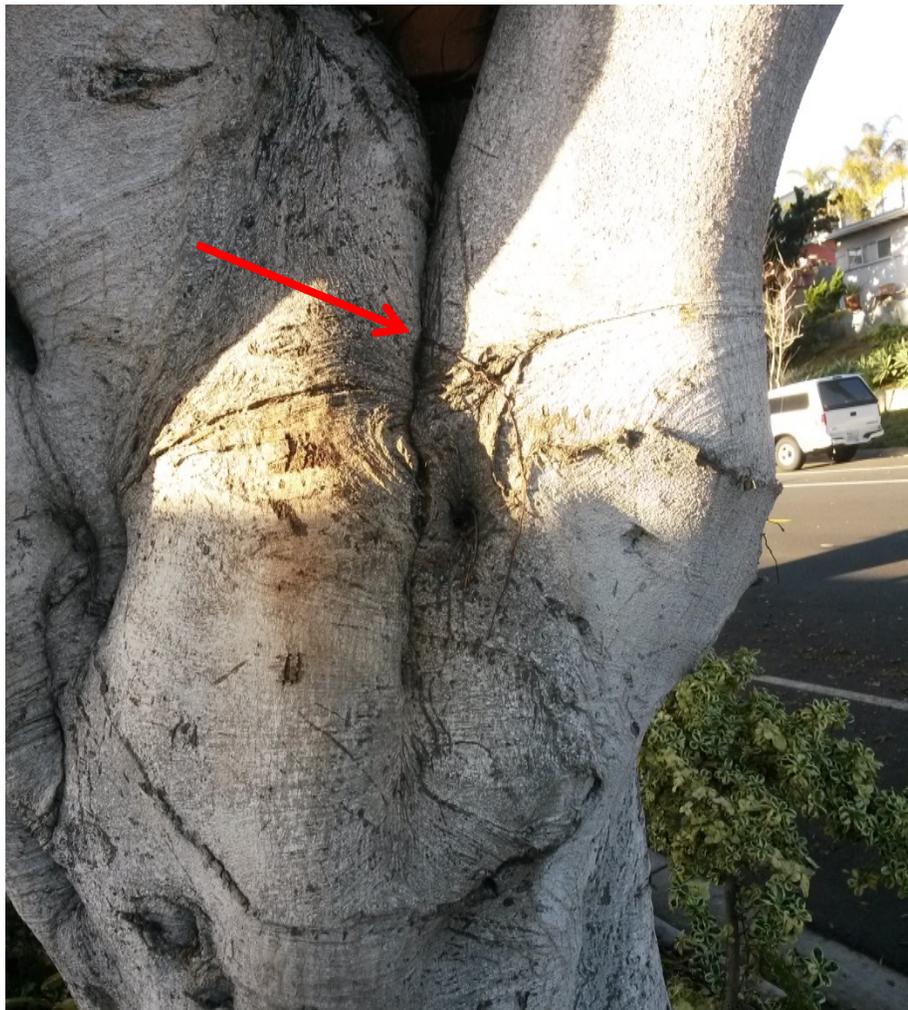
Photo #4

In the picture above you can see one of the largest areas of included bark (**red arrow**) signifying a more weakly attached growth.

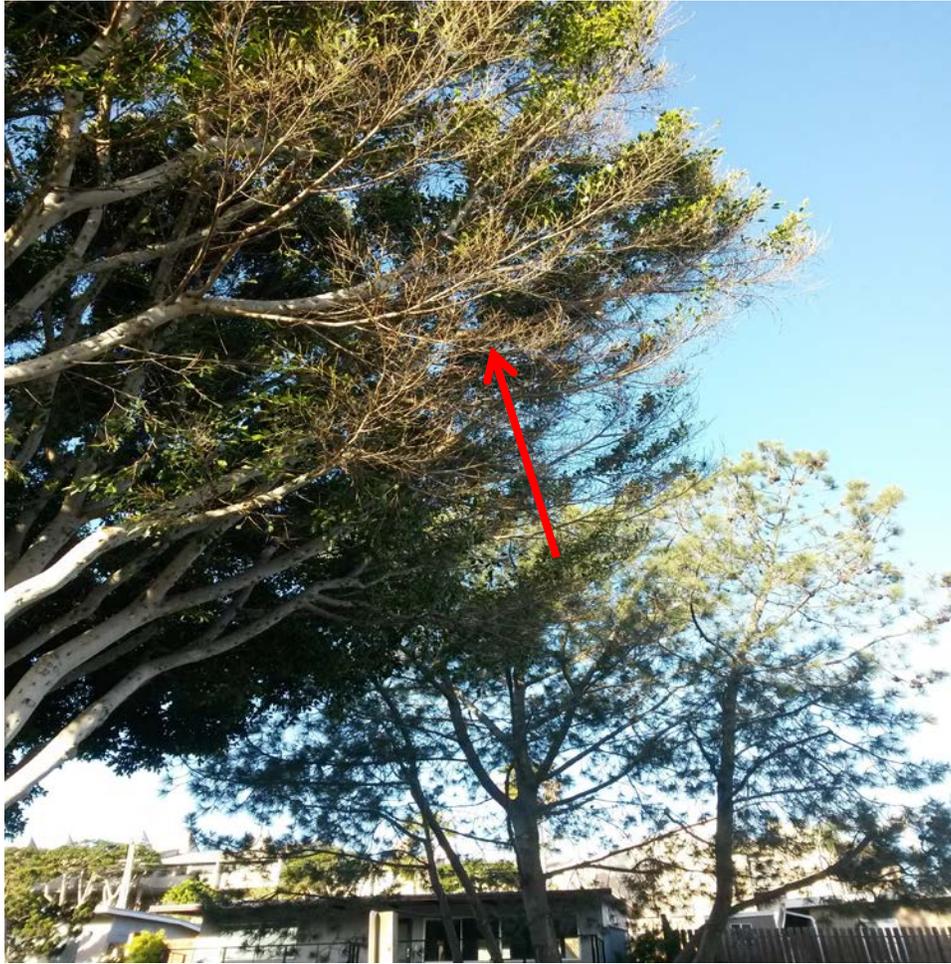
- There were signs of die back on the tips of the limbs on the North side of the tree. (see Photo #5 in Appendix A).
- The roots of the tree appeared to be pruned back from the street but did not show signs serious decay (see Photo#6 in appendix A).

Shown above you can see some of the die back on the north side of the tree possibly a result of the girdled stems (red arrow).

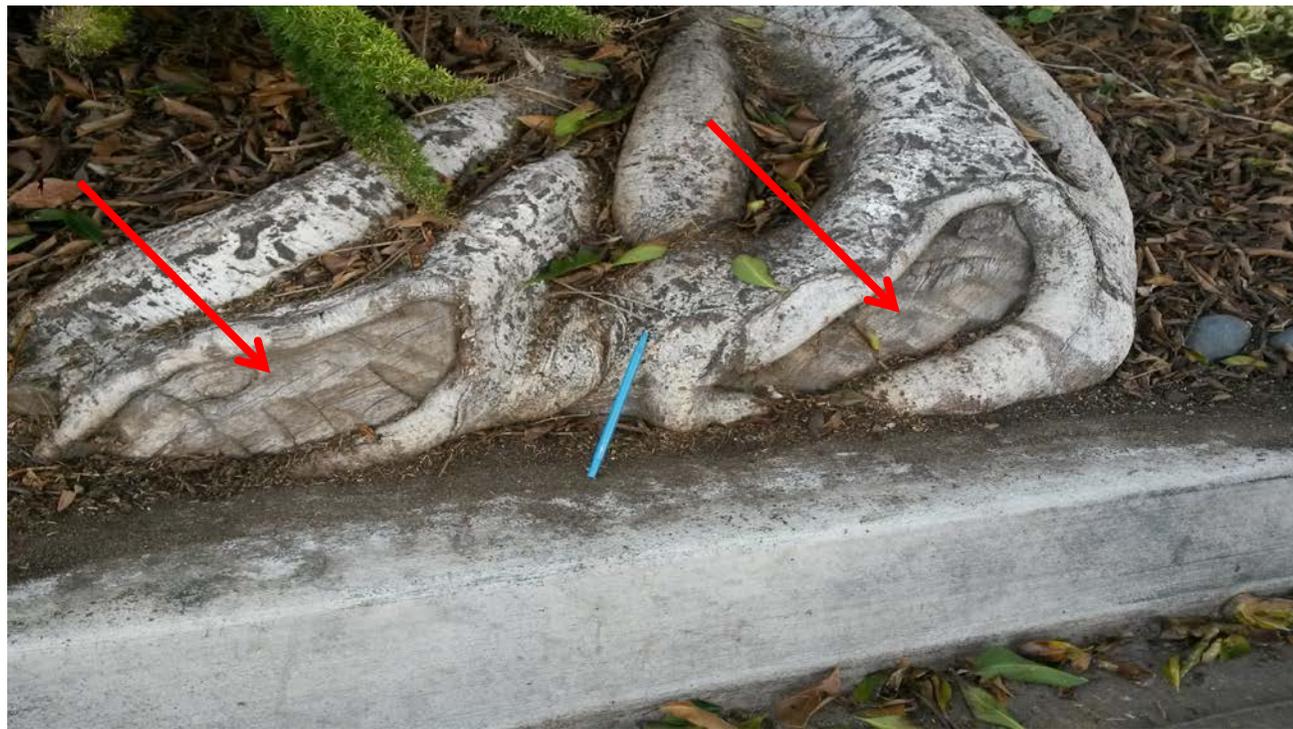
Photo #6

Shown above you can see where the roots have been pruned back and compartmentalized (**red arrow**), which is a sign of vigor and good responsive growth.

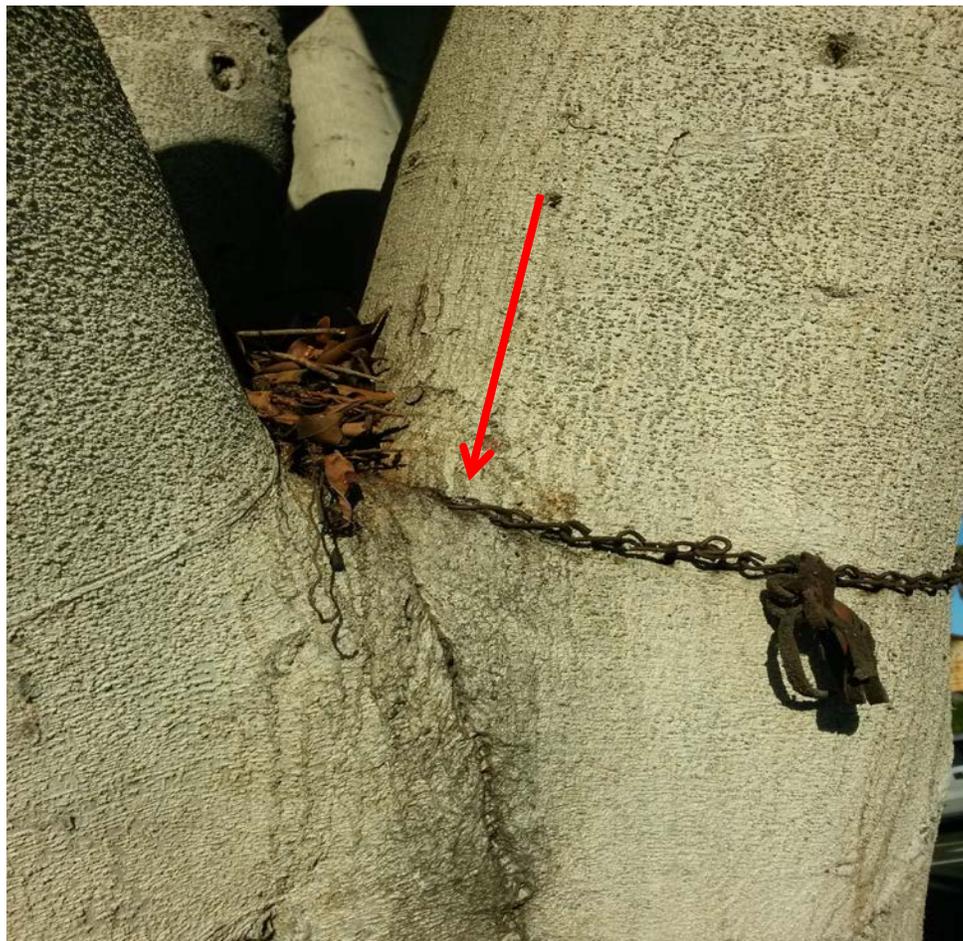
- The tree had numerous Chains wrapping around the limbs. One chain in particular that was girdling a stem and had tree growth around it (see Photo #7 in Appendix A).

The *likelihood of failure* for this tree is *possible* since many of the stems grow in a horizontal nature which constitutes a large bending moment one in particular that is being girdled by a chain.

Shown above you can see one of the chains girdling a stems of the tree (**red arrow**).

Both subject trees are in fair to good health and are currently presenting a moderate risk. I would recommend removing as much of the chains and cords around the limbs as possible. I would also recommend doing a gradual crown reduction over a 5 year period at a rate of no more than 5-6 feet per year to maintain a squattier height and reduce the some stress from the overextended and horizontal growth. Doing this with the structure and canopy balance of the tree in mind should bring down the risk of failure from moderate to low and would be my suggested course of action.

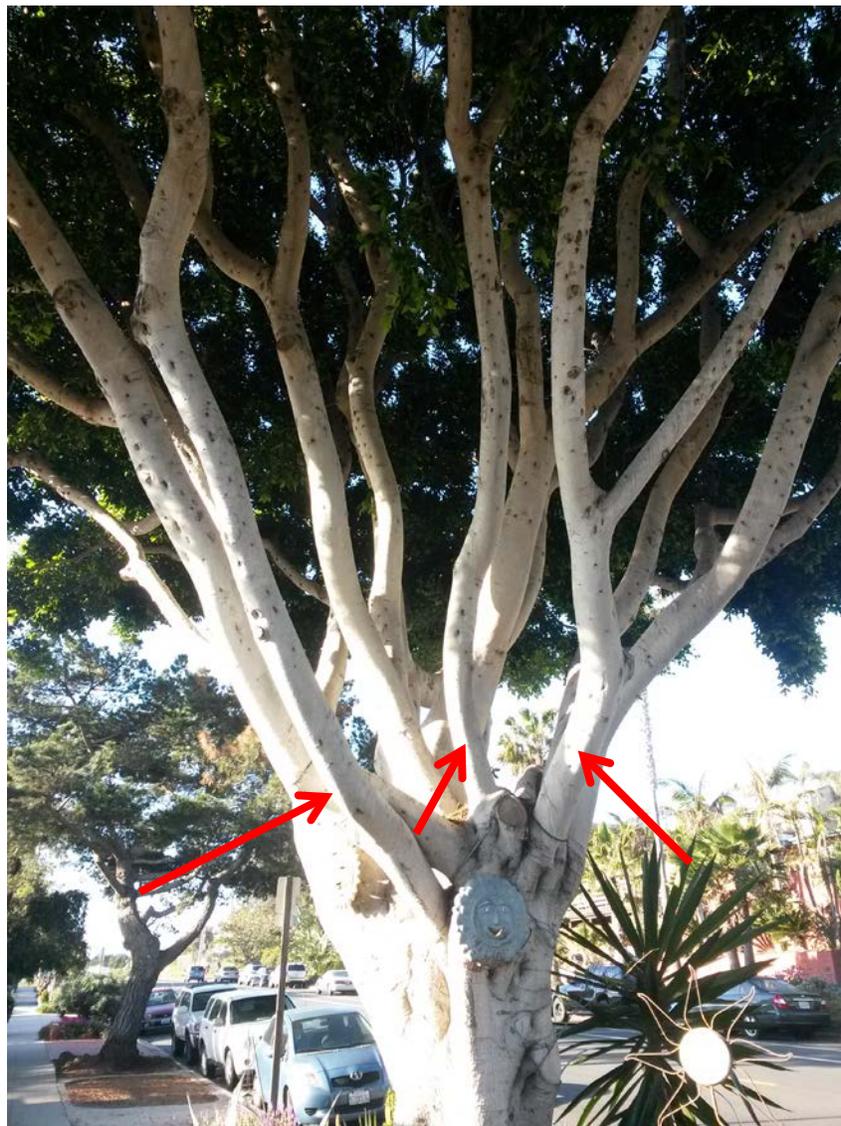
Photo # 8

Shown above you can see the poor structure of the tree with the multiple stems coming from the main trunk (red arrows).

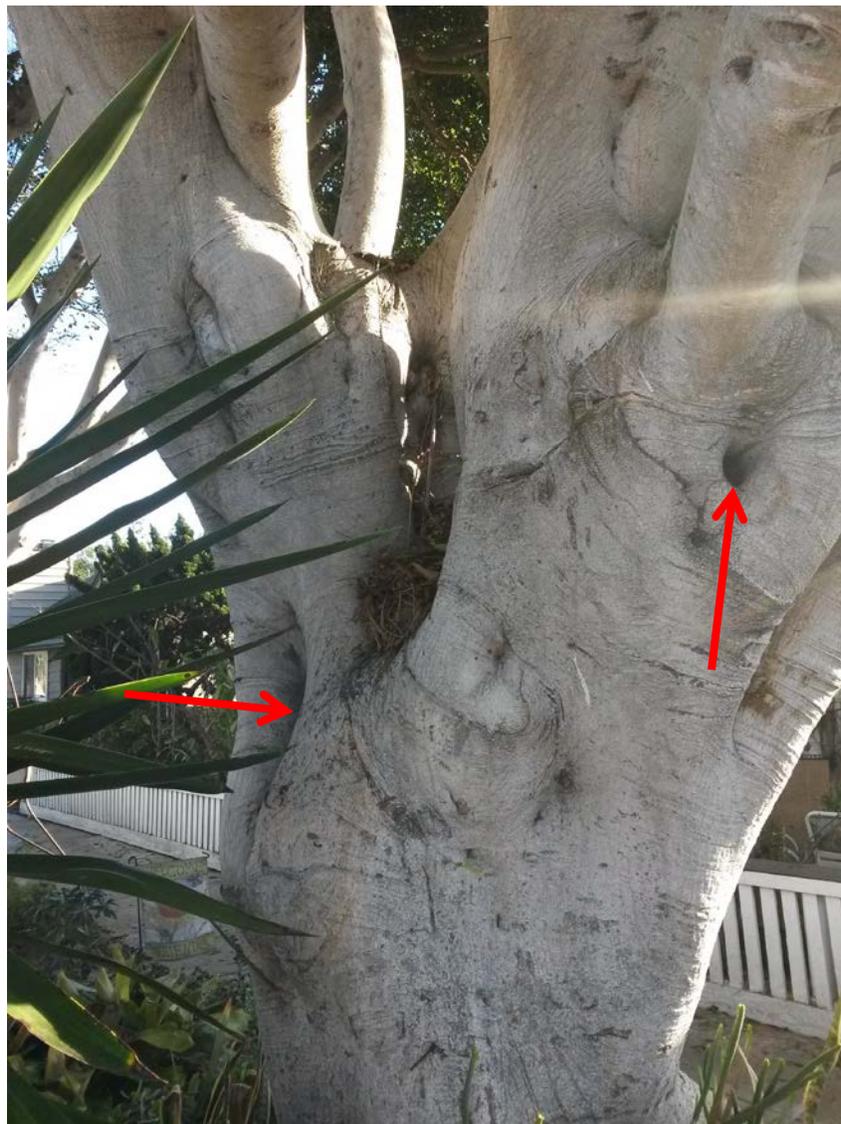
Photo #9

Shown above are examples of some of the cavities around the trunk of the tree (**red arrows**) which appeared to be well compartmentalized.

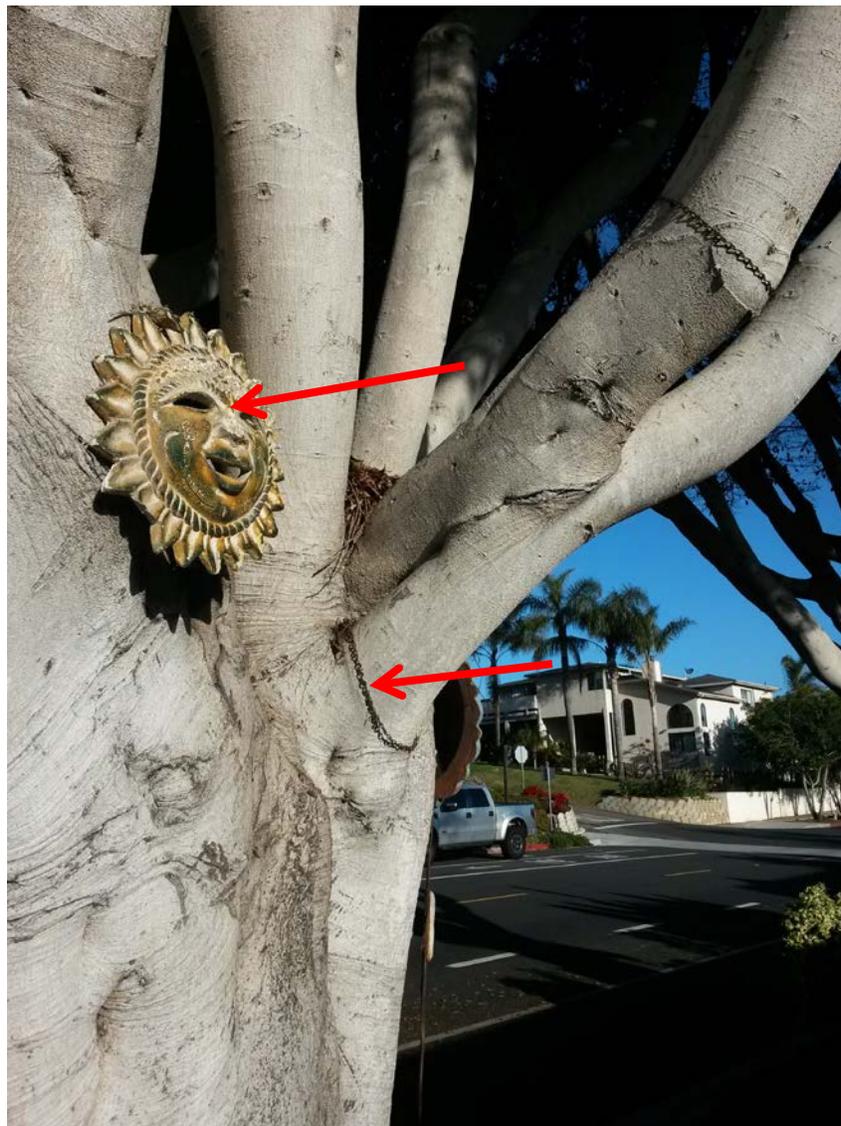
- The tree was in fair health based on the color and density of the foliage for the given species at this time of year (see Photo #1 in Appendix A).
- The tree had a DSH of 37 inches and an approximate height of 50 feet.
- The tree had multiple stems coming out of the main trunk indicating attributes of poor structure but not uncommon to this species (see Photo #8 in Appendix A).
- There were a number of smaller cavities on the trunk but the decay appeared to be **compartmentalized** (see Photo #9 in Appendix A).
- The roots of the tree appeared to be pruned back from the street but had responded with vigor compartmentalizing the wounds to mitigate decay. I also did not see any visual indications of up uprooting in the surrounding
- The tree had numerous Chains wrapping around the limbs from hanging pots and adornments (see Photo #10 in Appendix A).

Shown in the photo above is one of the multiple chains and adornments on the tree (red arrows) that could potentially girdle and cause structural and health issues in the future.
