**Section Three - Systems Description**

**Building Name:** *Fire Station 1*

**Building Name:** *Fire Station 4*

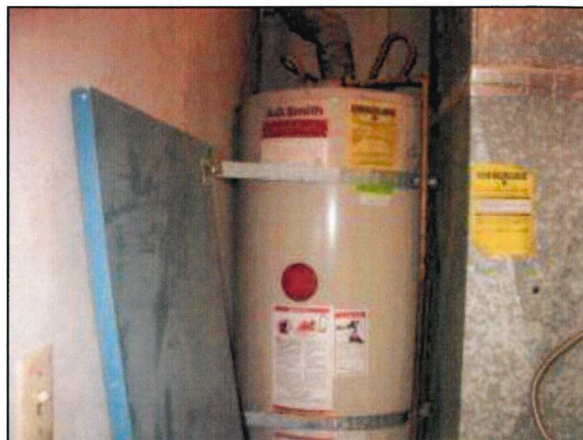
*Photo 14 – Fire Station #1* The gas-fired water heater is located in the closet in the rest room.

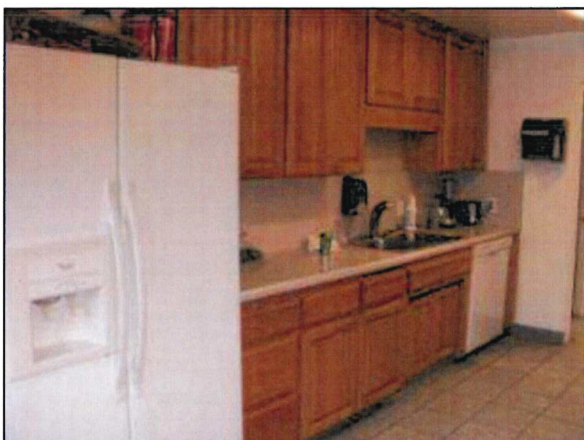
*Photo 23 – Fire Station #1* The kitchen has a domestic refrigerator, double sink, and garbage disposal.

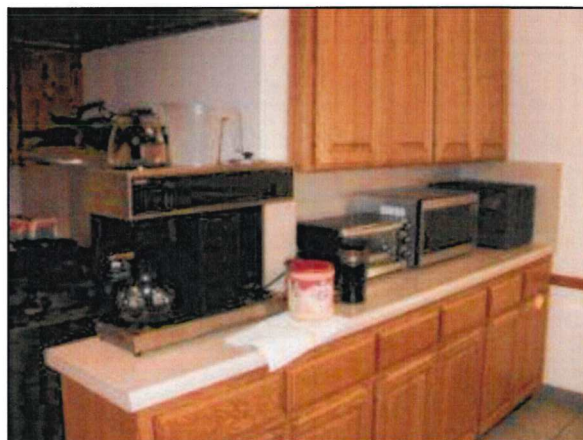
*Photo 24 – Fire Station #1* The kitchen has a commercial-style coffee maker. The remainder of the appliances are domestic in type.

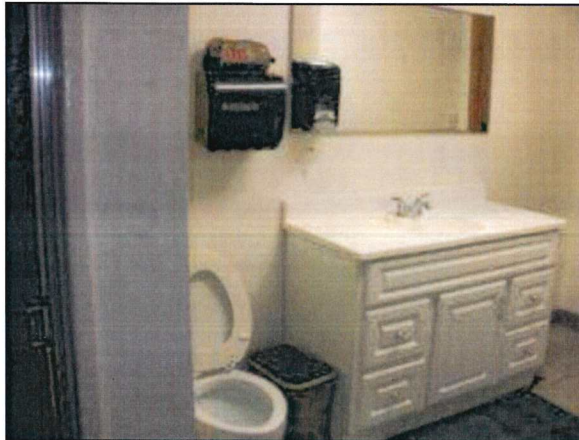
**Photo 25 – Fire Station #1** A general view of the captain’s restroom and general conditions.

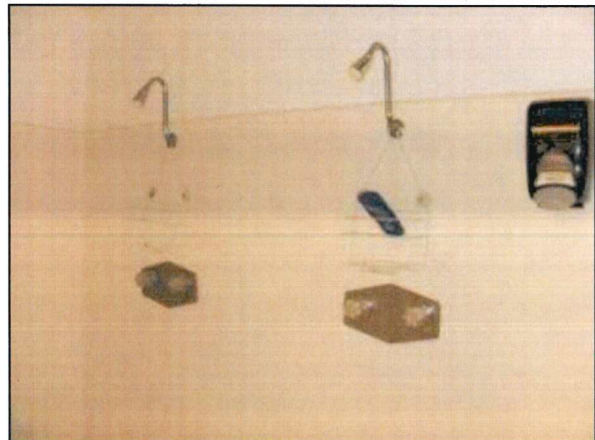
**Photo 26 – Fire Station #1** A general view of the shower station in the locker room and general conditions.

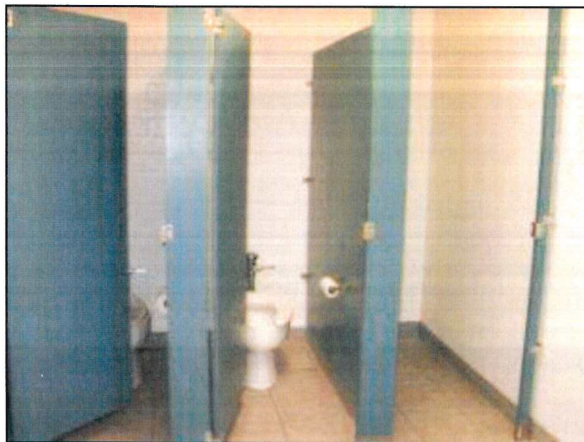
**Photo 27 – Fire Station #1** A general view of the commodes in the locker room and general conditions.

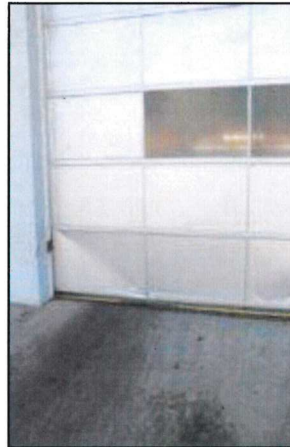
**Photo 30 – Fire Station #1** Garage doors display evidence of impact damage.

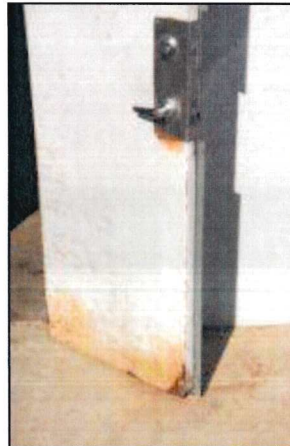
**Photo 34 – Fire Station #1** The exterior door to the hose tower is significantly rusted.

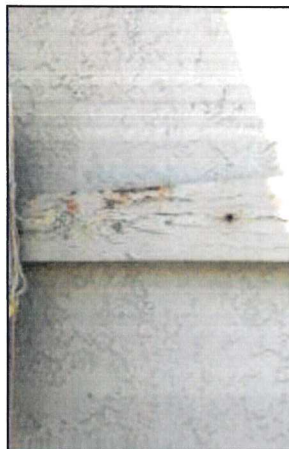
**Photo 35 – Fire Station #1** Exterior wood trim exhibits cavitations, heavy rot and peeling of paint, and possible termite damage.

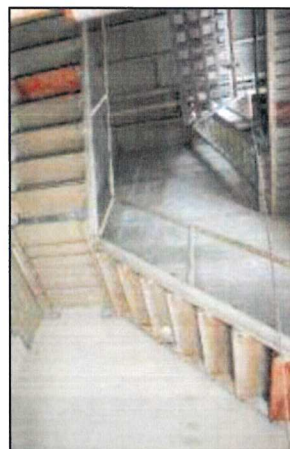
**Photo 36 – Fire Station #1** Stairs in the hose tower have deteriorated and have been patched over time. Other sections require repairs.

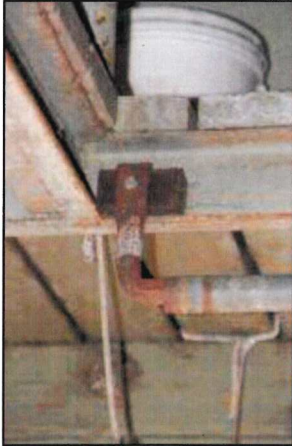
*Photo 37 – Fire Station #1* Steel structural members of the stairways show significant rust.

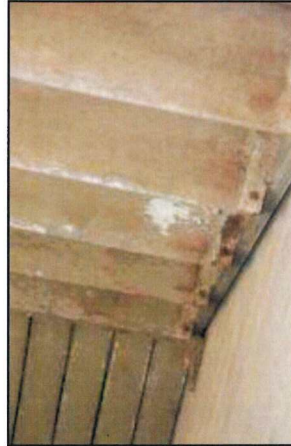
*Photo 38 – Fire Station #1* Paint at the stairway shows severe peeling and flaking. Stair brackets are corroded.

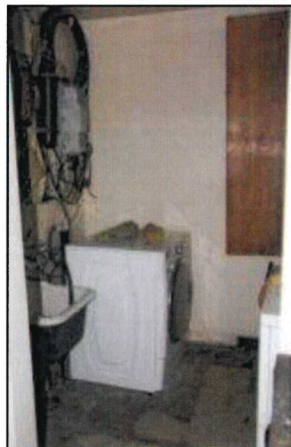
*Photo 40 – Fire Station #1* The laundry room floor is completely deteriorated with missing sections and staining. The washer and dryer are not fitted with seismic straps.

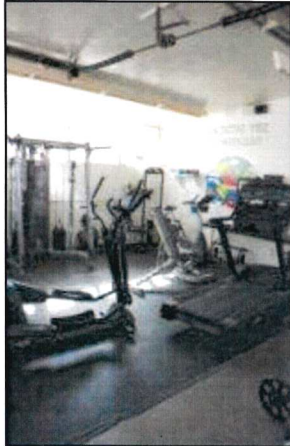
**Photo 41 – Fire Station #1** A general view of the gym area.

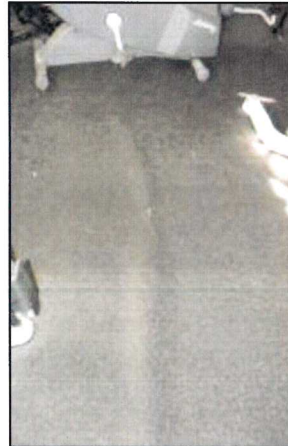
**Photo 42 – Fire Station #1** The rolled rubber gym floor is not properly adhered to the base and lacks trim guards to prevent lifting and air pockets.

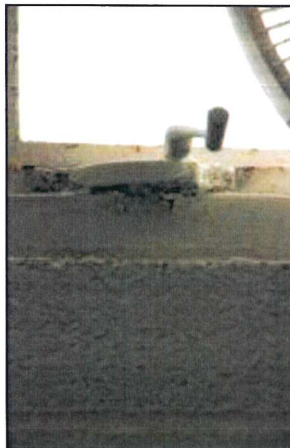
**Photo 43 – Fire Station #1** Significant deterioration of window crank handles and frames is present.

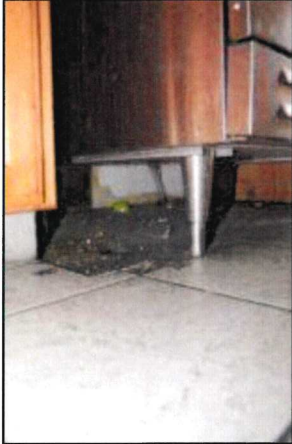
**Photo 45 – Fire Station #1** Flooring around the kitchen range is missing and debris has accumulated.

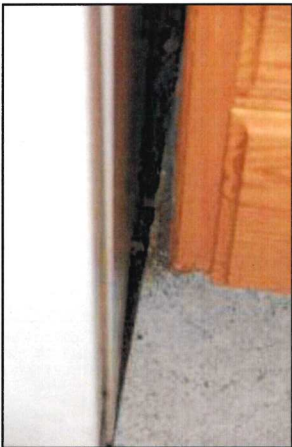
**Photo 47 – Fire Station #1** Heavy debris has accumulated beside the refrigerator. The debris may attract pests.

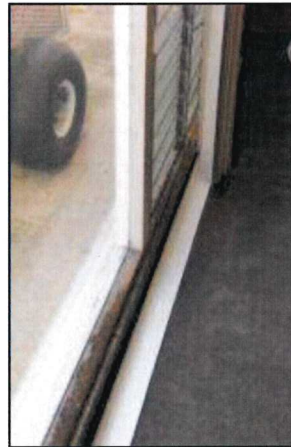
**Photo 48 – Fire Station #1** Floor to ceiling windows exhibit deterioration of frames and water damage.

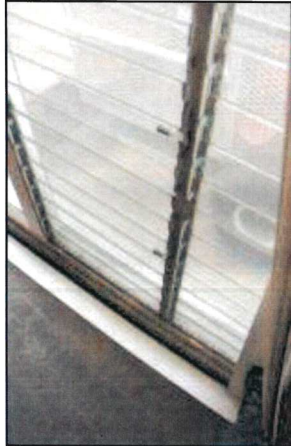
**Photo 49 – Fire Station #1** Windows show deteriorated frames. The outdated louver windows allow air and moisture intrusion.

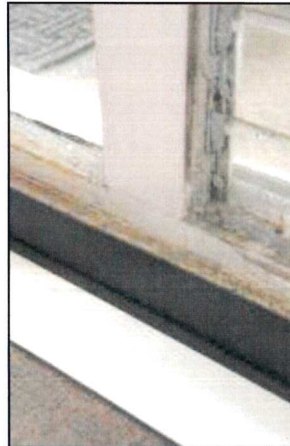
**Photo 50 – Fire Station #1** Windows show deteriorated frames. The outdated louver windows allow air and moisture intrusion.

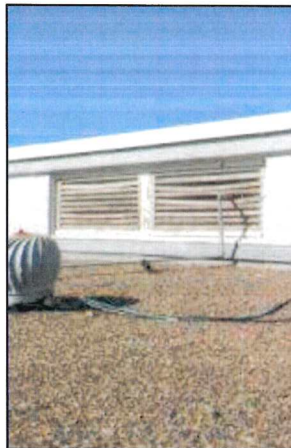
**Photo 51 – Fire Station #1** Rooftop vent wood is buckled and rotted. The loose wiring should be run through conduit.

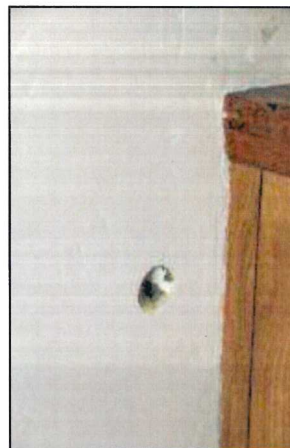
**Photo 52 – Fire Station #1** Damage to the walls is present due to lack of door stoppers.

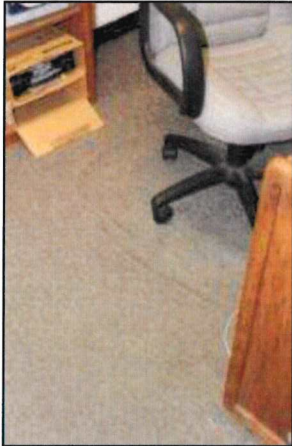
*Photo 53 – Fire Station #1* Carpet generally lacks proper adhesion.

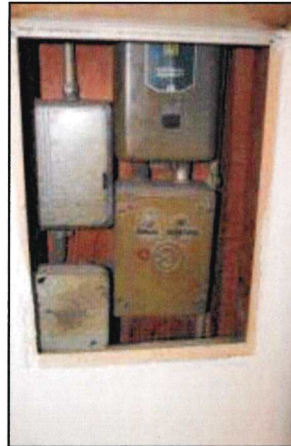
*Photo 54 – Fire Station #1* A view of an electrical box within a wall.

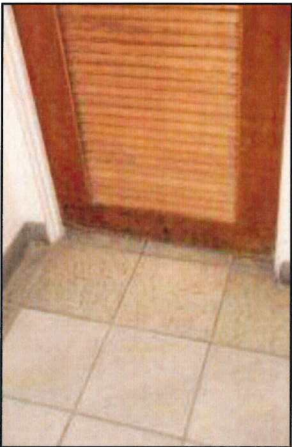
*Photo 55 – Fire Station #1* The wood vented door to the restroom is stained and deteriorated. The floor is mismatched as a result of previous repairs of underground plumbing.

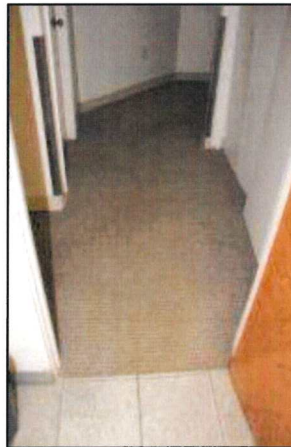
*Photo 56 – Fire Station #1* Carpet in the living area hallway is worn and stained.

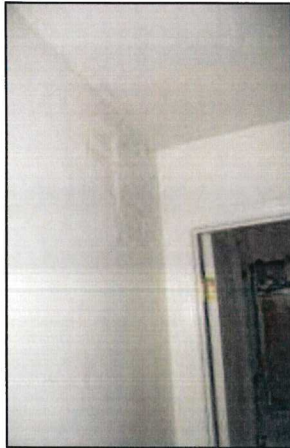
*Photo 57 – Fire Station #1* Sections of wall patched with tape are present in the facility.

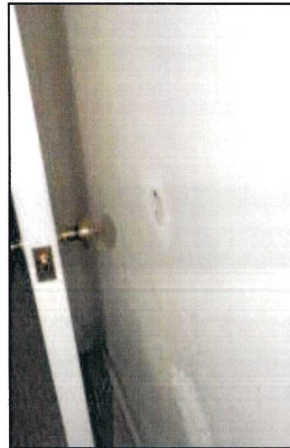
*Photo 58 – Fire Station #1* The wall is damaged as a result of impacts from door handles.

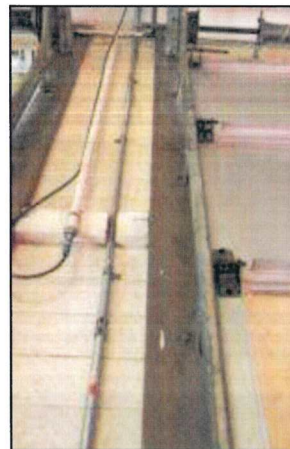
*Photo 60 – Fire Station #1* Overhead door frames are deteriorated and have split as a result of age.

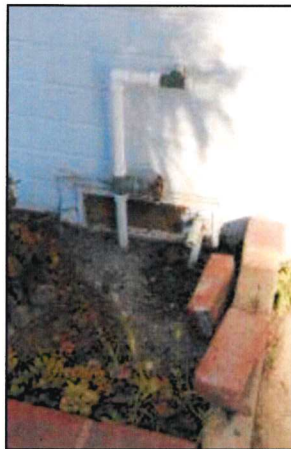
**Photo 62 – Fire Station #1** Planters show some deterioration and loose bricks.

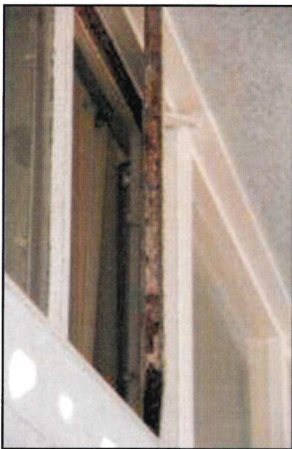
**Photo 63 – Fire Station #1** Windows are significantly deteriorated with corrosion and peeling paint.

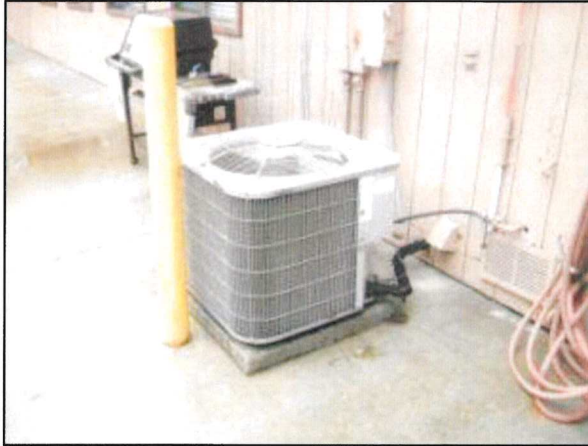
**Photo 1 – Fire Station #4** The 3.5-ton condensing section is located at the rear of the facility and is paired with the furnace located in the bedroom closet.

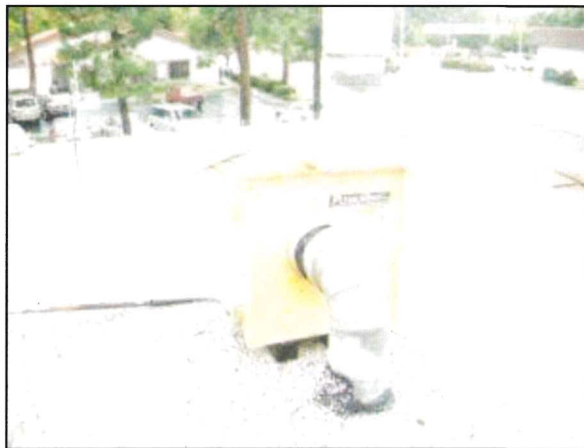
**Photo 4 – Fire Station #4** The garage is ventilated by means of a vehicle exhaust system that is mounted on the roof. The system is similar to that present in Fire Station #5.

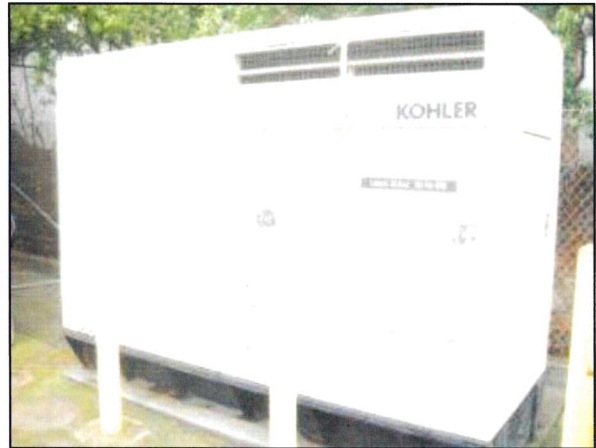
**Photo 6 – Fire Station #4** The Kohler generator is located at the rear of the facility's site.

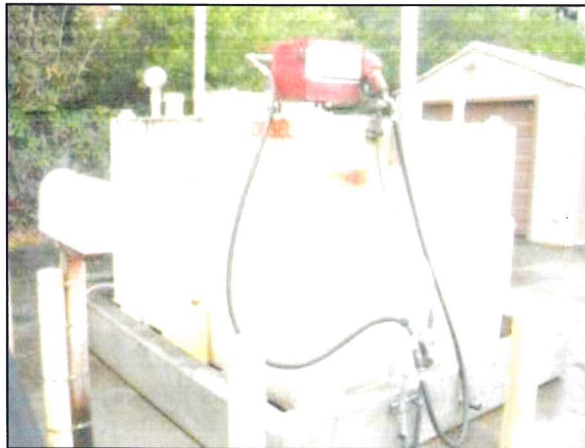
**Photo 7 – Fire Station #4** A 1000-gallon fuel farm and dispensing system is present at the rear of the Station's site. The tank is above-ground and curbed.

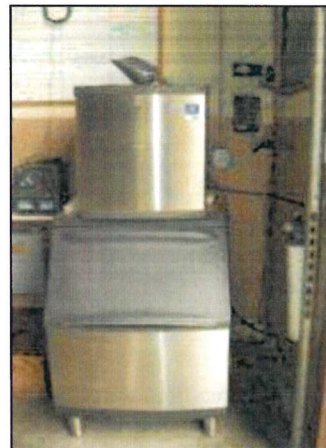
**Photo 8 – Fire Station #4** An icemaker is present in the garage. The unit required cleaning at the time of the inspection.

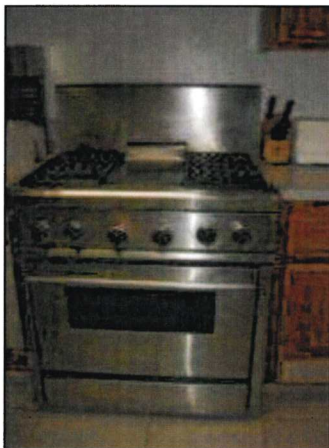
*Photo 9 – Fire Station #4* A commercial kitchen range is located in the kitchen area. The unit was in good condition at the time of the inspection.

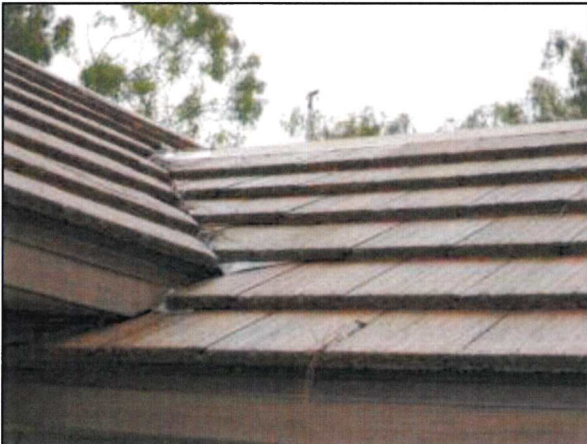
**Photo 27 – Fire Station #4** “A general view of the new clay composition tile roof valley.

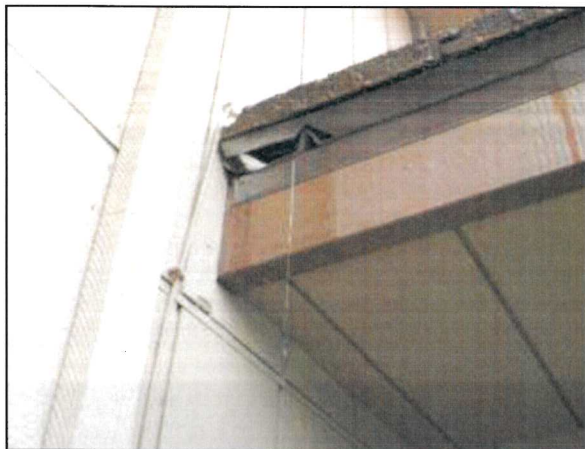
*Photo 31 – Fire Station #4* The section of roof near the front entry exhibits poor flashing.

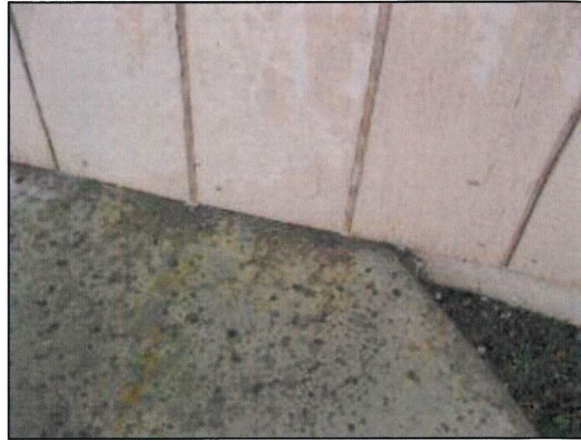
*Photo 34 – Fire Station #4* The concrete sidewalk slab abuts the building sheathing.

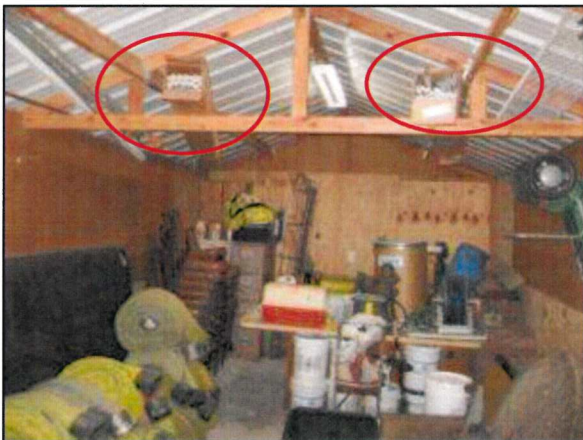
**Photo 51 – Fire Station #4** No electrical sub panels are present in the storage shed. The electrical feed is from the main building. Note the fluorescent tube storage in the rafters.

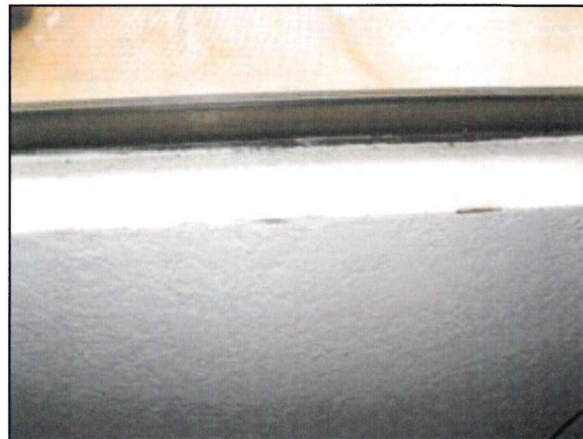
**Photo 60 – Fire Station #4** The windows in the bedrooms are fitted with drywall window sills. The drywall is drag stucco and paint.

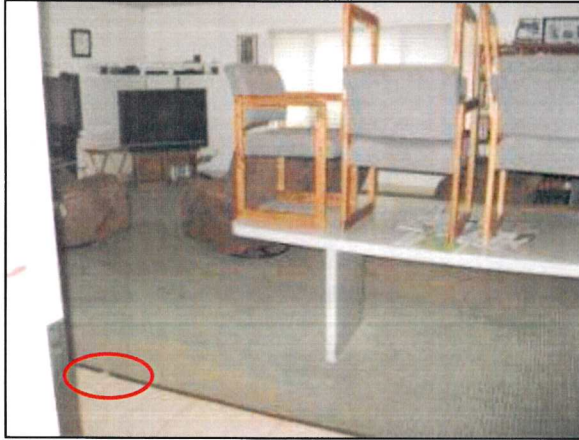
**Photo 61 – Fire Station #4** A general view of the lounge area with a damaged carpet transition strip.

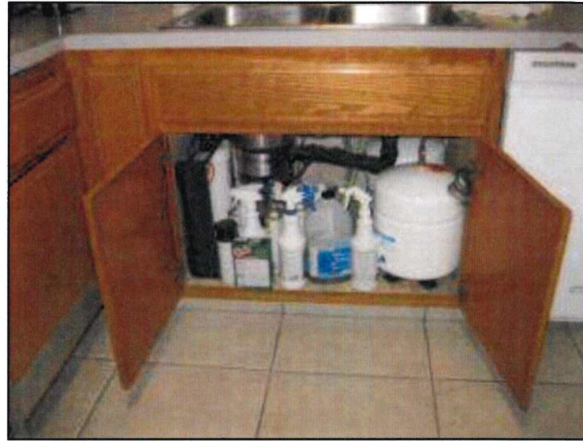
*Photo 66 – Fire Station #4* The kitchen sink is equipped with a garbage disposal and reverse osmosis water filtration system.

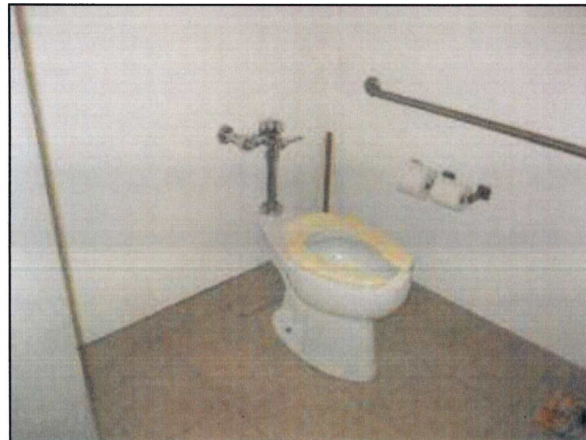
*Photo 70 – Fire Station #4* A general view of the main restroom and commode.

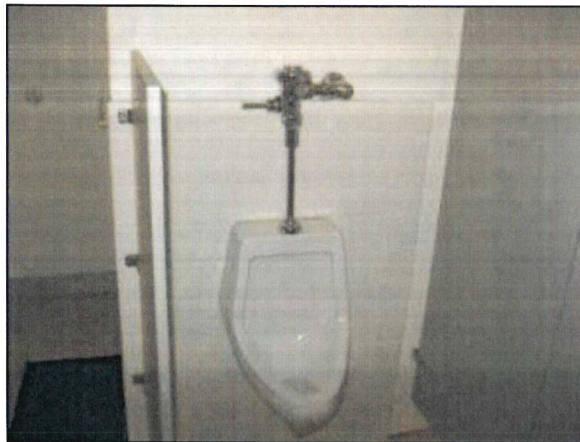
*Photo 71– Fire Station #4* The urinal in the main restroom.

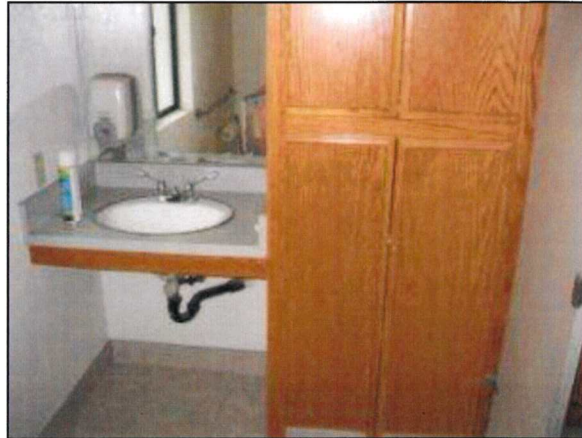
**Photo 74 – Fire Station #4** The sink and wood storage cabinet in the main restroom.
