City of Encinitas

3.29.17 Assessment of Ficus Tree At 682 Second Street (Front-1)

MARCH 29, 2017

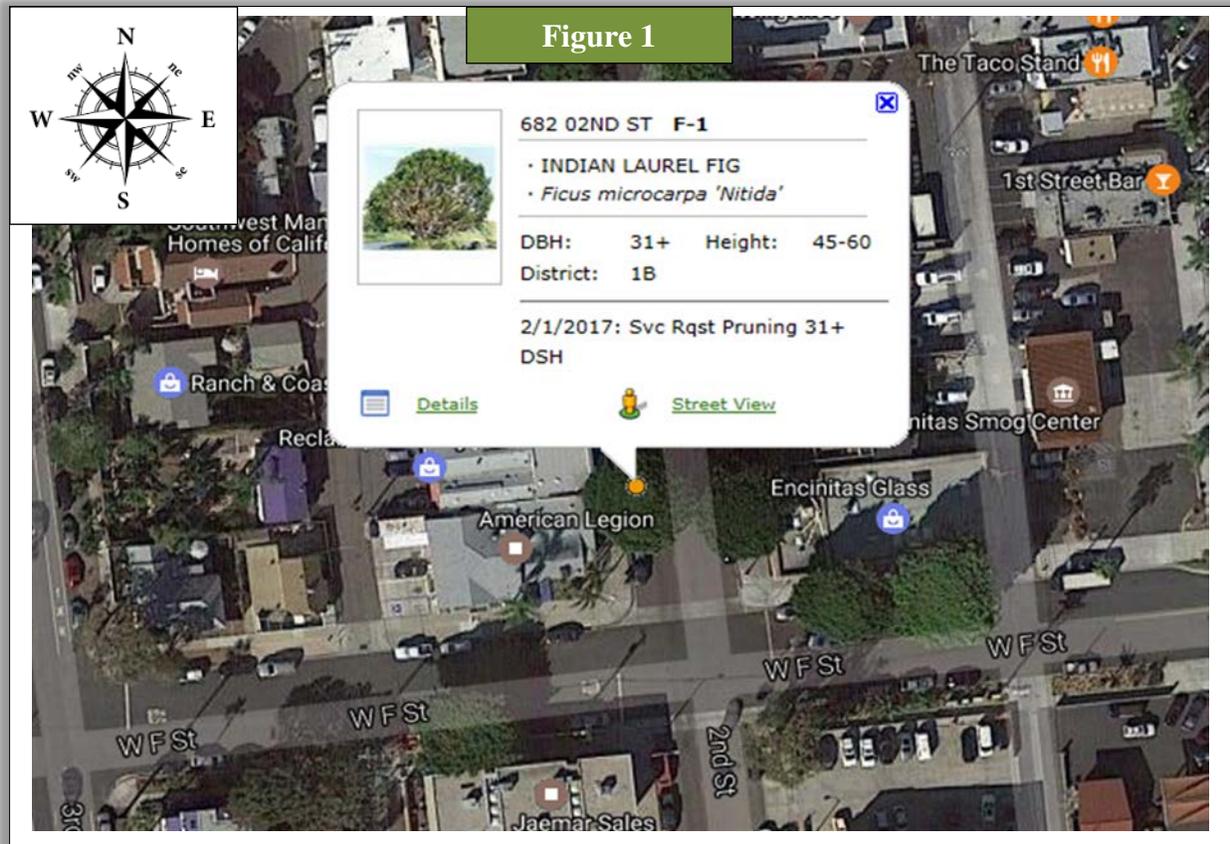
In March of 2017, West Coast Arborists, Inc., (WCA) was contacted by John Ugrob (City of Encinitas) in regard to the assessment of an Indian Laurel Fig tree (*Ficus microcarpa 'nitida'*) located near 682 2nd St. In ArborAccess (WCA's tree inventory database), the tree is inventoried as 682 02ND ST F-1 and had a Facility I.D. # of 5102ETREE (see Figure 1 below).

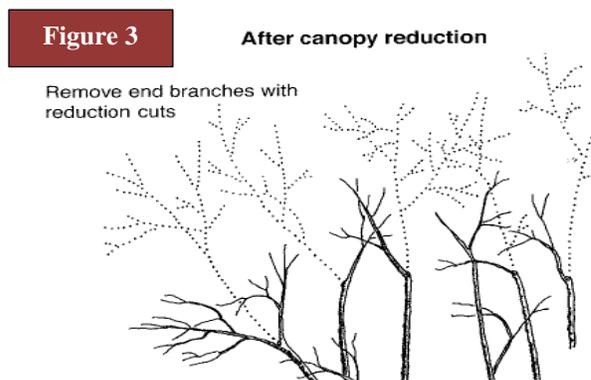
- Shown above is an example of reduction pruning techniques to achieve a canopy reduction. The diagram is from the International Society of Arboriculture “*Best Management Practices for Tree Pruning*” 2008 publication.
- If there are not suitable laterals meeting the 1/3rd size correlation, pruning other reduction cuts may only be considered under the direction of an ISA Certified Arborist. Some of these reduction pruning cuts will be done to a shoot, branch, or stem that extends nearly as far as the removed parent branch; if this is the case then additional subordination pruning cuts back to a bud or young growth may be acceptable in order to maintain a point of **apical dominance** and to achieve the reduction goal.

1. Remove the tree and replace it with a healthy site adequate species.
2. Reducing the overall canopy height by approximately 30% with the structure and canopy balance of the tree in mind (see Figure 3 and Appendix B for more details). This recommended pruning should be done in compliance to ANSI A300 Arboricultural Standards and will need to be applied over multiple spaced out pruning doses to minimize health impacts on the tree. Pruning techniques such as **reduction pruning**, and **removal pruning cuts** should be used (not **topping**) to achieve this overall squattier appearance and are further explained in Appendix B. The end outcome should be a reduction of **mechanical stress** from overextended loads. It will likely take multiple spaced out pruning doses (taking up to 5 years) to achieve a residual risk of “Low” without topping or creating large injurious removal pruning cuts. This is also recommended to allow time for interior growth to further develop and broaden the options for new branches to prune back to. A routine monitoring plan to look for signs of heaving should be implemented as part of this preservation plan.
