City of Encinitas

4.10.17 Assessment of Ficus Tree At 687 2nd Street (Side-2)

APRIL 10, 2017

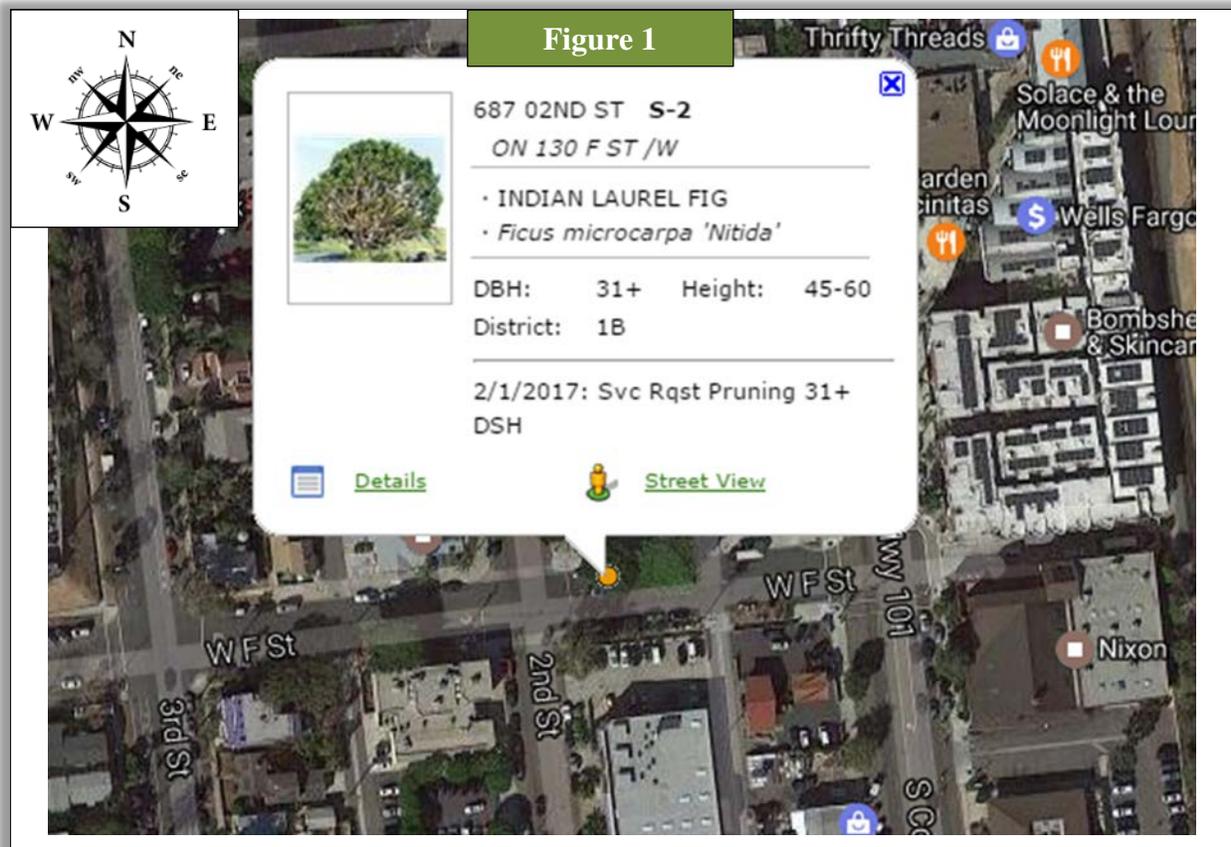
In March of 2017, West Coast Arborists, Inc., (WCA) was contacted by John Ugrob (City of Encinitas) in regard to the assessment of an Indian Laurel Fig tree (*Ficus microcarpa 'nitida'*) located near 687 2nd St. In ArborAccess (WCA's tree inventory database), the tree is inventoried as 687 2nd St. S-2 and had a Facility I.D. # of 5696ETREE (see Figure 1 below).

- The tree was growing in a tree well on the north side of F St (see Figure 1 and Photo #1 in Appendix A).
- Judging by the color and density of the foliage, the tree appeared to be in fair health for the species and time of year. The tree had a moderate-low **live crown ratio** of approximately 40% which is common for street trees necessitating raised crowns for vehicle and building clearance (see Photo #1 in Appendix A).
