City of Encinitas

4.4.17 Assessment of Ficus Tree At 965 Second Street (Front-1)

John Ugrob
Utility & Maintenance Supervisor
Street/ NPDES Division
City of Encinitas

APRIL 4, 2017

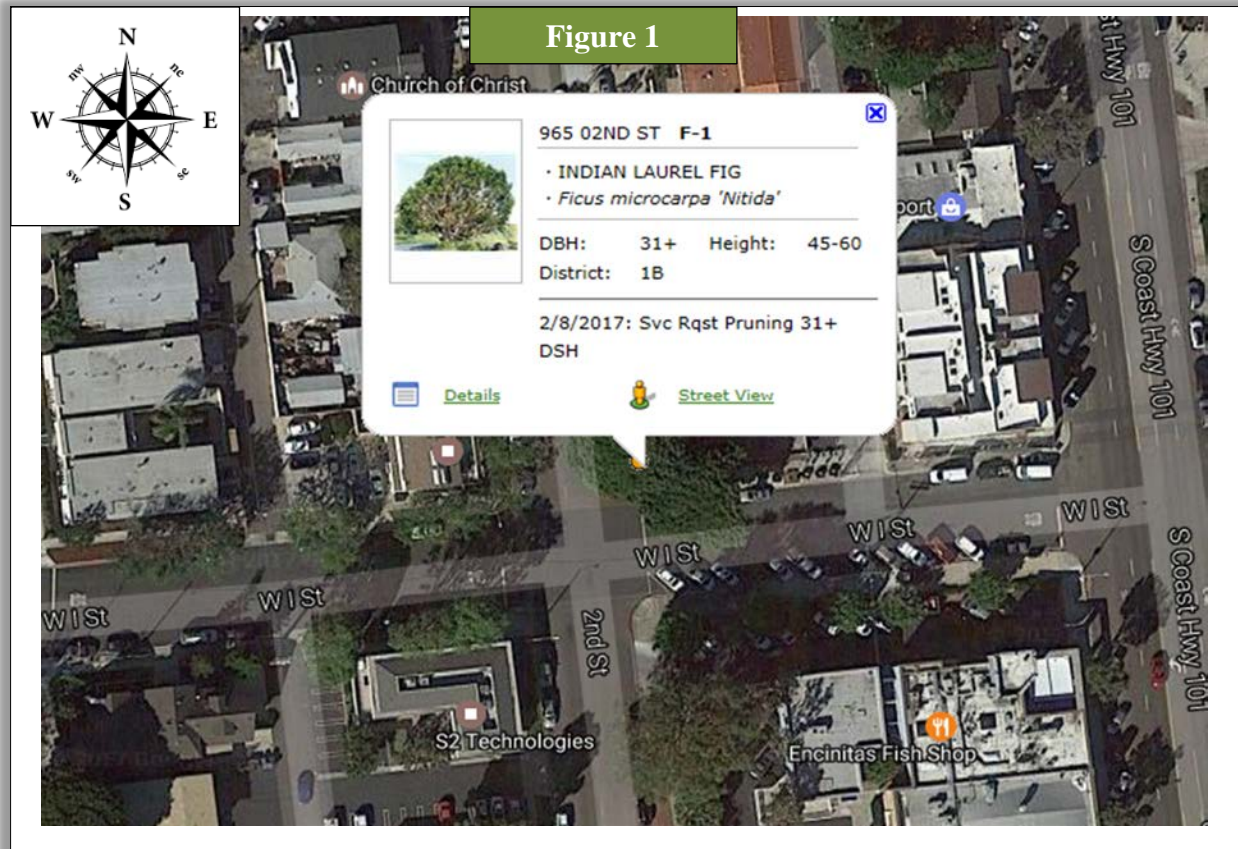
In March of 2017, West Coast Arborists, Inc., (WCA) was contacted by John Ugrob (City of Encinitas) in regard to the assessment of an Indian Laurel Fig tree (*Ficus microcarpa 'nitida'*) located in front of 965 2nd St. In ArborAccess (WCA's tree inventory database), the tree is inventoried as 965 02ND ST F-1 Facility I.D. # 5952ETREE (see Figure 1 below).

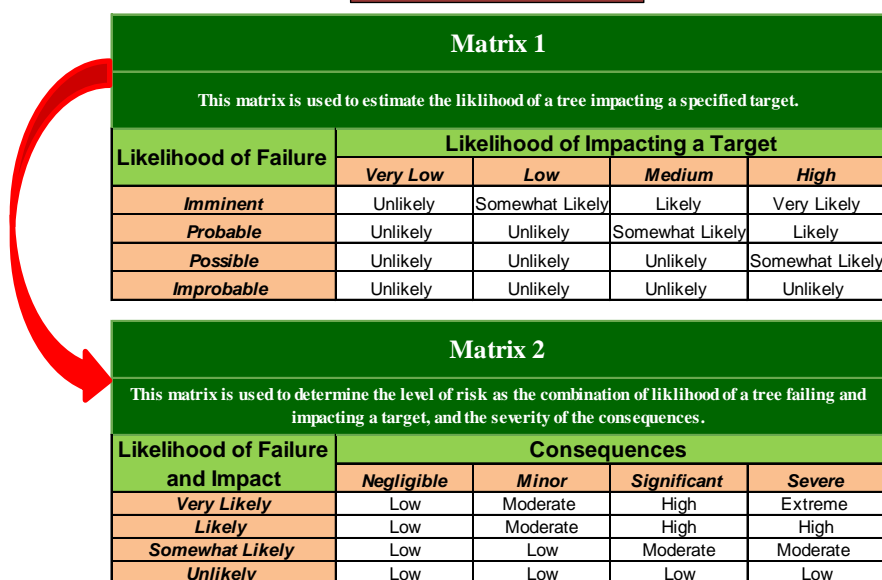
Figure 2

Data collected from the Level 2 Basic Assessment is used to derive a level of risk based on the matrices found in the *ISA Tree Risk Assessment Manual* (see **Figure 2** below). The level of risk determined (low, moderate, high, or extreme) is to be used by risk managers to help in tree management decisions. When assessing risk, the value of targets is taken into consideration in order to categorize the consequences of failure (negligible, minor, significant, or severe). The people who use and frequent the target zone are generally the most important target with buildings, structures, and cars being secondary in importance. Factors such as occupancy rate and protection factors are used to help determine the target that constitutes the highest overall Risk Rating.

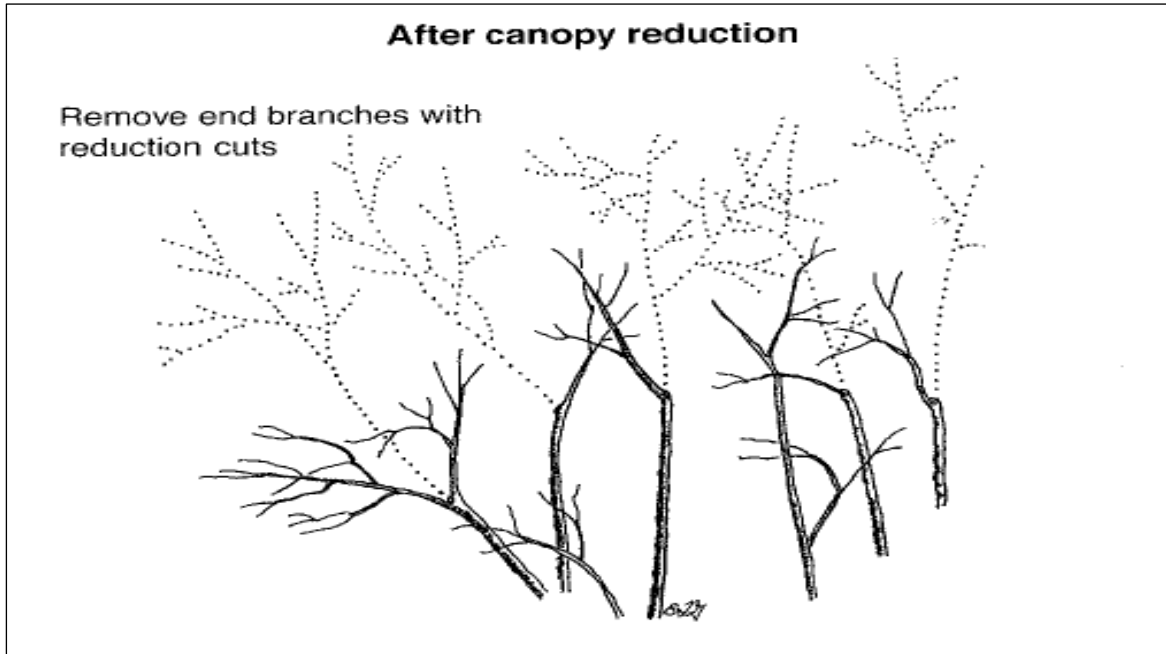
- Shown above is an example of reduction pruning techniques to achieve a canopy reduction. The diagram is from the International Society of Arboriculture “*Best Management Practices for Tree Pruning*” 2008 publication.
- If there are not suitable laterals meeting the 1/3rd size correlation, pruning other reduction cuts may only be considered under the direction of an ISA Certified Arborist. Some of these reduction pruning cuts will be done to a shoot, branch, or stem that extends nearly as far as the removed parent branch; if this is the case then additional subordination pruning cuts back to a bud or young growth may be acceptable in order to maintain a point of **apical dominance** and to achieve the reduction goal.

1. Remove the tree and replace it with a healthy site adequate species.
2. Reducing the overall canopy height by approximately 30% with the structure and canopy balance of the tree in mind. This recommended pruning should be done in compliance to ANSI A300 Arboricultural Standards and will need to be applied over multiple spaced out pruning doses to minimize health impacts on the tree. Pruning techniques such as **reduction pruning**, and **removal pruning cuts** should be used (not **topping**) to achieve this overall squattier appearance. If there are not suitable laterals meeting the 1/3rd size correlation, pruning other reduction cuts may only be considered under the direction of an ISA Certified Arborist. Some of these reduction pruning cuts will be done to a shoot, branch, or stem that extends nearly as far as the removed parent branch; if this is the case then additional subordination pruning cuts back to a bud or young growth may be acceptable in order to maintain a point of **apical dominance** and to achieve the reduction goal (further explained in Appendix B). The end outcome should be a reduction of **mechanical stress** from overextended loads. It will likely take multiple spaced out pruning doses (3-5) to achieve a residual risk of "Low" without topping or creating large injurious removal pruning cuts. A routine monitoring plan to look for signs of heaving should be implemented as part of this preservation plan. If the tree begins to go into decline despite efforts and care for preservation, then removal should be considered.
