# City of Encinitas

## 3.23.16 Assessment of Ficus Trees

MARCH 23, 2016

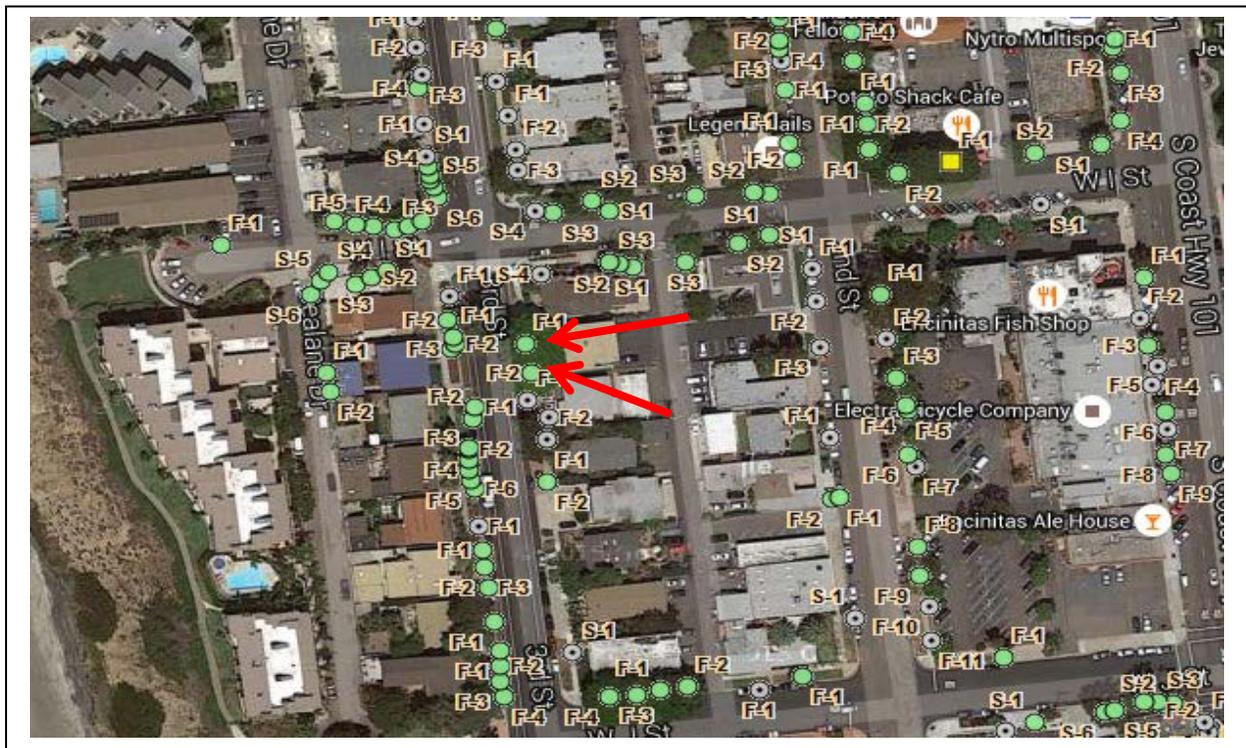
In March of 2016, West Coast Arborists (WCA) was contacted by John Ugrob (City of Encinitas – Parks Department) in regard to the assessment of two Indian Laurel Fig trees (*Ficus microcarpa nitida*) located at 1011 3<sup>rd</sup> St. (see **red arrows** in photo below). In ArborAccess (WCA’s tree inventory database), the two trees are inventoried as “Front 1” and “Front 2.”
