Update to the Revised Report Geotechnical Investigation

Leucadia Mixed-Use 1900-1950 North Coast Highway, Encinitas, California

Subject: Update to the Revised Report
Geotechnical Investigation
Leucadia Mixed-Use
1950 North Coast Highway, Encinitas, California

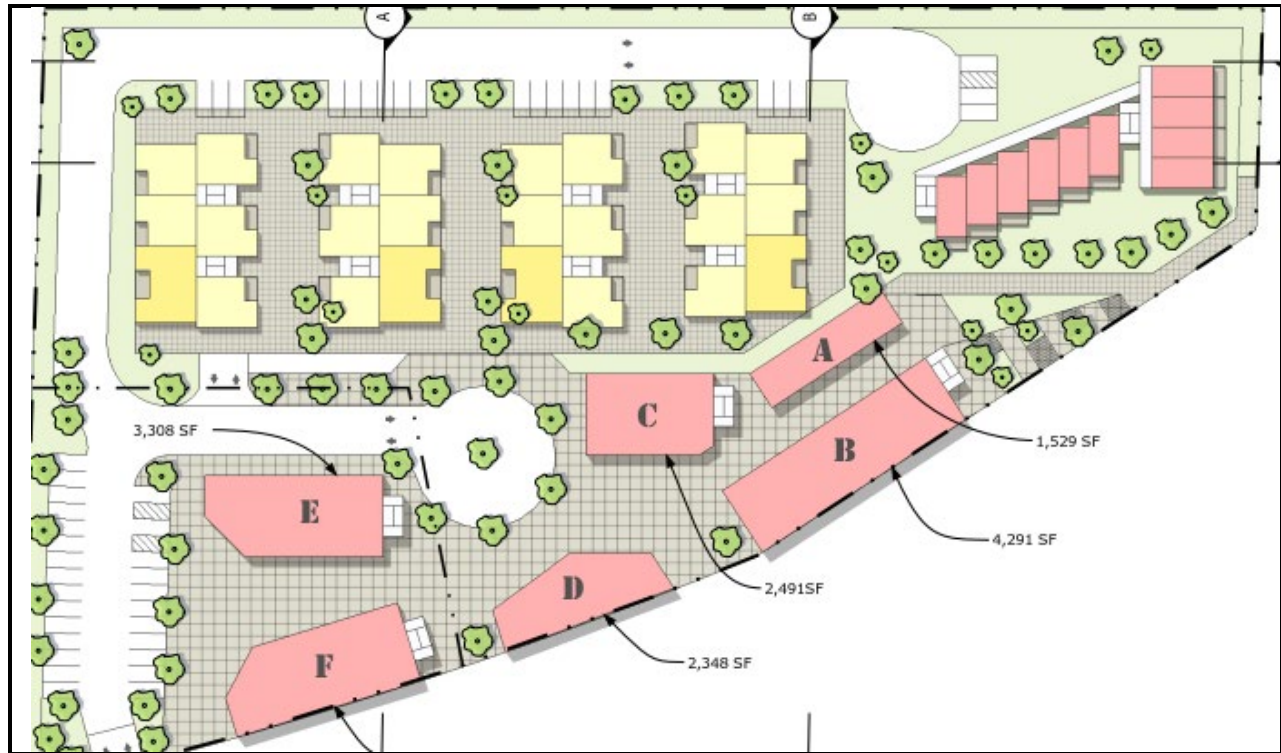
Figure 2-3. Concept Plan 3
(source: SDA 2019)

Figure 2-3 (following page) shows a sketch of the Conceptual Plan 3 (SDA 2019).

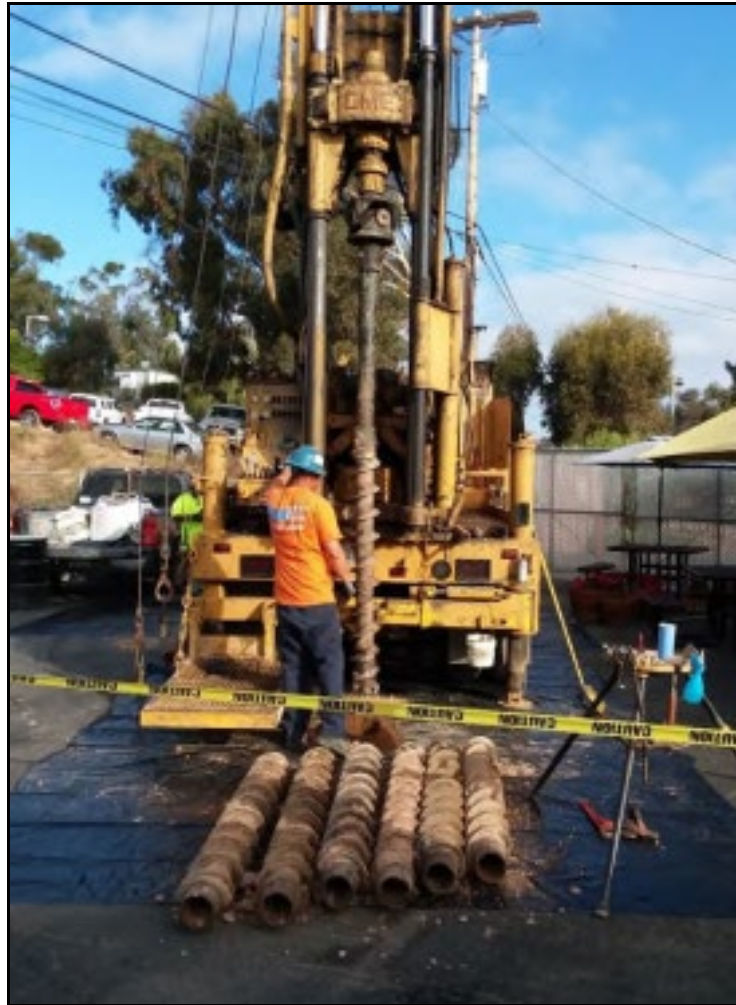
Figure 3-2. Drilling Operations, September 17, 2019

The borings were advanced by a CME 95 truck-mounted drilling rig utilizing hollow-stem auger drilling equipment. Boring locations were determined in the field by the geologist. Figure 3-2 (following page) depicts drilling operations. Table 3-1 abstracts the indications of the borings.

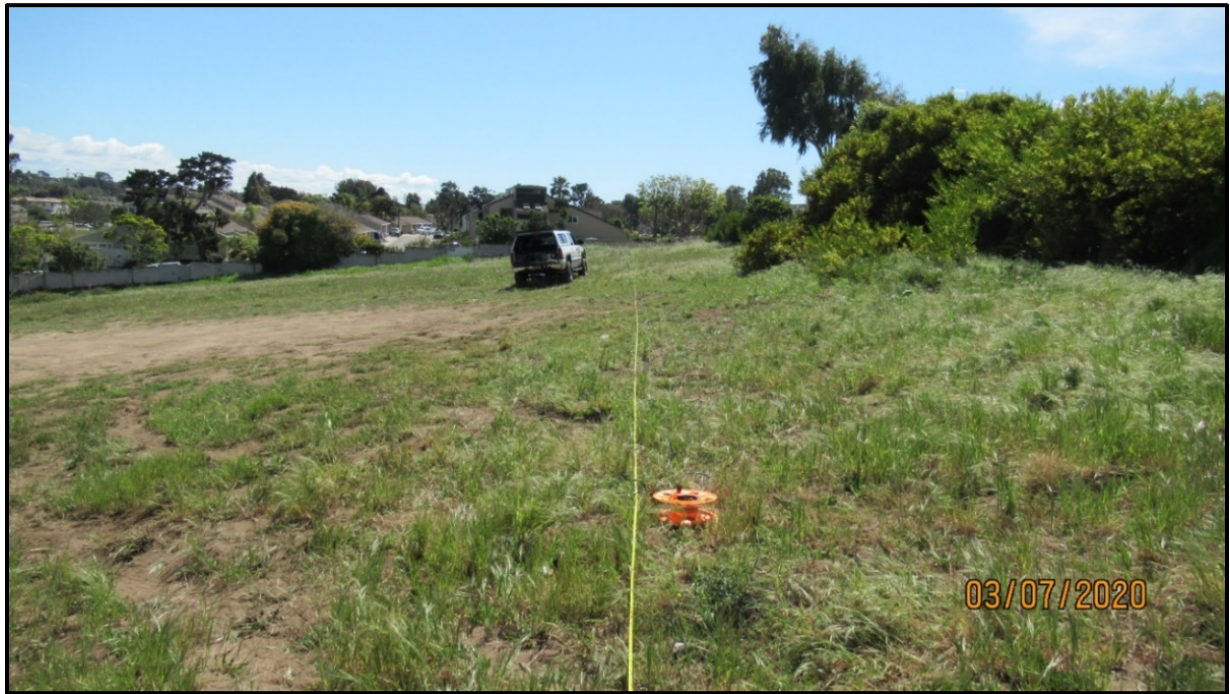
Figure 3-4. Seismic Survey Line, View towards the South

A 24-channel Geometrics StrataVisor NZXP model signal-enhancement refraction seismograph was used in conjunction with 24 4.5-Hz geophones spaced at regular intervals. For the MASW survey, two seismic records were obtained by multiple hammer strikes of a 16-pound sledge hammer on steel plates positioned 25 feet from the end of each terminus of the seismic line. Vibrations were recorded using a one second record length at a sampling rate of 0.5 milliseconds.

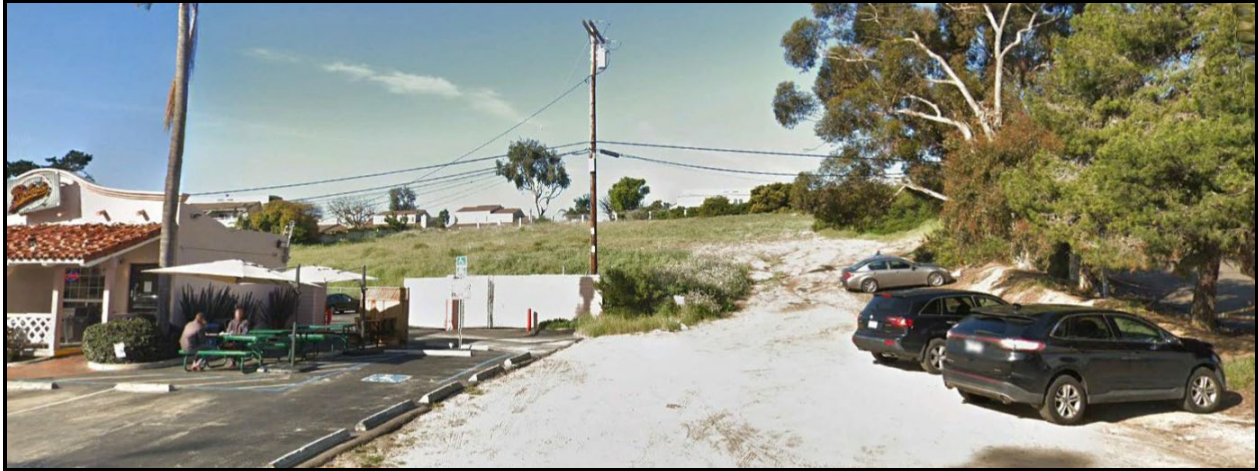
Figure 4-2. Surface Conditions

Figure 4-2 (following page) depicts surface conditions looking west from Parcel 06 to 21.

The western edge of the site is a north-south trending ridge with elevations between +88 feet and 95 feet msl. This ridge slopes to the east across Parcels 21 and 06 (the southern parcels) at a surface gradient of about 10%, descending about 30 feet to Highway 101. On Parcel 20, the parking lot areas have been graded into the slope, creating two benched areas, with slopes on the east and west.

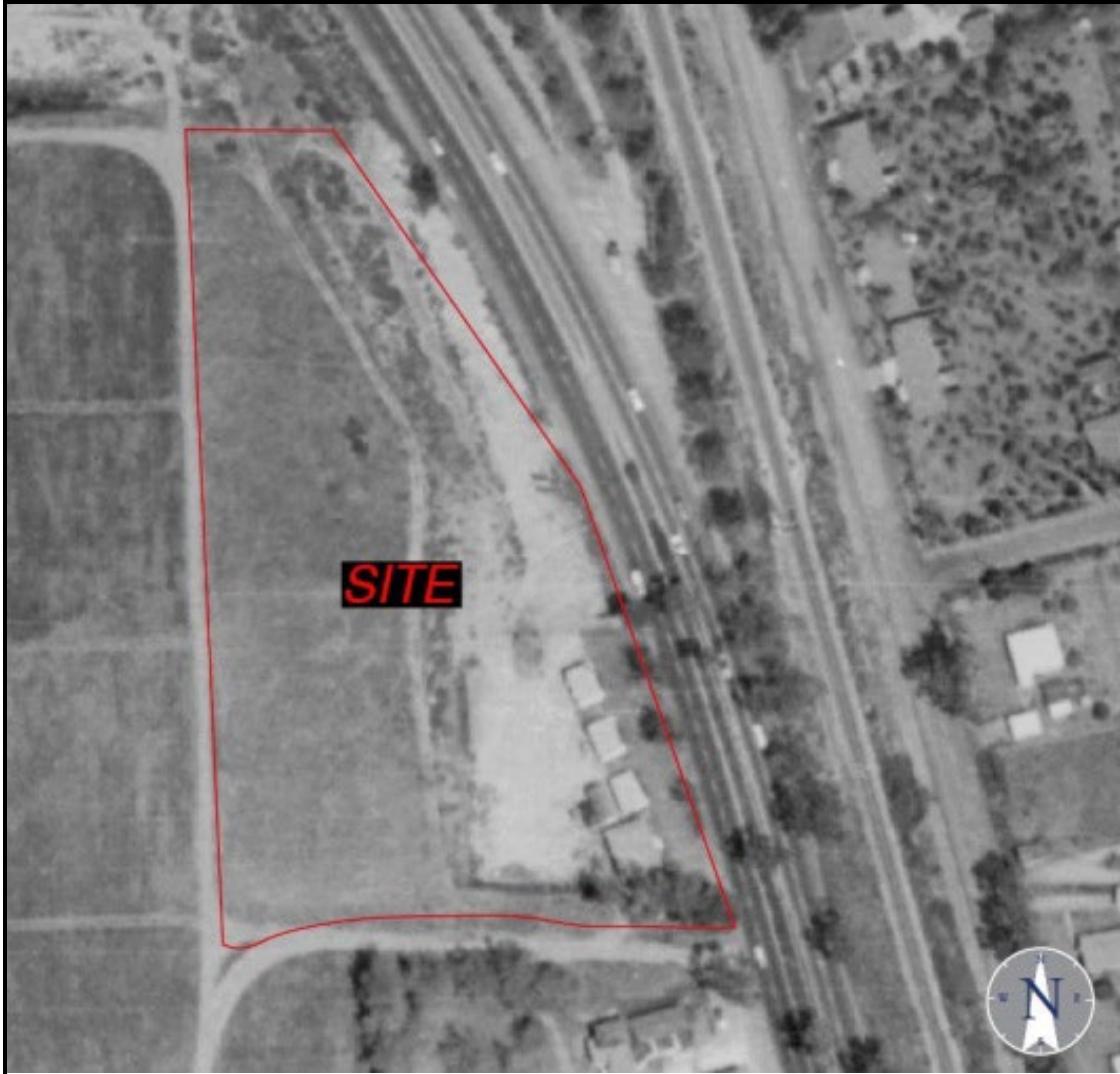
Figure 4-9. 1964 Aerial Photo

Figure 4-9 shows the site condition in 1964. Evident in review of this figure is that the parking lot behind the buildings on the southeast corner of the site was expanded by cutting into the slope to the west.

In addition to the parking lot cuts, in the northern portion of the site adjacent to Highway 101, the photo indicates cutting of the lower lying area between the road and the ascending slope to the west. This area is the existing right-of-way with wet and dry utilities installed within it.

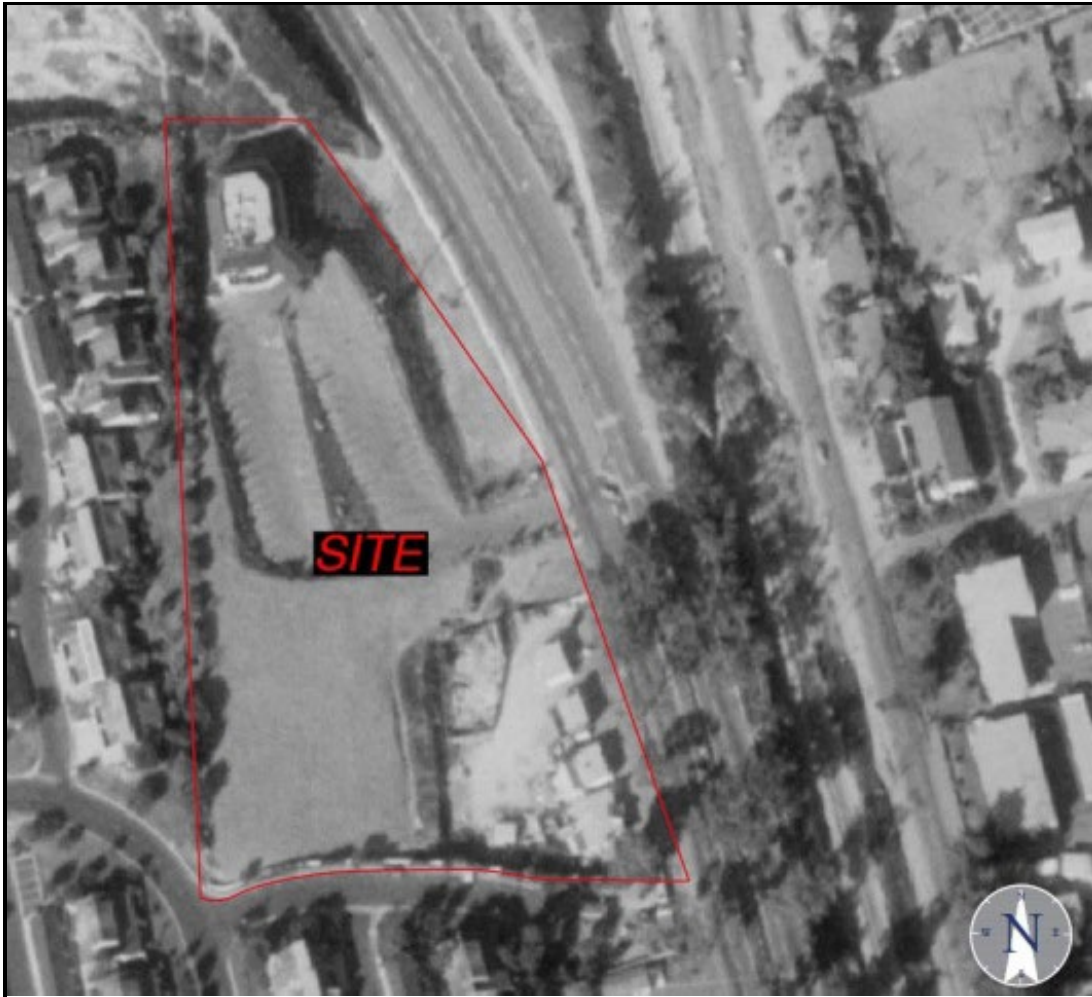
Figure 4-10. 1980 Aerial Photo

Figure 4-10 shows the site in 1980. Evident in this figure is the southeast parking lot graded to the present day configuration with cut slopes exceeding 25%. Also evident in the north, are two parking lots serving the restaurant in the northern portion of the site that were cut into the natural slope, creating manmade cut slopes steeper than 25% in order to accommodate parking.

Figure 4-10 may be compared to Figure 4-7 (and Plate 3), from which it can be seen that the graded slopes are those identified in Figure 4-7 as having grades exceeding 25%.

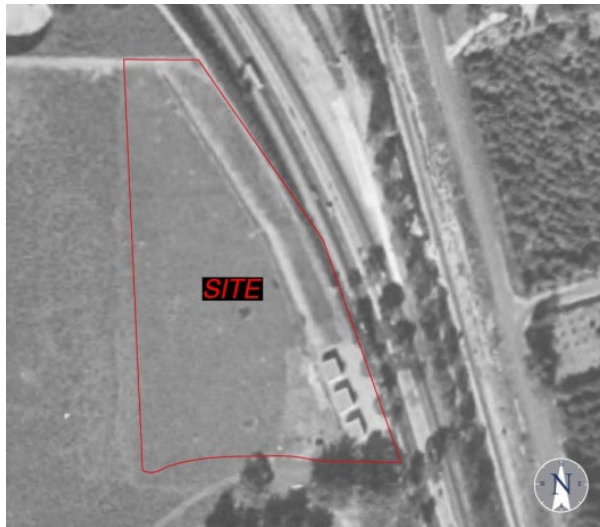
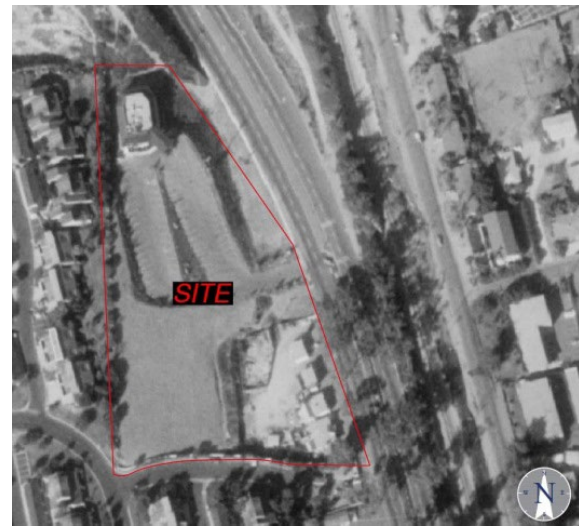
For further comparison, Figure 4-11a and Figure 4-11b (following page) juxtapose 1947 and 1980 photos for the purpose of presenting 'before grading' and 'after grading' site conditions. It appears clear that grading has altered the site over the period 1947 to 1980.

Figure 4-11a. 1947 Site Condition

Figure 4-11b. 1980 Site Condition
