**STORM WATER  
MANAGEMENT  
INVESTIGATION**

**TORREY CREST  
1220-1240 MELBA ROAD AND  
1190 ISLAND VIEW LANE  
ENCINITAS, CALIFORNIA**

**GEOCON**  
INCORPORATED

**JANUARY 8, 2021  
REVISED MARCH 21, 2021  
PROJECT NO. G2438-52-01**

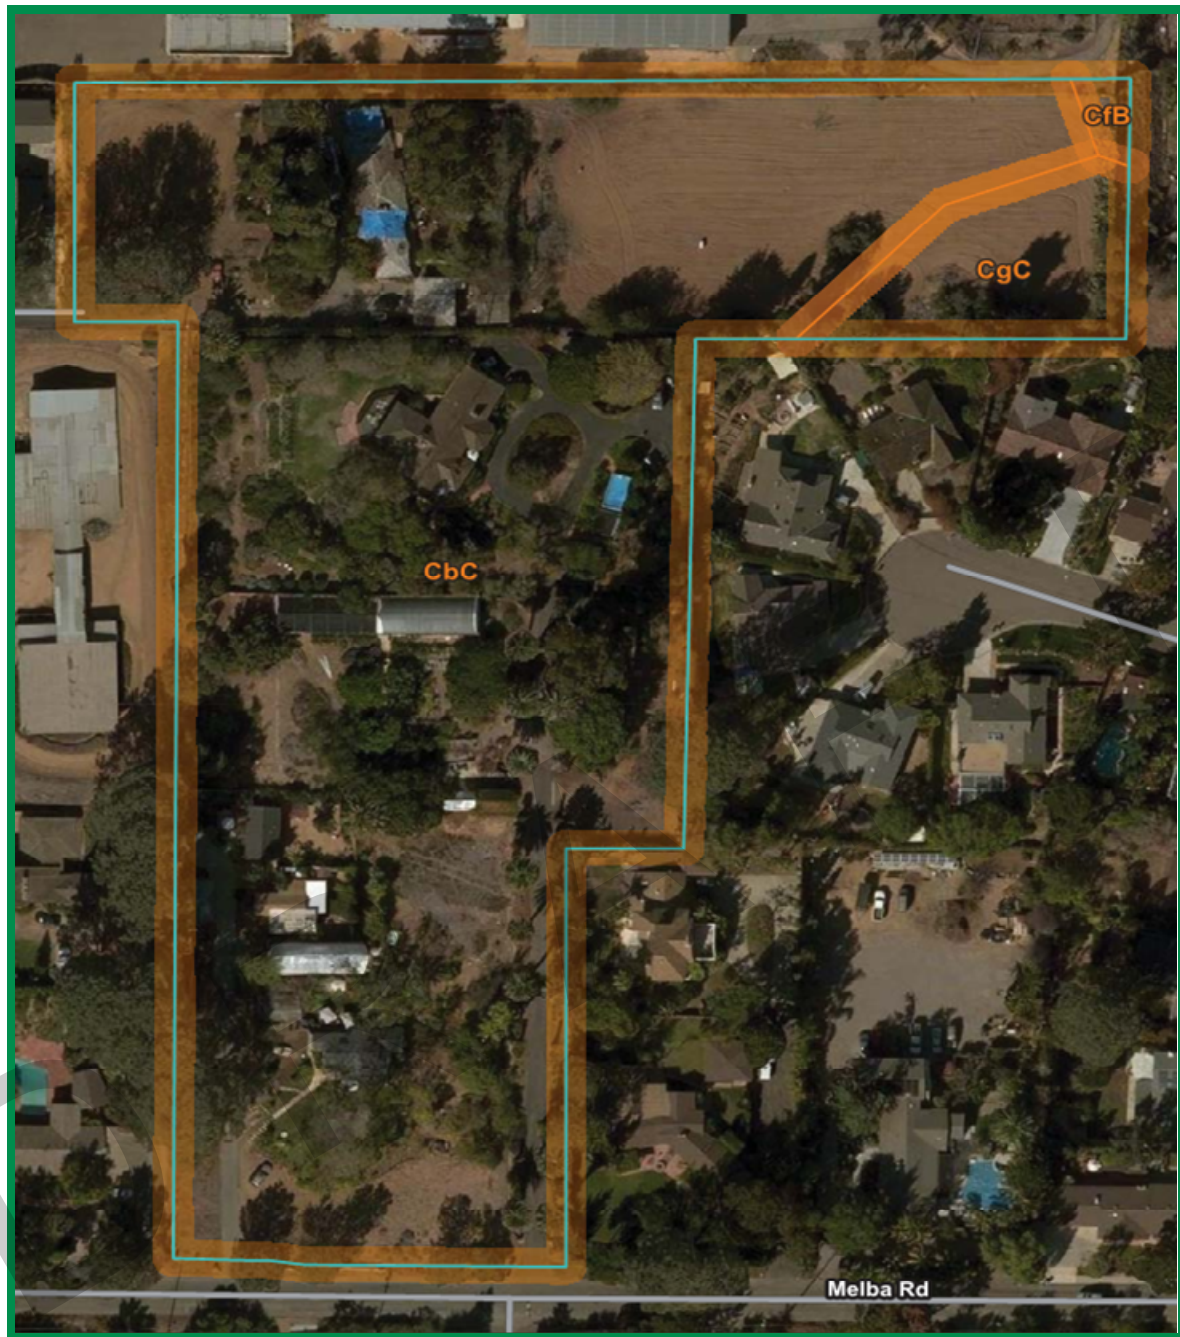
**Hydrologic Soil Group Map**

The property is surficially underlain by Very Old Paralic Deposits with very slow infiltration rates and should be classified as Soil Group D. The Hydrologic Soil Group Map presents output from the USDA website showing the limits of the soil units. Table 2 presents the information from the USDA website for the subject property.
