# North Coast Highway 101 Streetscape Project Leucadia Flood Abatement Design Marine Biology Technical Report

Technical Memorandum

## North Coast Highway 101 Streetscape Project

### Marine Biology Technical Report

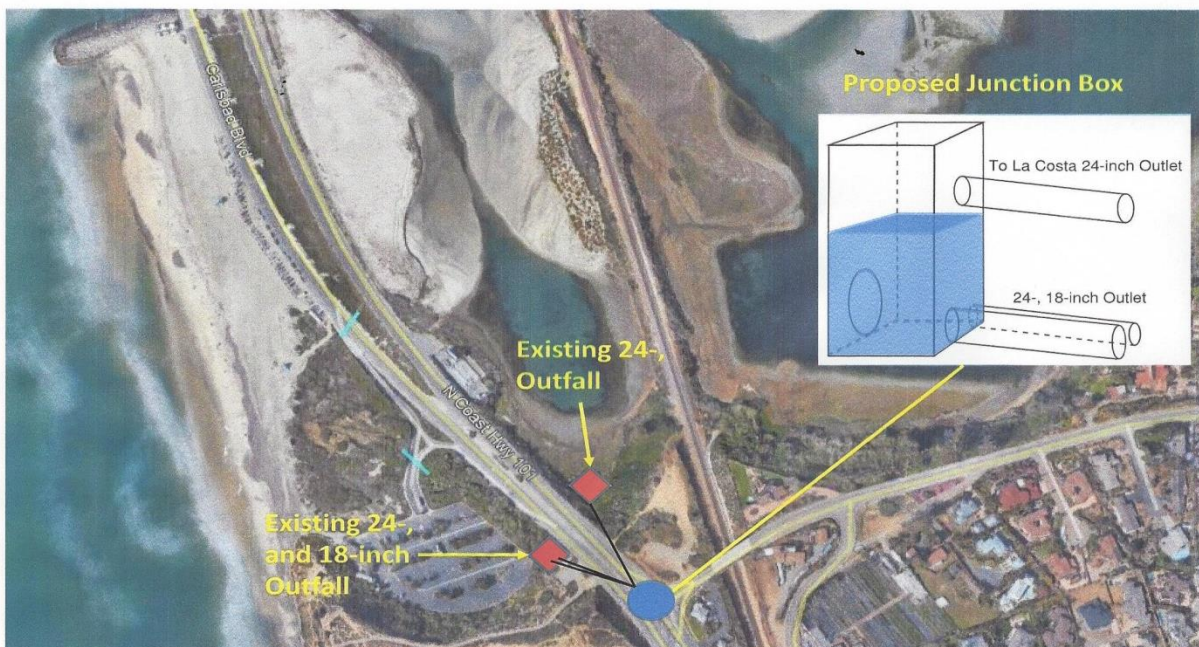
**Figure 1. Existing Batiquitos Lagoon stormwater outfalls and proposed junction box.**

The North Coast Highway 101 Streetscape Storm Drain Improvement Project includes the installation of storm drains and conduits along Highway 101 in Northwest Encinitas / Leucadia to reduce the potential for flooding in the area. The Project will install pretreatment basins for water quality treatment of stormwater before the water enters the conduit, which will flow to the Ponto Beach basin on the west side of Highway 101 and eventually out to the Pacific Ocean. During many rainfall events, the Ponto storm drain system will not be able to handle all of the runoff water, and in that event pretreated stormwater will be diverted into the West Basin of Batiquitos Lagoon (Figure 1).

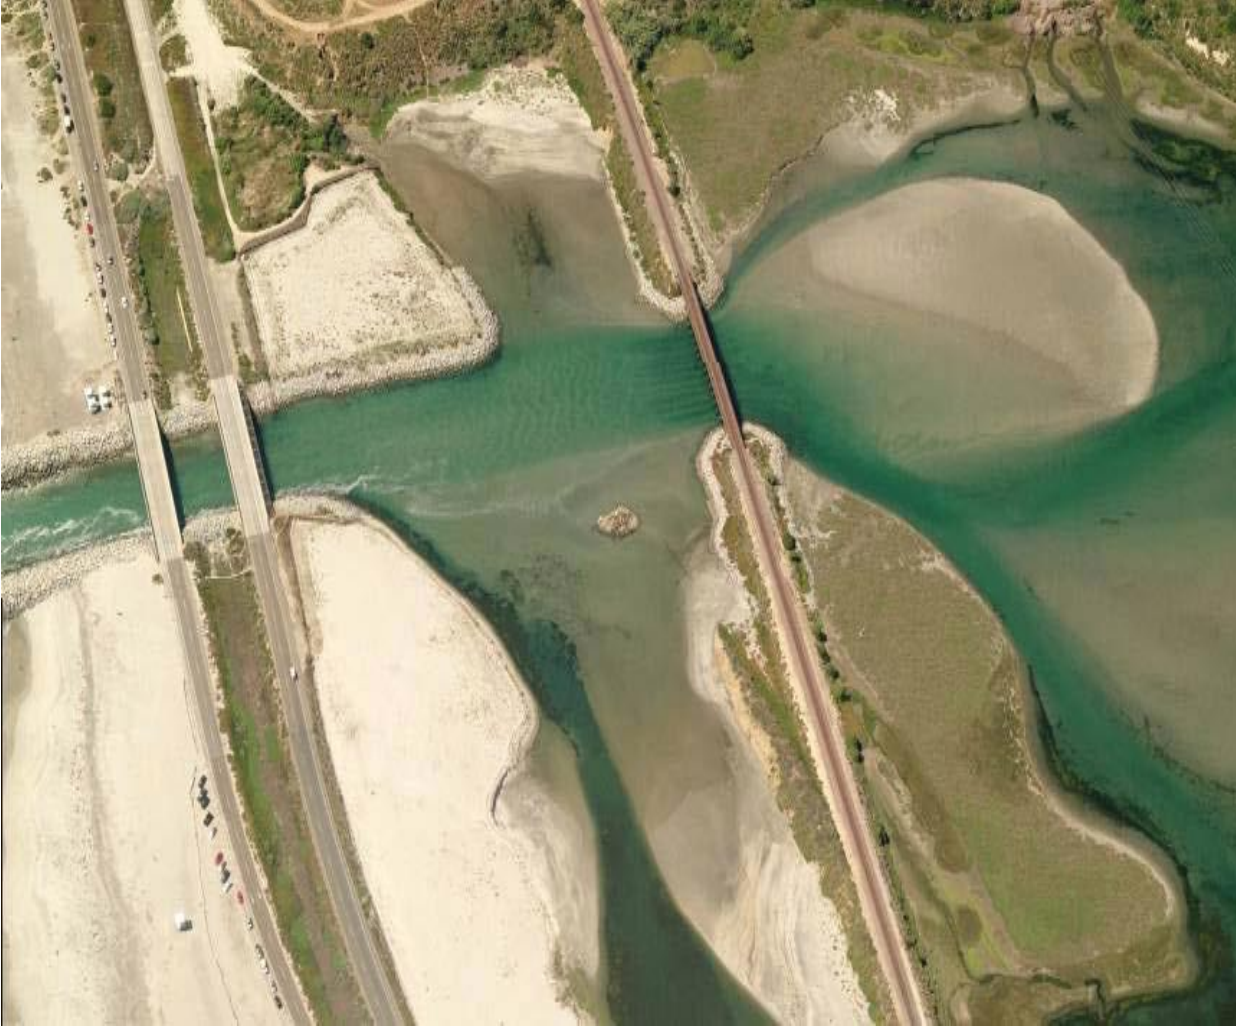
**Figure 4. Shoal conditions in the West Basin and East Basin in 2008 (from Merkel and Associates 2009).**

Maintenance dredging has not occurred frequently enough to prevent flood shoal accumulation well above the quantities envisioned by the original design (Merkel and Associates 2009). This resulted in a deteriorating tidal circulation pattern, with the lower end of the tidal range being truncated, increasing low tide lag behind the ocean tides, and a greater degree of distinction between the tidal patterns for the lagoon basins. The continued tidal muting of the lagoon by flood shoal accumulation combined with sediment infill at mid-tide elevation ranges resulted in reduction of the lagoon's tidal prism (Figure 4).
