**Section Three - Systems Description**

**Building Name:** *Fire Station 1*

**Building Name:** *Fire Station 4*

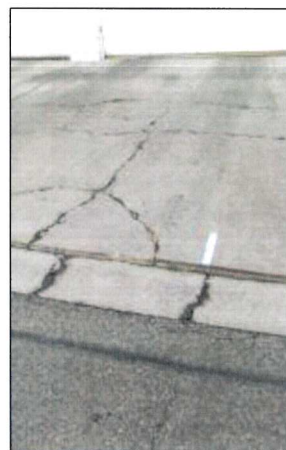
**Photo 28 – Fire Station #1** The concrete at the garage is severely cracked and deteriorated. Loss of underlying support is also evident.

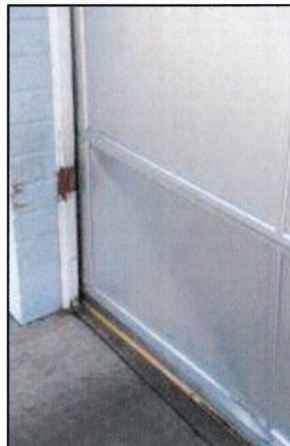
**Photo 32 – Fire Station #1** Garage doors display evidence of impact damage.

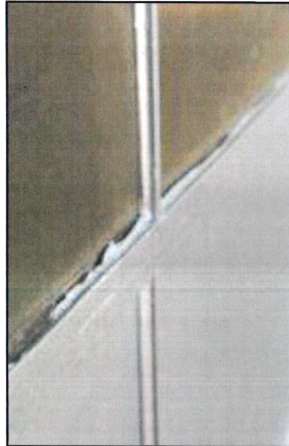
**Photo 33 – Fire Station #1** Garage doors exhibit peeling and chipping of frame paint..

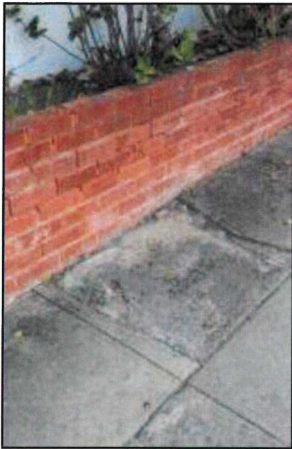
**Photo 61 – Fire Station #1** Concrete sidewalk exhibits deterioration through scaling and spalling.

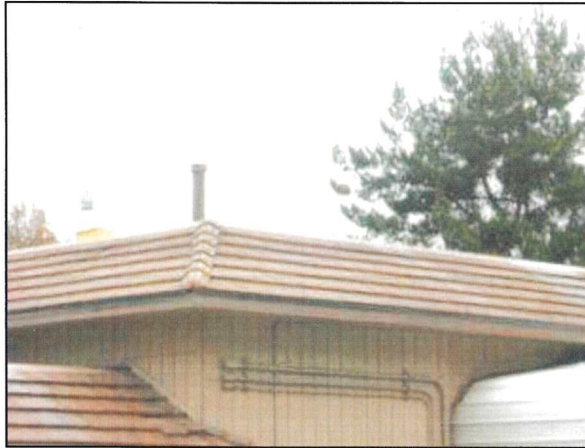
**Photo 5 – Fire Station #4** The garage is ventilated by means of a vehicle exhaust system that is mounted on the roof. The system is similar to that present in Fire Station #5.

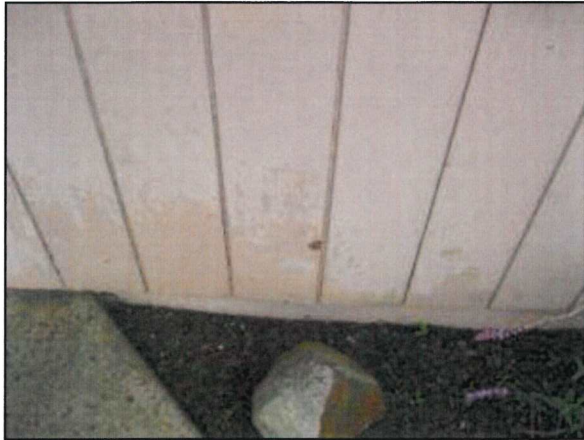
*Photo 33 – Fire Station #4* The fire station structure is sheathed in 5/8" T-111 plywood siding.

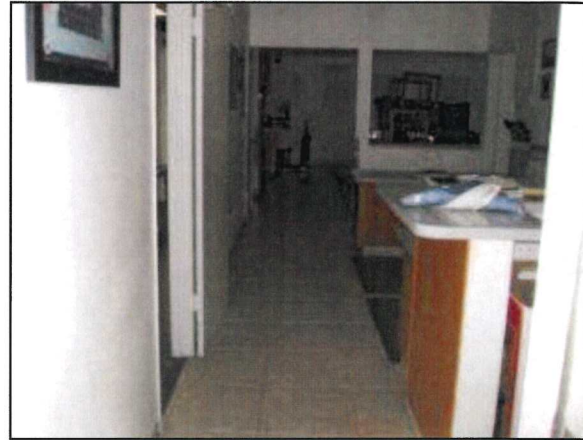
**Photo 58 – Fire Station #4** The entrance from the garage to the office area exhibits ceramic tile flooring.

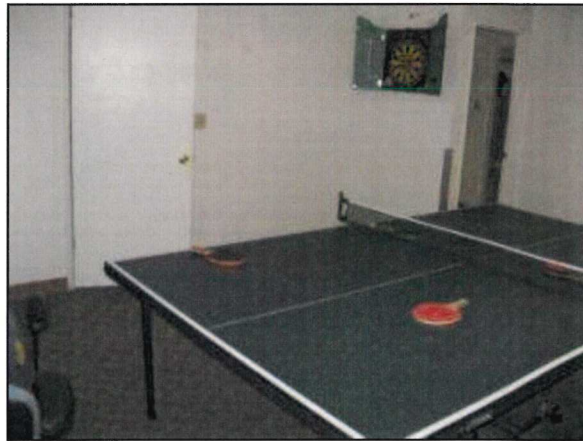
*Photo 68 – Fire Station #4* A general view of the game room.

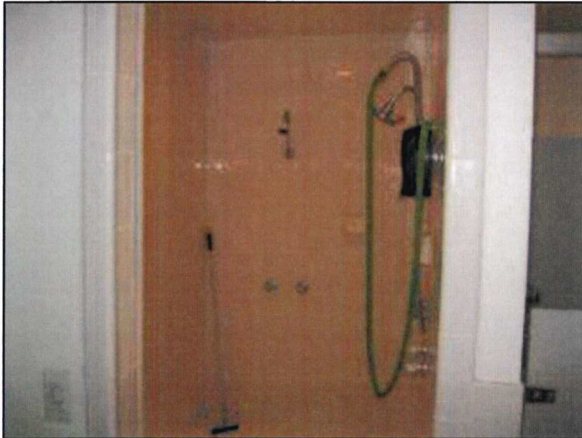
**Photo 73– Fire Station #4** The shower in the main restroom.
